home-approved®

your survey report

████████████████████ **Gerrards Cross, Bucks, SL9** ██████████

Client	████████████████████
Date of Inspection	2 June 2015
Inspection Completed by	Matthew Brown AssocRICS

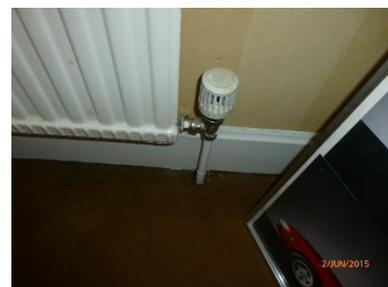
Not all radiators are fitted with TRV's

Estimated costs £700-800.00

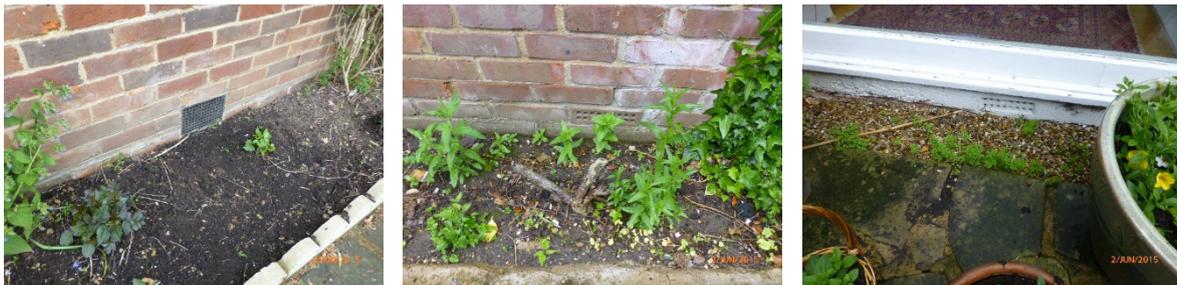
Details/Defects/Issues: There is a lack of ventilation to the suspended timber floor as the air bricks are too small and too few in number.

Air bricks are too small and few in number

The existing air bricks should be increased in size to a minimum of 225mm square and additional air bricks should be installed to the front, side and rear elevations in accordance with BS 5250. Air bricks should be provided with grills to prevent entry by rodents.

Estimated costs £600-700.00

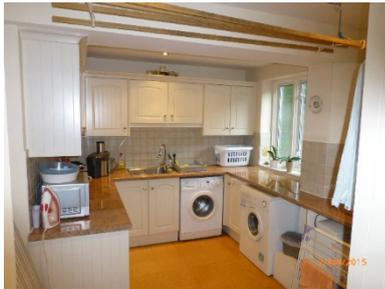
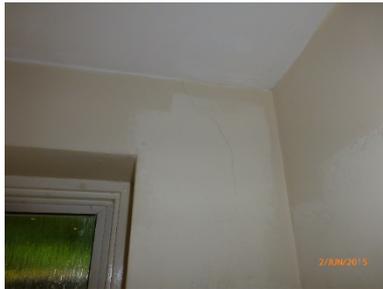
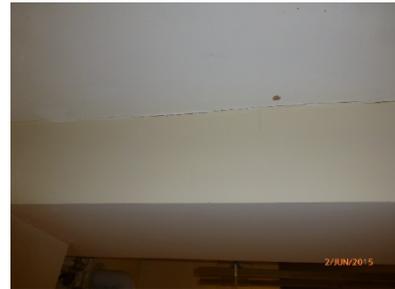
Details/Defects/Issues: The ceiling and walls are finished smooth and painted with emulsion. There is cracking to the ceiling line and to the walls. None of the cracks suggest significant building movement or distortion and are more likely the result of general settlement and expansion. Prior to decoration the walls should be lined in Wallrock and the joint between the ceiling and walls should be raked out, prepared and sealed with flexible acrylic sealant. 'Wallrock' is a non-woven material which is suitable for covering up untidy and poorly plastered surfaces including cracks.

Cracks to the walls and the ceiling

Estimated costs £300-400.00 (decoration)

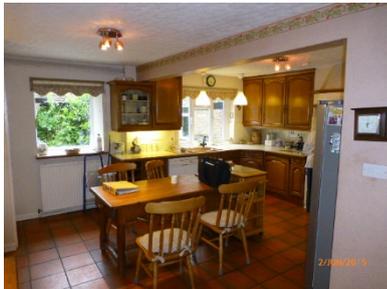
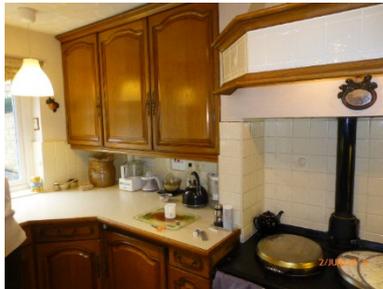
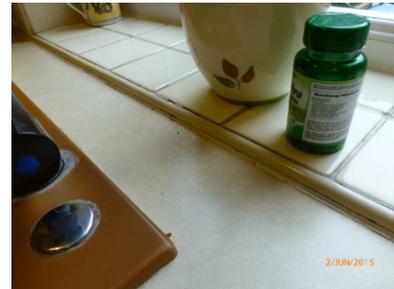
There is a cooker hood fitted above the hob but this does not duct through an external wall. Use of domestic appliances can create steam and moisture and you are advised to either duct the extractor fan through the rear facing external wall or install a mechanical means of ventilation in line with Approved Documents F and L of the Building Regulations 2010. This should be in the form of an extractor fan with a 15 minute overrun timer facility. A three pole isolation switch should also be installed.

The silicone sealant to the edges and abutments of the worktops has been poorly applied and will need to be replaced. The existing silicone will need to be completely removed prior to applying the new sealant in one continuous application. It is important to ensure that these areas are correctly sealed as water escaping often goes unnoticed and serious damage can be caused to walls, flooring and floor timbers.

The joint between the worktops to the right side of the sink is swollen which is an indication that moisture has been able to penetrate the joints over time and cause swelling to the chipboard below the laminate. The only effective way to address the issue would be to remove and replace the worktops.

Extraction is not externally ducted

Sealant to the worktops is poor

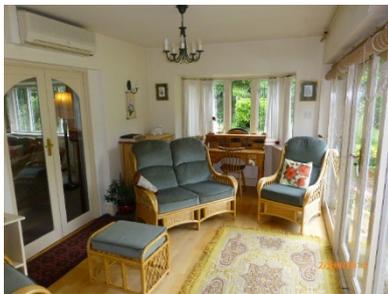
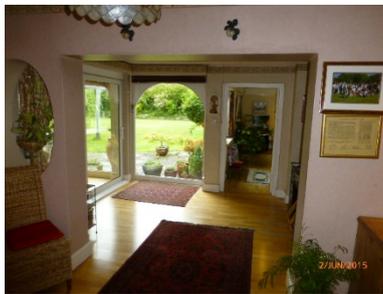
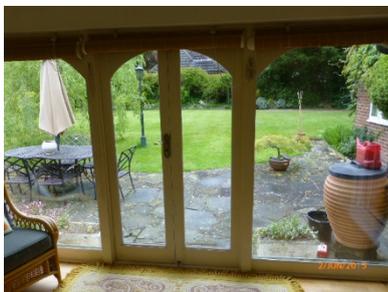
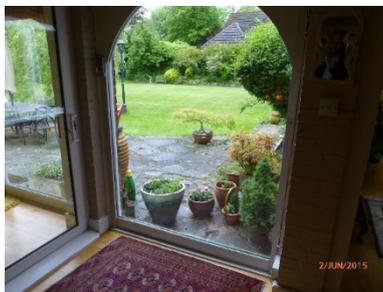
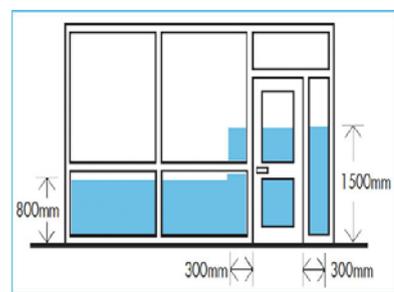
Details/Defects/Issues: The glazing to the rear facing windows is not toughened. This is a safety issue and in accordance with Approved Document N of The Building Regulations 2010, glass within a critical location should be toughened with each pane carrying the British Standard reference to confirm compliance.

The ceiling and walls are finished smooth and painted with emulsion. There is water staining to the ceiling and blistering to the wall above the window and to the right side of the door. The vendor advised there had been an issue with a blocked gutter which had caused an overflow and saturation to the walls and this in turn had leaked through the ceiling. She advised that the water butt had been relocated and the areas were now drying. Moisture readings were taken in these areas and none of the readings were high or abnormal. Prior to decoration the affected areas should be fully prepared and sealed with an alkaline based sealer to prevent re-staining.

Glass to glazing panels is not correctly etched to confirm compliance

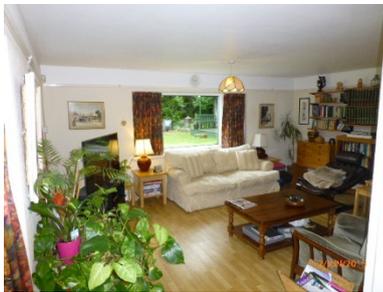
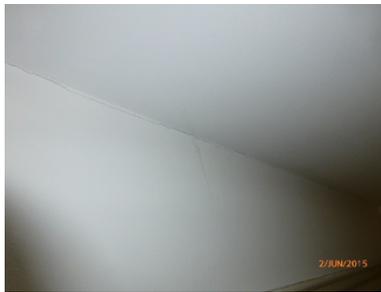
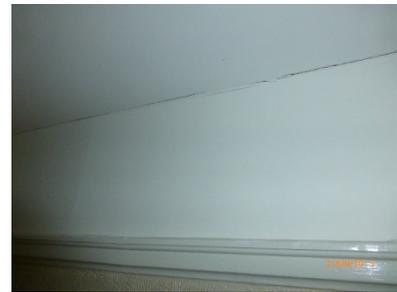
Details/Defects/Issues: The ceiling and walls are finished smooth and painted with emulsion. There is cracking to the ceiling line between the ceiling and walls. None of the cracks suggest significant building movement or distortion and are more likely the result of general settlement and expansion. Prior to decoration the joint between the ceiling and walls should be raked out, prepared and sealed with flexible acrylic sealant.

Cracking to the ceiling line

Estimated costs £200-300.00 (decoration)

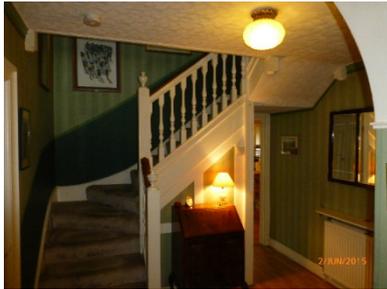
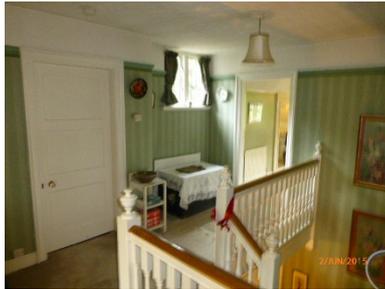
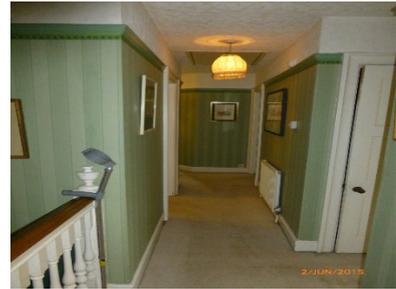
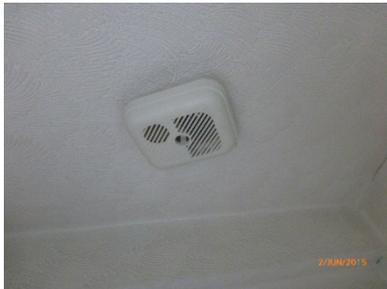
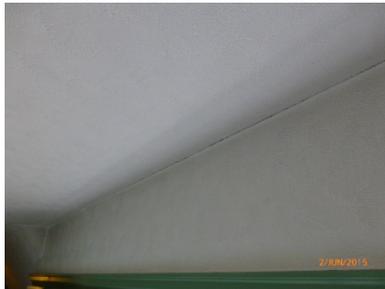
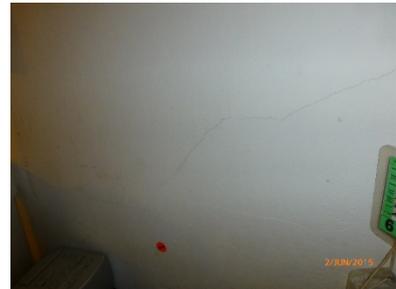
The ceiling and walls are finished smooth and painted with emulsion. There is cracking to the ceiling line between the ceiling and walls. None of the cracks suggest significant building movement or distortion and are more likely the result of general settlement and expansion. Prior to decoration the joint between the ceiling and walls should be raked out, prepared and sealed with flexible acrylic sealant.

The skirting inside the cupboard was cracked. None of the cracking suggests significant building movement or distortion and prior to decoration the ceiling should be lined in Wallrock.

Battery powered smoke detection

Cracks to the ceiling line

Crack to ceiling inside cupboard

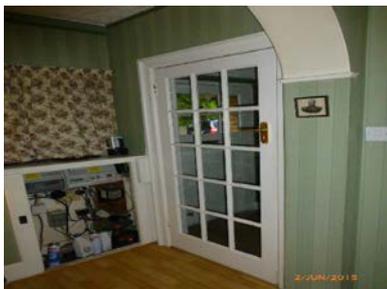
Details/Defects/Issues: The glazing to the entrance door is not toughened. This is a safety issue and in accordance with Approved Document N of The Building Regulations 2010, glass within a critical location should be toughened with each pane carrying the British Standard reference to confirm compliance.

Glass in a critical location

Estimated costs £200-300.00 (glazing)

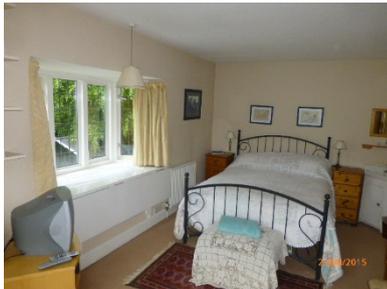
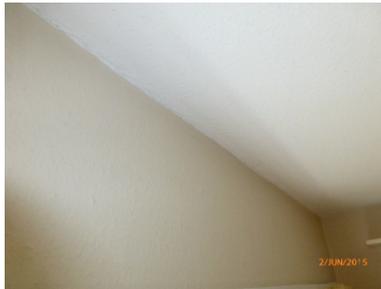
Details/Defects/Issues: The ceiling and walls are finished smooth and painted with emulsion. There is cracking to the ceiling line between the ceiling and walls. None of the cracks suggest significant building movement or distortion and are more likely the result of general settlement and expansion. Prior to decoration the joint between the ceiling and walls should be raked out, prepared and sealed with flexible acrylic sealant.

Cracks to the ceiling line

Estimated costs £200-300.00 (decoration)

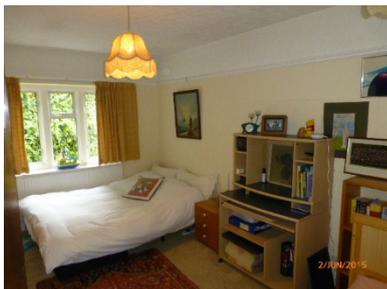
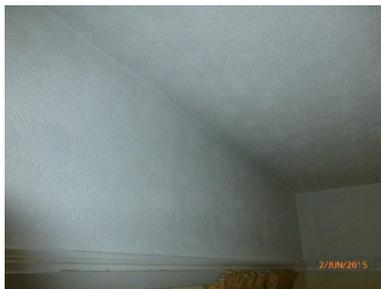
Details/Defects/Issues: The ceiling and walls are finished smooth and painted with emulsion. There is cracking to the ceiling line between the ceiling and walls. None of the cracks suggest significant building movement or distortion and are more likely the result of general settlement and expansion. Prior to decoration the joint between the ceiling and walls should be raked out, prepared and sealed with flexible acrylic sealant.

Cracks to the ceiling line

Estimated costs £200-300.00 (decoration)

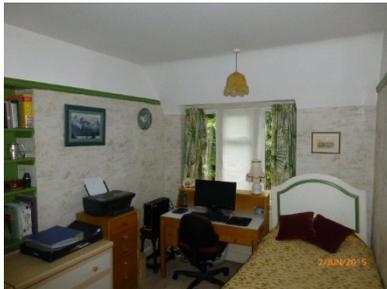
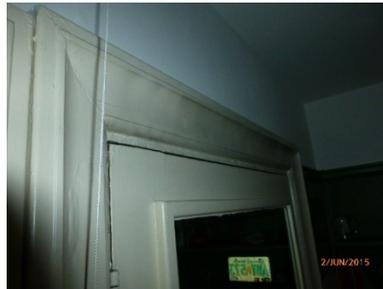
Details/Defects/Issues: The woodwork is finished in an oil based paint and the architrave surrounding the airing cupboard is stained with soot. This type of staining is consistent with the burning of candles within the room although there was no evidence of this at the time of the inspection. The woodwork will need to be washed down and then prepared and redecorated.

Staining to the door surround

Estimated costs £100-200.00 (decoration)

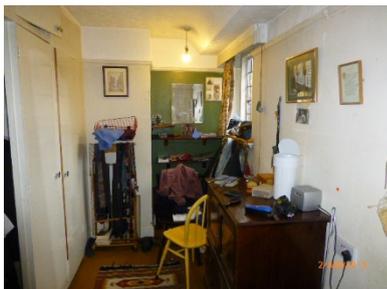
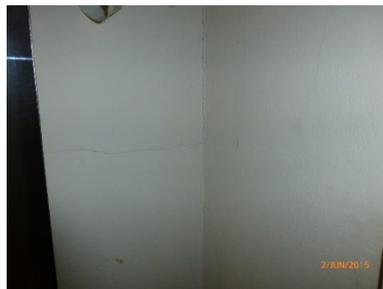
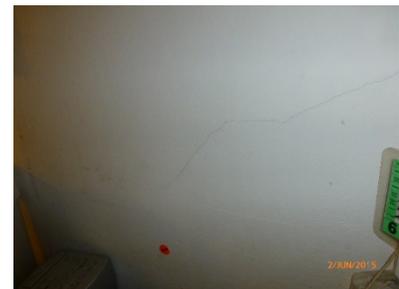
Details/Defects/Issues: The walls are finished smooth and painted with emulsion. There is cracking to the wall on the right side of the window and to the left side of the door. None of the cracks suggest significant building movement or distortion and are more likely the result of general settlement and expansion. Prior to decoration the wall should be lined in Wallrock.

Cracks to the wall

Estimated costs £200-300.00 (decoration)

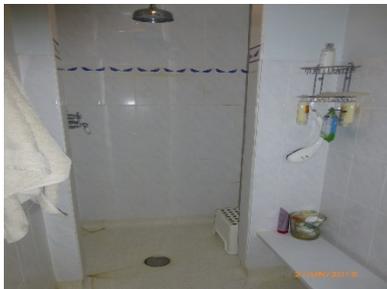
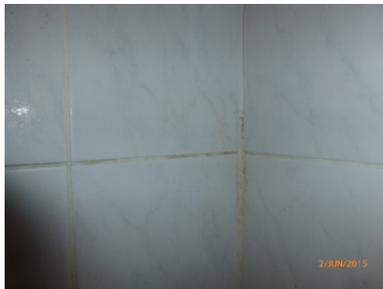
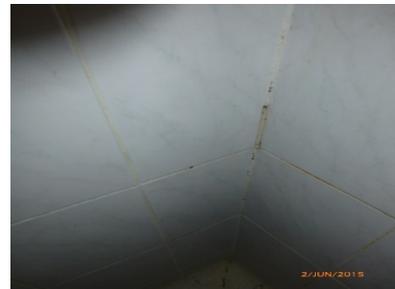
Details/Defects/Issues: The silicone sealant to the edges and abutments of the tiling has been poorly applied and will need to be replaced. The existing silicone will need to be completely removed prior to applying the new sealant in one continuous application. It is important to ensure that these areas are correctly sealed as water escaping often goes unnoticed and serious damage can be caused to walls, flooring and floor timbers.

There is a ceiling mounted extractor fan which ducts through the roof. The fan is not fitted with an overrun. Approved Document F of the Building Regulations 2010 advises that the extractor fan should be fitted with a 15 minute overrun timer facility and a three pole isolation switch. You are advised to seek further advice from an electrician and undertake remedial work as recommended.

Sealant to the abutments is poorly finished

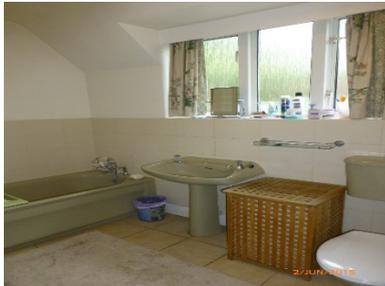
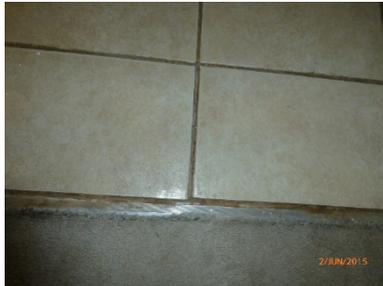
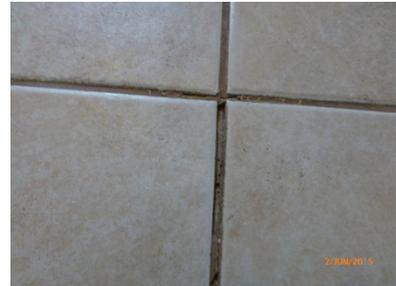
Details/Defects/Issues: The floor is covered with ceramic tiles. A number of the joints are loose and cracked. This is an indication that the tiles have been fixed with a non-flexible material. The tiles will need to be lifted and replaced and any new ceramic tiles should be fixed in place with flexible adhesive and the joints grouted with flexible grout.

No form of mechanical extraction is fitted within the room. Use of the shower or bath can create steam and moisture. You are advised to install a mechanical means of ventilation, in line with Approved Documents F and L of The Building Regulations 2010. This should be in the form of an extractor fan with a 15 minute overrun timer facility. A 3-pole isolation switch should also be installed. You are advised to seek further advice from an electrician and undertake remedial work as recommended.

Floor tiles are loose and the joints are cracked

Estimated costs £800-1000.00 (floor)

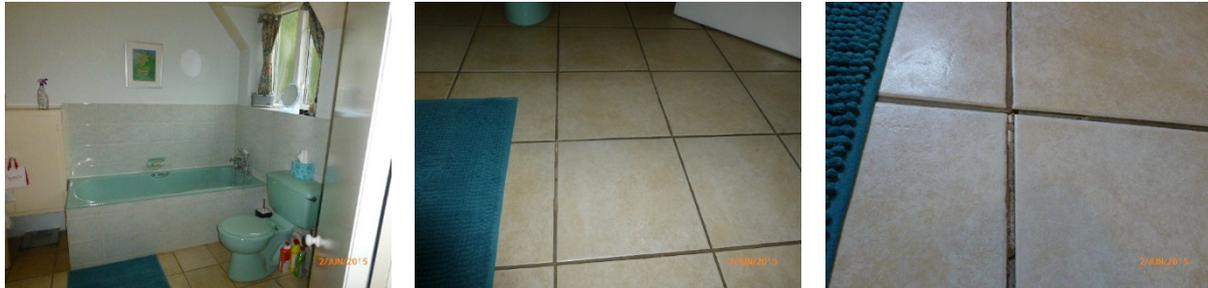
Details/Defects/Issues: The floor is covered with ceramic tiles. A number of the joints are loose and cracked. This is an indication that the tiles have been fixed with a non-flexible material. The tiles will need to be lifted and replaced and any new ceramic tiles should be fixed in place with flexible adhesive and the joints grouted with flexible grout.

No form of mechanical extraction is fitted within the room. Use of the shower or bath can create steam and moisture. You are advised to install a mechanical means of ventilation, in line with Approved Documents F and L of The Building Regulations 2010. This should be in the form of an extractor fan with a 15 minute overrun timer facility. A 3-pole isolation switch should also be installed. You are advised to seek further advice from an electrician and undertake remedial work as recommended.

Floor tiles are loose and the joints are cracked

Estimated costs £800-1000.00 (floor)

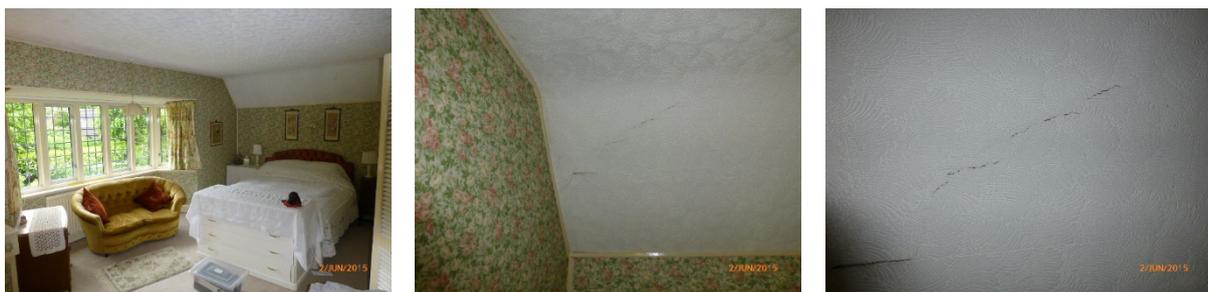
Details/Defects/Issues: The ceiling is finished in emulsion painted embossed paper. There is a crack to the skirting to the right side of the side facing window. None of the cracks suggest significant building movement or distortion and are more likely the result of general settlement and expansion. Prior to decoration the ceiling will need to be stripped and then lined in Wallrock and painted in emulsion paint.

Crack to the skirting

Estimated costs £300-400.00 (decoration)

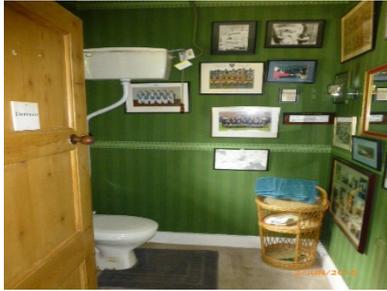
Details/Defects/Issues: No form of mechanical extraction is fitted within the room. You are advised to install a mechanical means of ventilation, in line with Approved Documents F and L of The Building Regulations 2010. This should be in the form of an extractor fan with a 15 minute overrun timer facility. A 3-pole isolation switch should also be installed. You are advised to seek further advice from an electrician and undertake remedial work as recommended.

No mechanical extraction

Estimated costs £400.00 (mechanical ventilation)

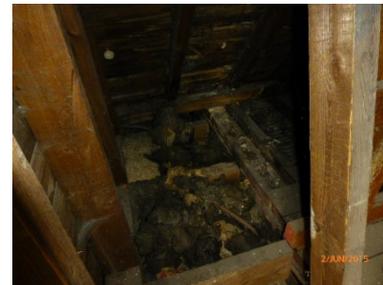
Details/Defects/Issues: The front section of the roof has recently been insulated and upgraded however the rear section remains fully boarded and the insulation in this area is inadequate. A small area behind the water storage tank provided access to the floor void where there was no evidence of insulation. Insulation should be upgraded in line with Approved Document L1B of The Building Regulations 2010 advises an insulation thickness of a minimum 270mm over the entire roof area with an allowance at the eaves for continuous airflow. This should also include insulation to the loft hatch in the form of compressed foam or similar.

Rear loft is fully boarded and not adequately insulated

Estimated costs £600-700.00

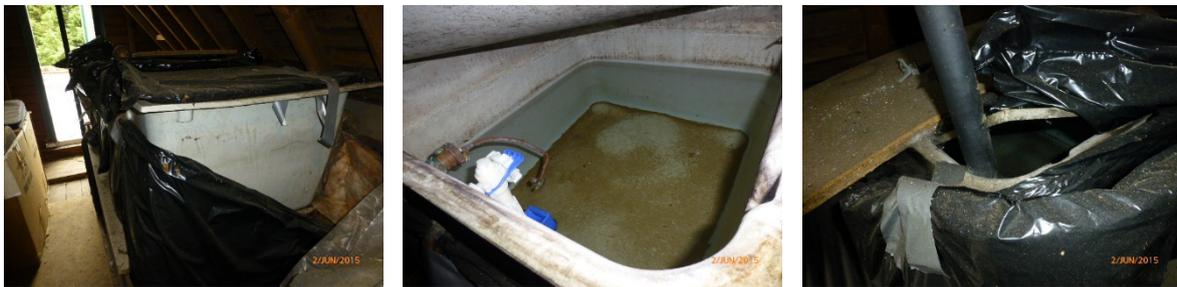
Details/Defects/Issues: The current cold water storage is not fitted with a Bye-law 30 kit and as a result the water is contaminated with dust and loft particles. A plumbing contractor should attend and drain down and sanitise the cold water tank and then re-fill. A Bye-law 30 kit should then be fitted to the cold water storage tank.

The pipes within the loft area are poorly insulated. All pipes should be lagged with foam insulation or similar and joints should be sealed with tape.

Cold water storage tanks are poorly sealed and the water is contaminated

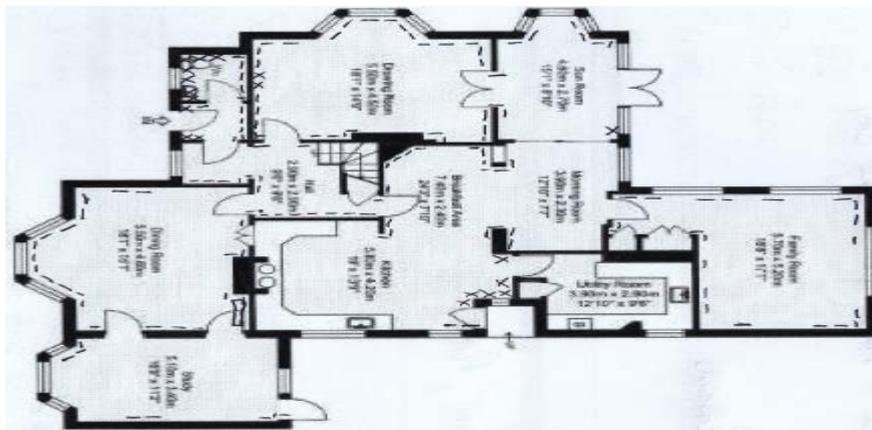
The walls to the WC, lounge 2, sunroom and kitchen provided high moisture readings. This is an indication of either rising damp or possibly an escape of water from the plumbing installation. Without further investigatory work, it is not possible to be certain of the cause of the problem but in my view, it is likely to be a failure in the DPC and the high ground levels externally.

It is recommended you seek advice from a contractor accredited to the Property Care Association (PCA) who can determine the cause of any issue, most effective method of treatment and the associated costs.

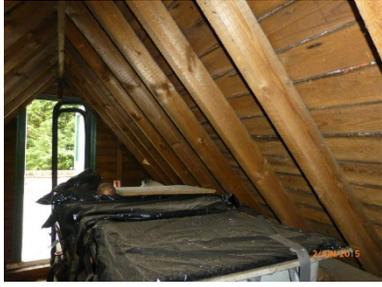
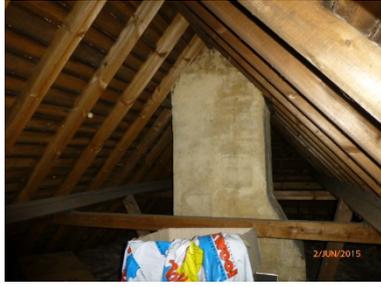
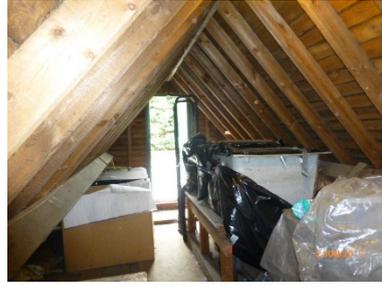
Details/Defects/Issues: The loft is accessible from the landing. An inspection revealed a traditional timber frame design typical for this type of building with no evidence of significant distortion. Some general splitting and staining of the timbers was observed but this is merely consistent with the building's age.

Roof is well constructed braced and supported

Whilst there was no evidence of wood boring insects at the time of the inspection, given the age and overall condition of the property, we would strongly advise that an appropriate timber treatment is carried out by a contractor accredited to the Property Care Association (PCA). The same contractor would also be best placed to advise further in regard to implications and costs.

It is essential for insulated roof voids with an underlay to be ventilated to reduce the risk of condensation and consequential rot damage to roof timbers. Due to the absence of an underlay in this case no alterations are yet required but when the covering is eventually renewed ventilation should be provided at the same time.

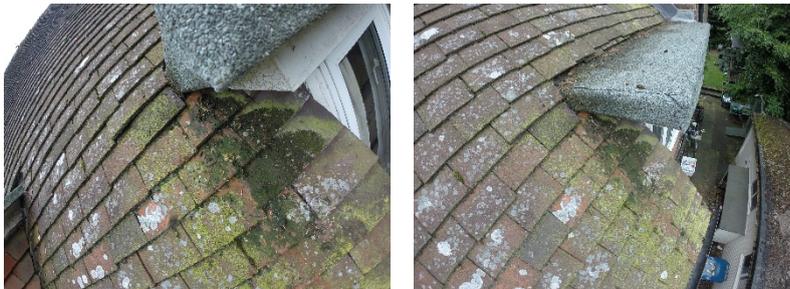
Details/Defects/Issues: A bumble bee nest was observed to the right side dormer window at first floor level. A specialist contractor should attend and establish if this can be moved. It is also important to check that this type of infestation is not protected in any way prior to attempting to remove or eradicate the issue.

Bumble bee nest in the side dormer window

Estimated costs £200-300.00

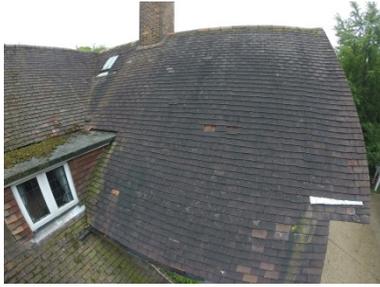
Some tiles to the roof slopes are missing/slipped/defective. These should be replaced with materials to match or re-fitted.

Missing/slipped/broken roof tiles

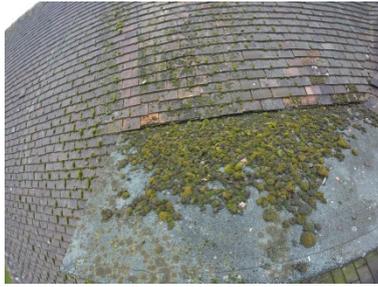
Spalled roof tiles

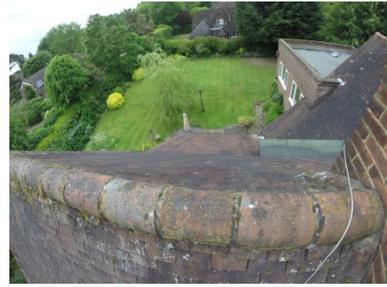
The mortar to the ridge tiles is loose and defective. The tiles need to be stripped, cleaned and then re-bedded on to new sand and cement mortar finished smooth. It is the practice of unscrupulous contractors to point over the existing mortar joints. This is not an acceptable form of repair.

Loose and defective ridge mortar

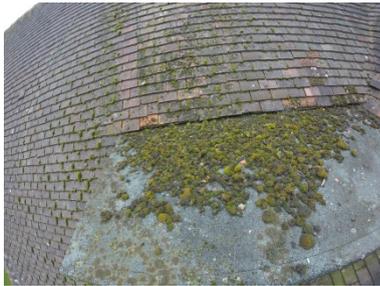
The felt coverings to the front dormer window and the right side bay roof are worn and you will need to consider replacement within a 2-3 year period. Costs have been provided below on an advisory basis as currently the roofs have not failed.

Front bay roof is worn

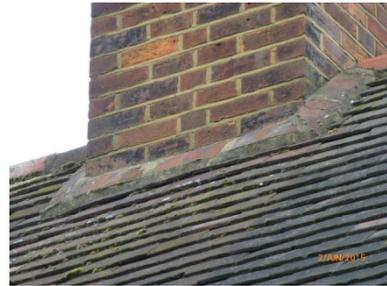
The edges and abutments which are currently sealed with cement/tiled fillets should be replaced with a more flexible material such as lead. The lead should be cut, wedged and pointed into the building.

Abutments are poorly sealed

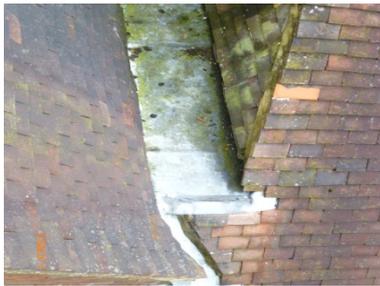
The lead lining to the rear valley is worn and will need to be replaced.

Lead valley is worn

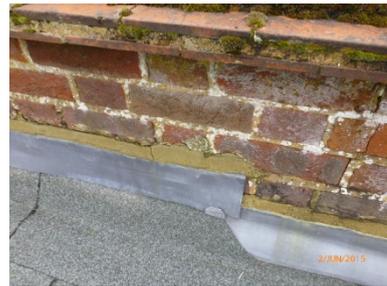
The abutment flashing to the rear balcony roof is lead and the pointing is loose and some sections of the lead have fallen away. The lead needs to be fully secured and the joint raked out and repointed.

Loose and defective pointing to the rear flat roof flashings

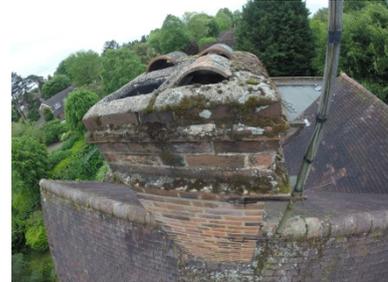
Front chimney

The pointing to the brickwork of the chimneys is loose and defective in several places. The joints will need to be raked out, prepared and re-pointed.

Loose and defective pointing

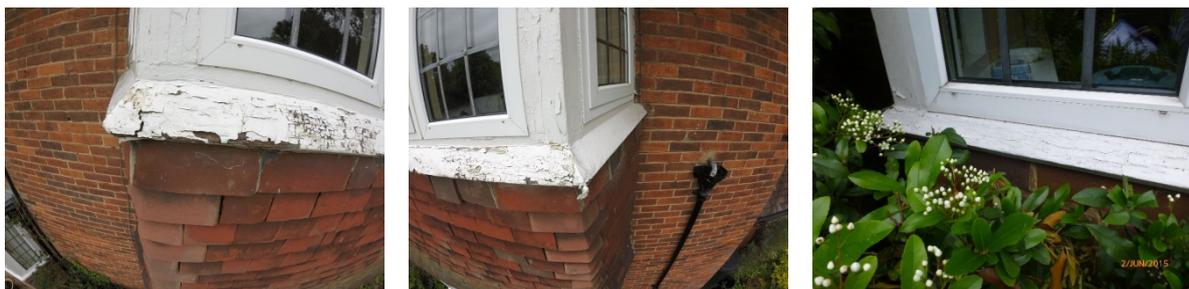
Wooden window frames are in a poor state of repair

Estimated costs £12,000-15,000.00 (replacement windows)

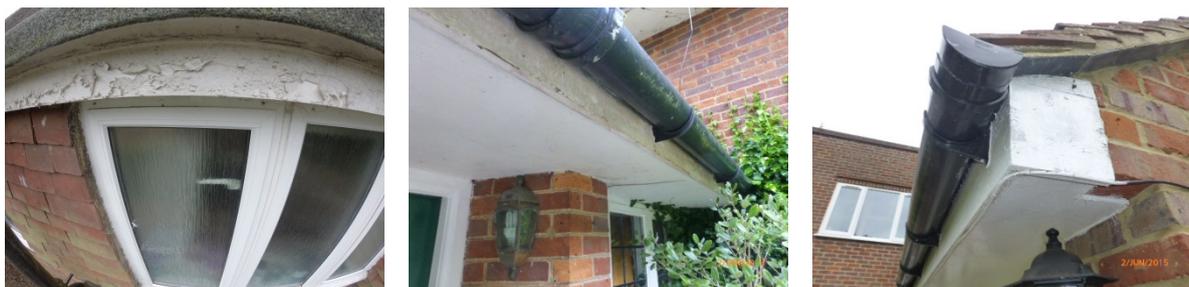
Decoration to the soffit and fascia boards is in a poor state of repair

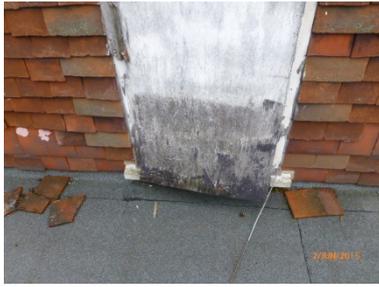
Loft door to balcony is worn

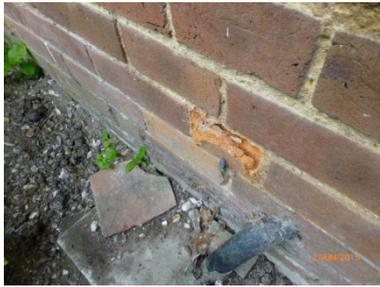
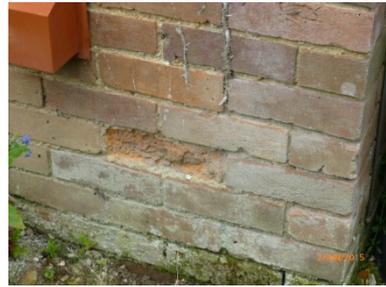
Loose pointing and spalled brickwork to the front and left side

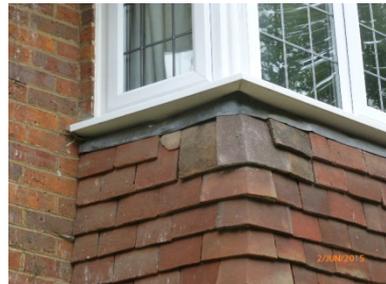
Missing hanging tiles to the various elevations

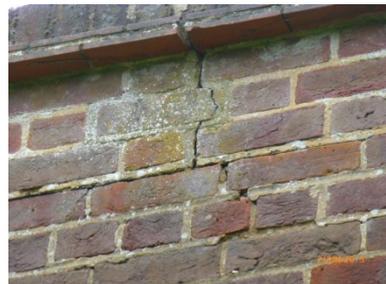
Deflection to the brickwork above the rear facing window

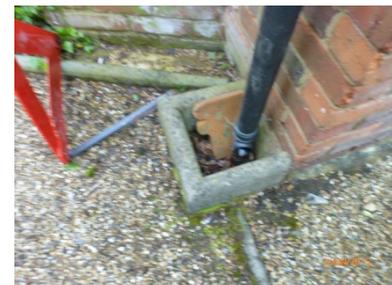
Open hoppers to the front, sides and rear

Estimated costs £100.00

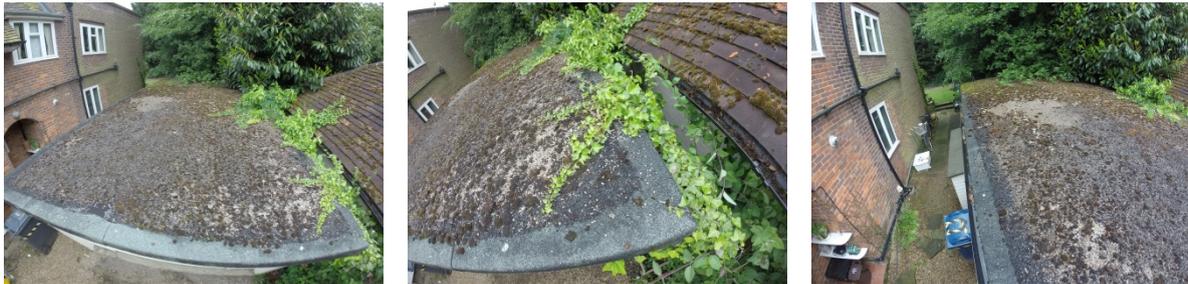
Details/Defects/Issues: There is a detached timber built garage to the right side. The roof to this is finished flat and covered with felt. The felt is showing signs of deterioration and you will need to consider the cost of replacement within a 2-3 year period. Costs have been provided below on an advisory basis.

Felt roof to the garage is worn

Estimated costs £2000-2500.00
