**home-approved®**

## your survey report

██████████, ██████████, Tadley, RG26 ██████████

<b>Client</b>	██████████
<b>Date of Inspection</b>	2 April 2015
<b>Inspection Completed by</b>	Matthew Brown AssocRICS

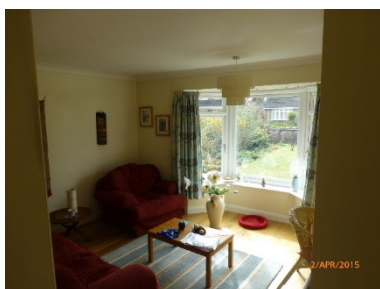
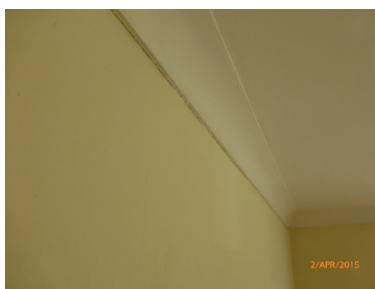
**Details/Defects/Issues:** The ceiling and walls are finished smooth and painted with emulsion. There is coving fitted to the perimeter of the ceiling. There is some cracking to the joints between the walls and ceiling. None of the cracks suggest significant building movement or distortion and are more likely the result of general settlement and expansion. Prior to decoration the joints should be raked out and sealed with flexible acrylic sealant.

Cracks to the coving joints

Estimated costs £200-300.00
-----------------------------

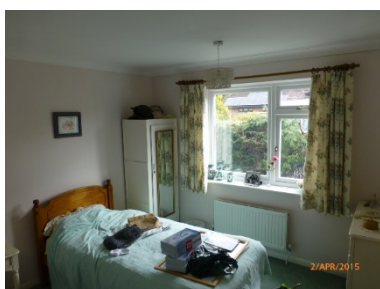
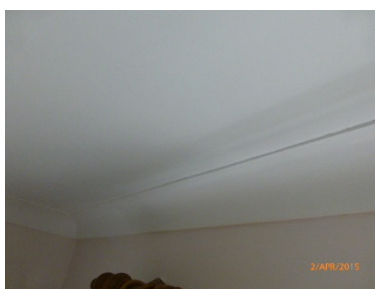
**Details/Defects/Issues:** The ceiling and walls are finished smooth and painted with emulsion. There is coving fitted to the perimeter of the ceiling. There is some cracking to the joints between the walls and ceiling. None of the cracks suggest significant building movement or distortion and are more likely the result of general settlement and expansion. Prior to decoration the joints should be raked out and sealed with flexible acrylic sealant.

Cracks to the coving joints

Estimated costs £200-300.00
-----------------------------

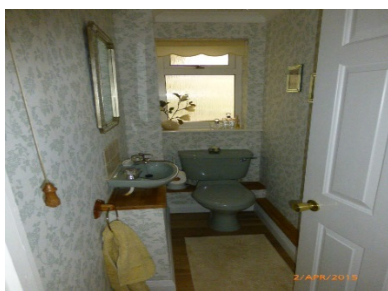
**Details/Defects/Issues:** There is no form of heating within this area. It is important that heating is balanced throughout the property to prevent the occurrence of cold spots, which can in turn cause condensation related issues. The central heating system should be extended and a fixed radiator fitted.

No form of mechanical extraction is fitted within the room. You are advised to install a mechanical means of ventilation, in line with Approved Documents F and L of The Building Regulations 2010. This should be in the form of an extractor fan with a 15 minute overrun timer facility. A 3-pole isolation switch should also be installed. You are advised to seek further advice from an electrician and undertake remedial work as recommended.

Estimated costs £200-300.00 (heating)

Estimated costs £400.00 (mechanical ventilation)

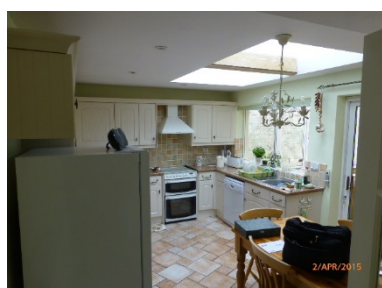
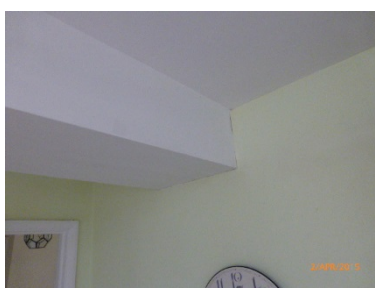
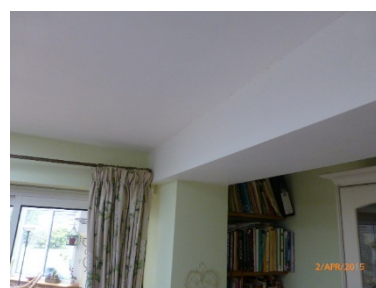
**Details/Defects/Issues:** The ceiling and walls are finished smooth and painted with emulsion. There is cracking around the boxed beam. None of the cracks suggest significant building movement or distortion and are more likely the result of general settlement and expansion. Prior to decoration the joints should be raked out and sealed with flexible acrylic sealant.

Cracking to the ceiling line around the drop down beam

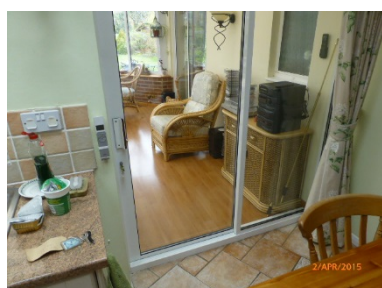
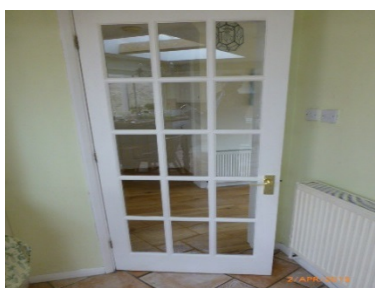
Glass to both doors is in a critical location

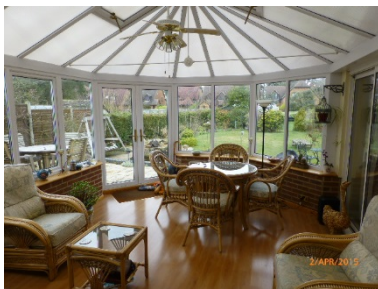
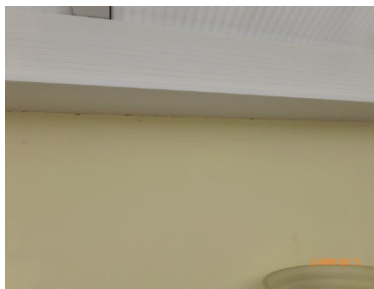
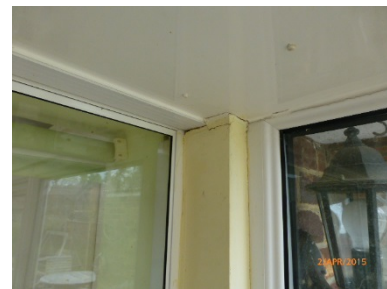
**Details/Defects/Issues:** The walls are finished smooth and painted with emulsion. At the joint between the wall and the uPVC cladding there is cracking and there is also poor finishing to the wall plaster around the window to the kitchen. None of the cracks suggest significant building movement or distortion and are more likely the result of differential movement between the wall and the uPVC. Prior to decoration the joints should be raked out and sealed with flexible acrylic sealant and the plasterwork around the window frame should be better finished and the joint sealed with flexible acrylic sealant.

Cracks to the tops of the walls and around the window/door frames

Estimated costs £200-300.00 (decoration)

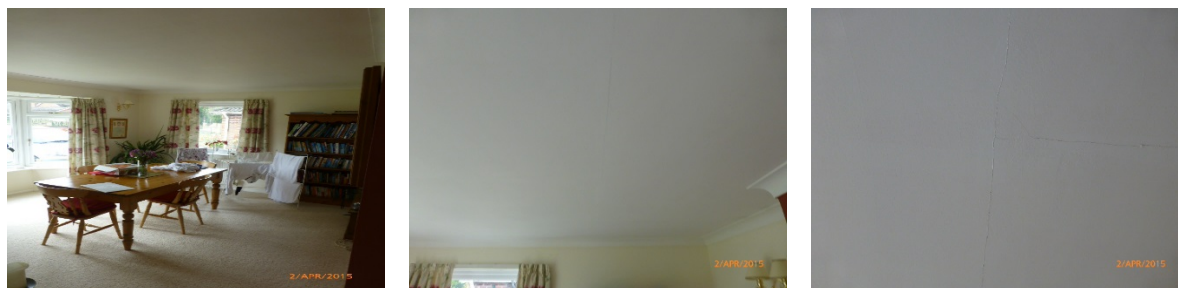
**Details/Defects/Issues:** The ceiling is finished smooth and painted with emulsion. There is cracking to the ceiling surface. None of the cracks suggest significant building movement or distortion and are more likely the result of general settlement and expansion. Prior to decoration the ceiling should be lined in Wallrock.

Cracks to the ceiling

Estimated costs £200-300.00
-----------------------------

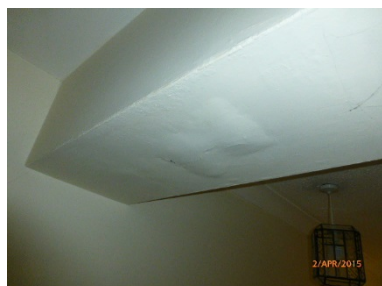
**Details/Defects/Issues:** There is a drop down beam in the ground floor rear hallway. The underside to the boxing is poorly finished and has blistered and distorted. This may be due to an historical escape of water and there was nothing observed at the time of the inspection to suggest that any leak was on-going. There was no staining or discolouration to the plasterwork. The defective area of boxing should be cut out and replaced and all decoration made good.

Damage to beam boxing

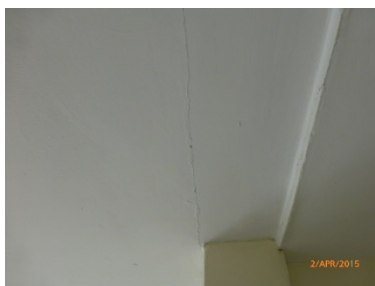
The landing ceiling is finished in a textured coating. Textured coatings are known to potentially contain asbestos and further information is provided later in the report. There is cracking to the landing ceiling surface. None of the cracks suggest significant building movement or distortion and are more likely the result of general settlement and expansion. Due to the textured finish it is not possible to effectively repair these areas and our advice is that the ceiling should be over-boarded with plasterboard, finished smooth in plaster and completely redecorated.

Cracks to the landing ceiling

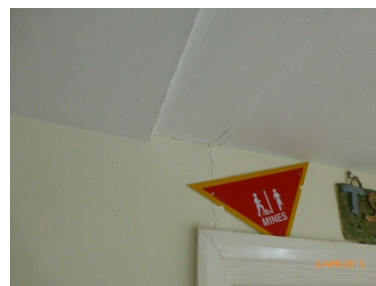
There is cracking above the door to bedroom 2. None of the cracks suggest significant building movement or distortion and are more likely the result of differential movement between the solid wall and the stud wall over the door. Prior to decoration the wall should be lined in Wallrock.

Crack above bedroom door

Estimated costs £200-300.00 (decoration)
--

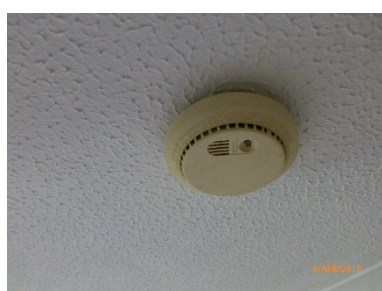
The current provision for smoke/heat detection within the property is battery powered only which falls below current standards set out in Approved Document F of The Building Regulations 2010. Provision should be made for the installation of a mains powered, fully linked smoke/heat detection system to the property.

Battery powered smoke detection

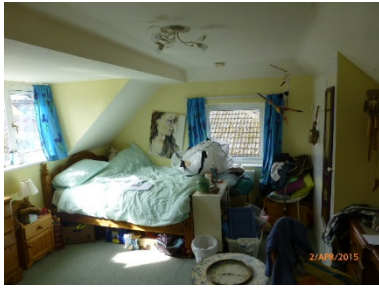
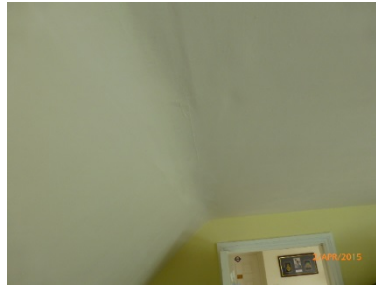
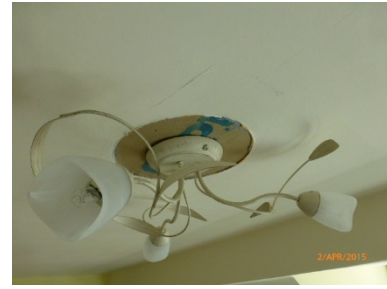
**Details/Defects/Issues:** The ceiling is finished smooth and painted with emulsion. There is a skimming to the front and rear. The finishing to the rear skimming is poor and as part of any redecoration work this area will need to be caulked and better finished prior to lining in Wallrock. There is also an area of plaster around the light fitting which is missing where the original light fitting has been replaced with a smaller unit. Again, the area around the light should be caulked and finished smooth prior to lining in Wallrock.

Poor finish to the skirting

Poor finish around the light

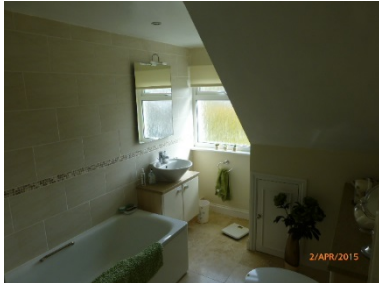
**Details/Defects/Issues:** The lighting is not suitably IP rated and presents a safety issue. As part of any electrical repairs and upgrades the lights should be replaced with IP rated fittings.

Lights are not IP rated

Estimated costs £200-300.00
-----------------------------

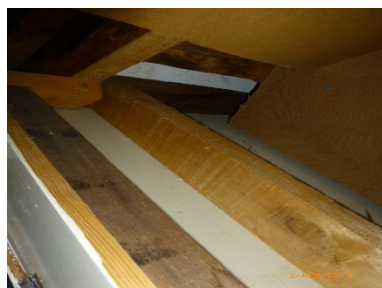
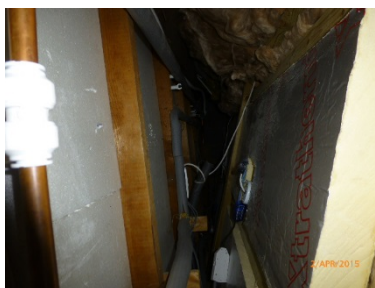
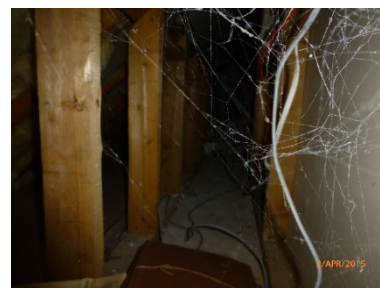
**Details/Defects/Issues:** The loft was accessible from the eaves storage cupboards and a small hatch on the landing. Insulation to both the eaves storage areas and the main loft is inadequate and needs to be upgraded in line with Approved Document L1B of The Building Regulations 2010 which advises an insulation thickness of a minimum 270mm over the entire roof area with an allowance at the eaves for continuous airflow. This should also include insulation to any loft hatches or access panels in the form of compressed foam or similar. Upgrades should also include the stud walls to the eaves storage areas which should be fitted with compressed foam.

Insulation is missing from the stud walls within the eaves storage area

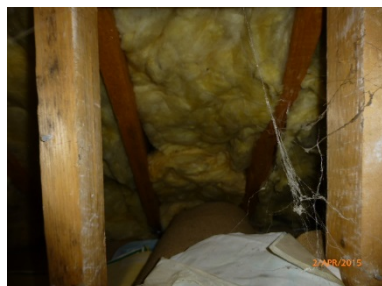
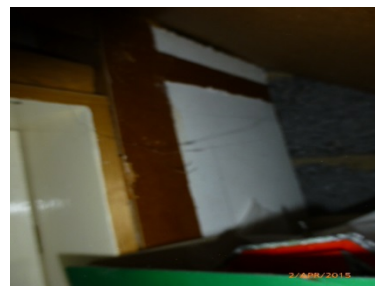
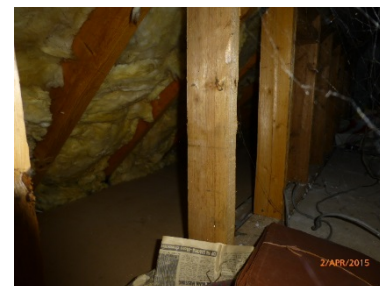
Glass fibre and polystyrene insulation in some areas

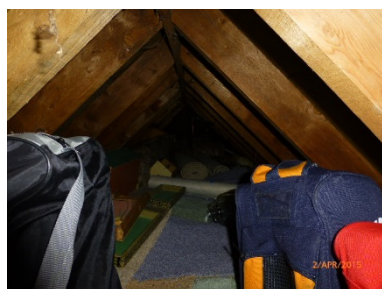
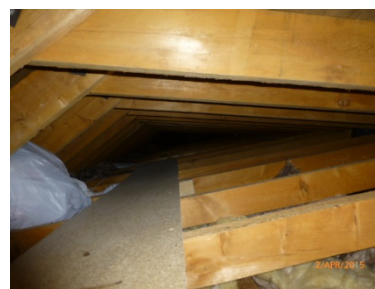
Insulation to the main loft is inadequate

Estimated costs £800-1000.00
------------------------------

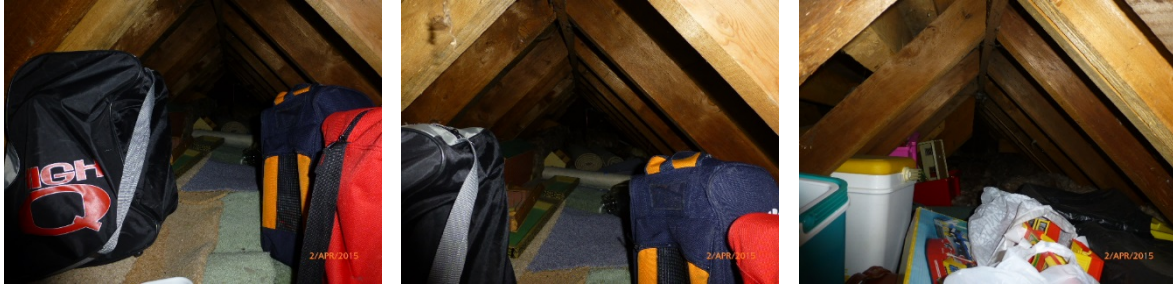
**Details/Defects/Issues:** The water storage tank is located in the main loft to the left side however access to the tank was not possible at the time of the inspection due to access restrictions. The loft floor was covered with carpet which meant it was not safe to walk or crawl within the loft space. This also meant that the roof timbers could not be fully inspected.

The floor of the loft was covered with carpet and the access was restricted due to the height

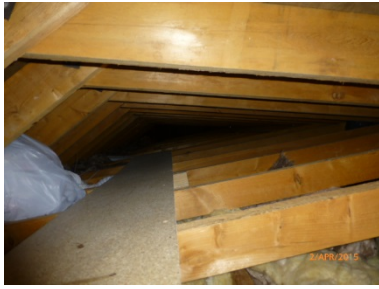
**Details/Defects/Issues:** The loft is accessible from the landing and also from the eaves storage areas in bedroom 2, the master bedroom and bedroom 4. An inspection revealed a traditional timber frame design typical for this type of building with no evidence of significant distortion. Some general splitting and staining of the timbers was observed but this is merely consistent with the building's age. Areas of the eaves storage area have also been fully boarded which restricted full access to the roof timbers.

Ventilation within the loft space is poor with no provision for ventilation provided either to the roof slopes or to the eaves. Cross ventilation at high and low level of the loft space is important to reduce the effects of condensation and resulting rot damage to roof timbers. Tile ventilators should be fitted to the external roof slopes at high and low level on all sides of the pitch roofs to provide suitable cross ventilation to roof timbers.

Roof is constructed in untreated timber

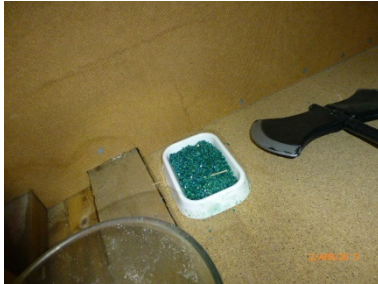
**Details/Defects/Issues:** The vendor advised that there had been a recent issue with mice in the loft space and that poison had been laid in an attempt to eradicate the issue. Poison trays were observed to the eaves storage areas and the main loft and there was also a rodent break back trap in the loft. You are strongly advised to ensure that this type of issue is regularly maintained as rodents and pest infestations can cause significant damage to the fabric of the building and in particular problems by chewing through electric cables within the loft space.

Rodent poison in the eaves storage and loft areas

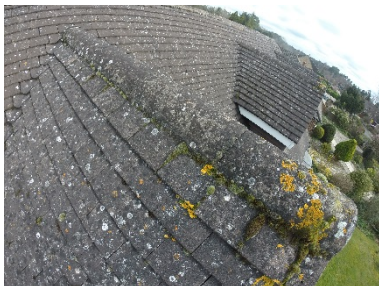
The mortar to the hip and ridge tiles is loose and defective. The tiles need to be stripped, cleaned and then re-bedded on to new sand and cement mortar finished smooth.

Ridge and hip mortar has cracked

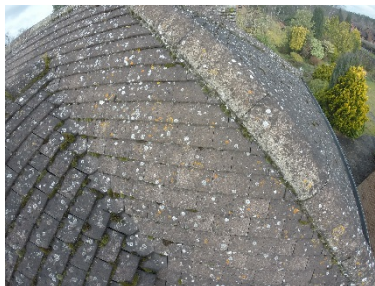
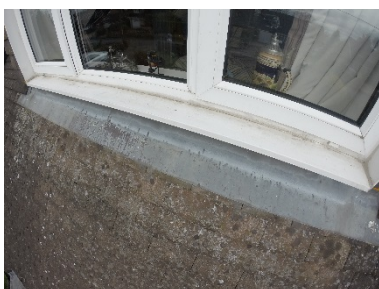
There are lead aprons fitted to the front and side dormer windows. The lead has been installed in lengths exceeding 1.5m which has resulted in the lead beginning to ridge and split. The lead will need to be replaced in accordance with The Lead Sheet Association: "Rolled Lead Sheet, The complete Manual".

Lead aprons have been poorly fitted and are ridging

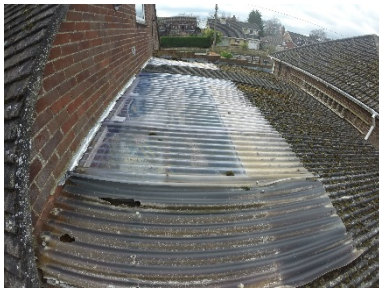
The plastic sheeting to the rear of the garage flat roof is in a poor state of repair and will need to be replaced.

Damage to plastic sheeting

Estimated costs £2500-3000.00 (roof repairs)

Estimated costs £85-90.00 per sqm to replace the flat roof

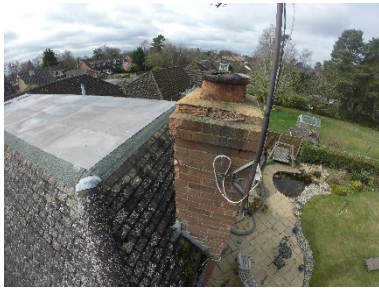
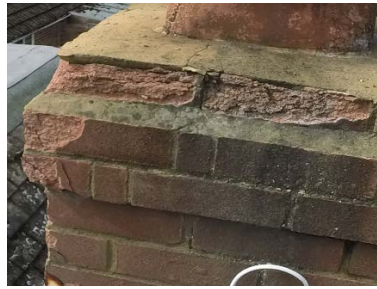
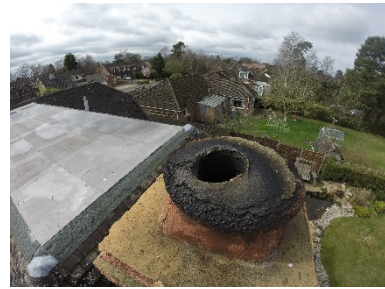
**Details/Defects/Issues:** There is a single flue brick built chimney which protrudes the base of the rear roof slope. There are a number of spalled and defective bricks to the top corbelling and left side rear. All defective bricks should be cut out and replaced. At the same time the flashing around the base of the chimney pot will need to be cut out and replaced.

The chimney pot is open and vulnerable to weather ingress. The flue should be fitted with a pot and vented cowl to aid and promote cross ventilation to the chimney flue and in turn reduce the potential for internal damage due to condensation and weather ingress.

Rear chimney services the lounge    Spalled bricks & cracked flaunching    Open flue

Estimated costs £1000-1200.00

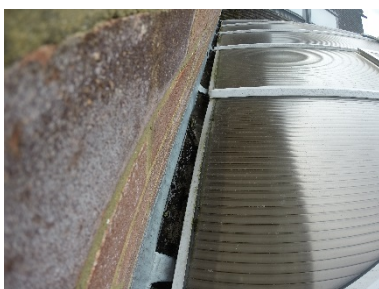
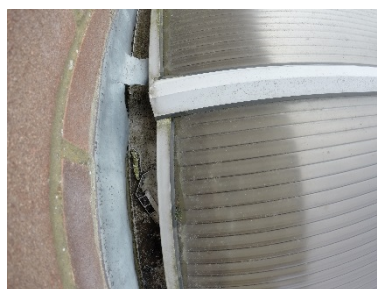
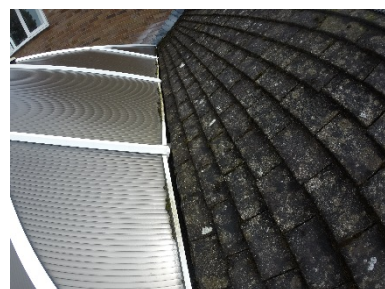
**Details/Defects/Issues:** The guttering and rainwater pipes are plastic. At the rear of the property the joint between the conservatory and the main building is sealed with a plastic trough. However, where the conservatory roof has been finished so close to the building and to the roof, it is difficult to access the guttering for clearing and maintenance. Unfortunately, this is a design issue and cannot be addressed as to do so would involve increasing the size of the box gutter to allow for a reduction in the length of the roof sheets.

Narrow box gutter to both sides of the conservatory

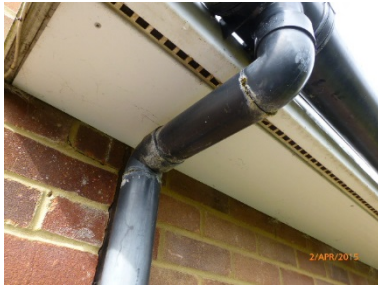
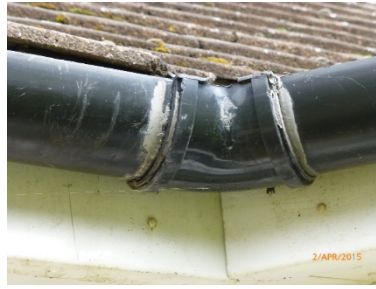
There are a number of joints and fittings to the gutters and rainwater pipes which are showing signs of leakage. All defective joints should be replaced.

Some leaking gutter joints to the front and side

Estimated costs £150-200.00 (gutters)

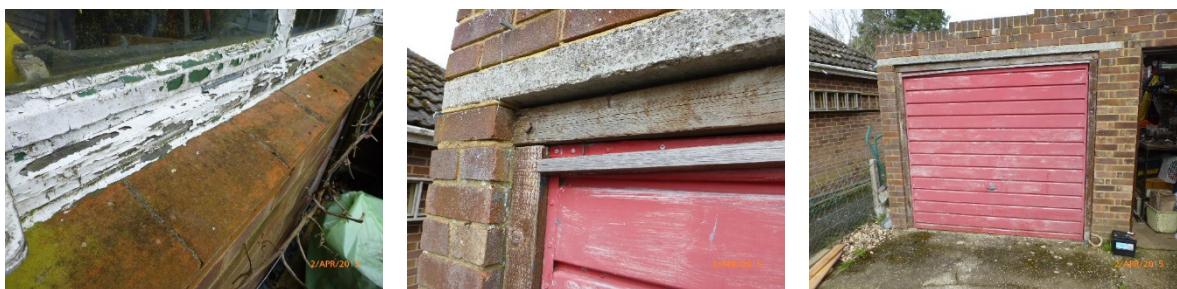
The door frame to the garage is constructed in timber and the windows are metal casements fitted into timber frames. The joinery, metal frames and the main door to the front of the garage are in a poor state of repair and will require complete overhaul including burning off loose and defective paintwork, application of bare wood primer to any exposed timber and then re-finishing in undercoat and gloss paint to all joinery, metal frames and doors.

Garage joinery and door are in a poor state of repair

Estimated costs £600-700.00

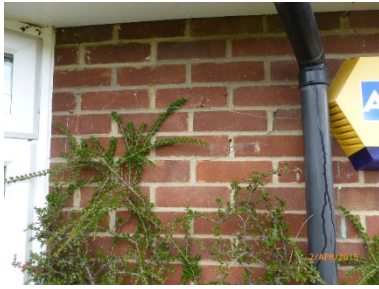
Crack to right of right side bay

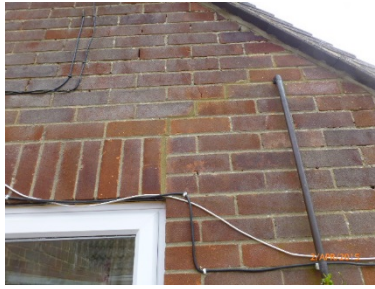
Crack to the left side wall

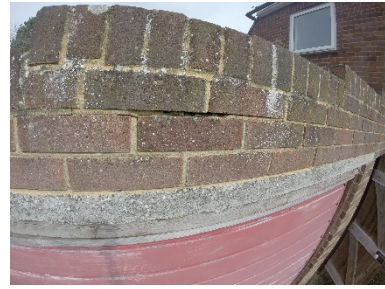
The parapet wall to the garage is in a poor state of repair and will require complete rebuilding. The top coping should also be finished in an engineering brick to prevent spalling and water penetration through the parapet wall.

Garage parapet is loose and defective

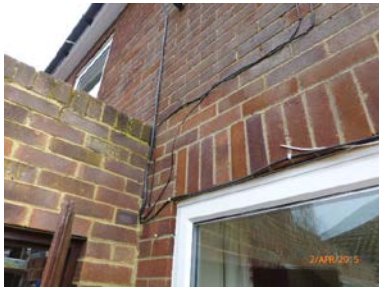
Crack between the garage and house

Estimated costs £800-1000.00

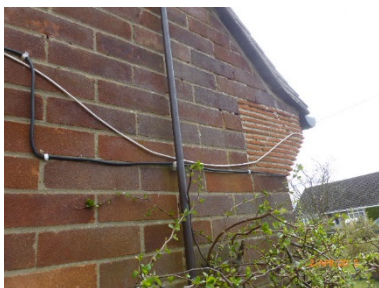
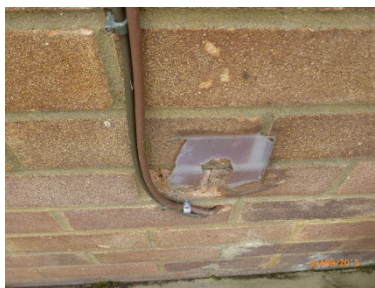
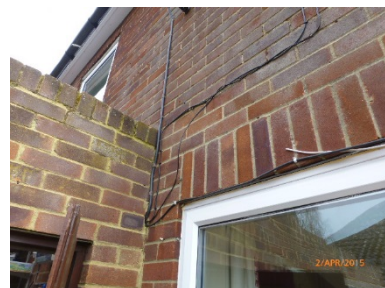
Poorly fitted cables to the front left and the rear

Estimated costs £100.00

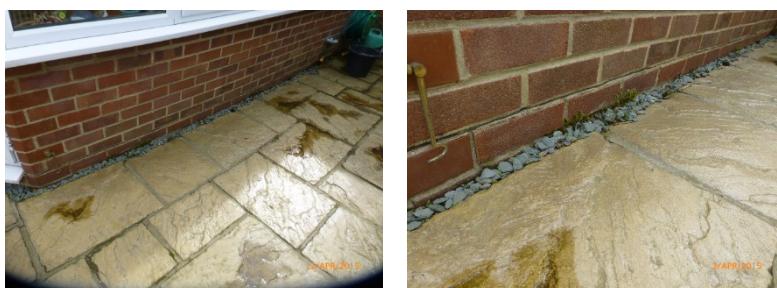
Ground levels should finish at a level 150mm below the level of the damp proof course which is usually to the underside of the door sills or to the top of air bricks in the case of suspended timber floors. In the case of the ground levels around the conservatory these finish above this minimum requirement and should be reduced accordingly. Where it is not possible to reduce the ground level then a French drain should be installed which consists of a channel being cut between the ground surface and the main building to a depth and width of 150mm, a perforated land drain should then be installed discharging to a water course or soak away and the channel filled with shingle.

Ground levels around the conservatory are finished too high

Estimated costs £800-1000.00
------------------------------

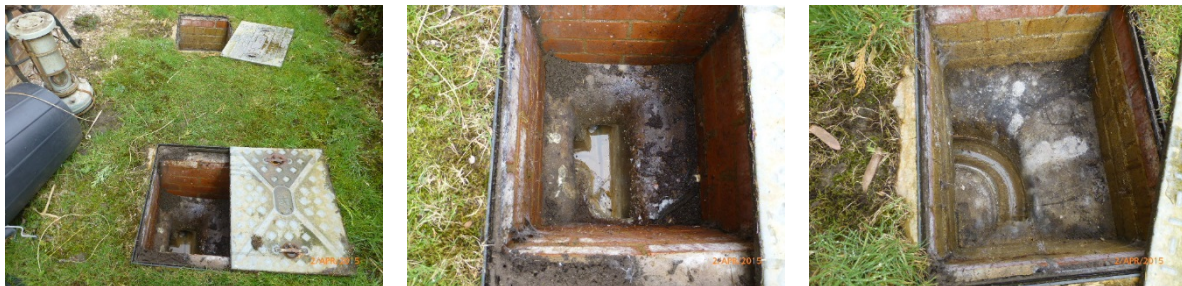
Inspection chambers to the side of the property are soiled

Estimated costs £150-200.00

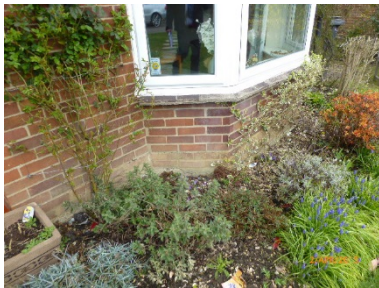
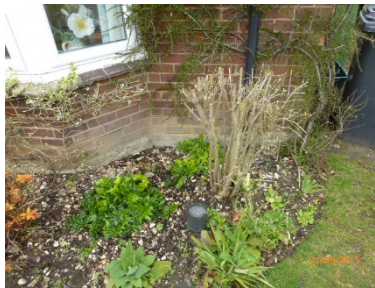
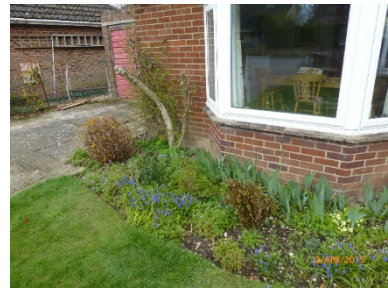
**Details/Defects/Issues:** There are a number of shrubs, small trees and creeping plants planted in the front flower beds and in close proximity to the building. To the left and right side the boundaries are divided with conifer trees/bushes, some of which are planted in close proximity to the main building. Trees and shrubs can cause damage to foundations and underground services such as drainage. Where there are trees or large shrubs in close proximity to the property it would be appropriate to draw up a programme of management to restrict future growth to prevent possible damage.

Trees and shrubs planted next to the front of the building

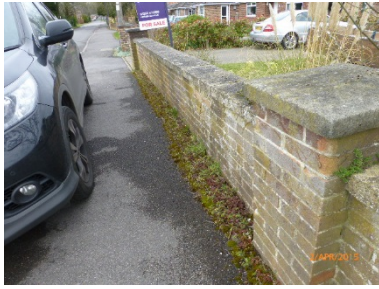
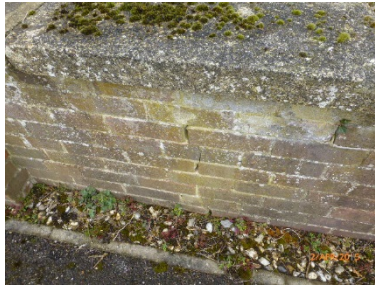
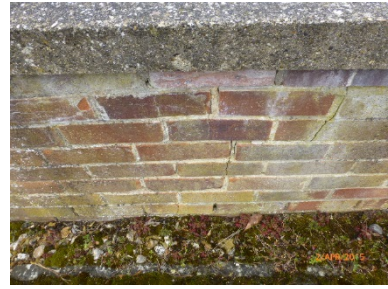
Front boundary wall is leaning and cracked

Estimated costs £1800-2000.00
