your survey report

Flat 2, [REDACTED], N4 3 [REDACTED]

17 February 2015

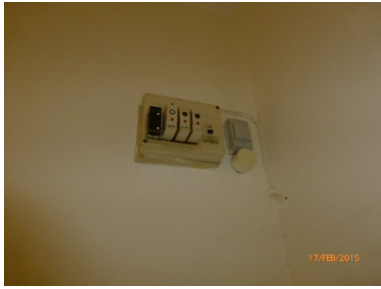
Fuse-board

- ✓ Replacement fuse-board
- ✓ Mains powered smoke/heat detection system
- Replacement sockets and switch faces
- ✓ Improvement to the wiring installation

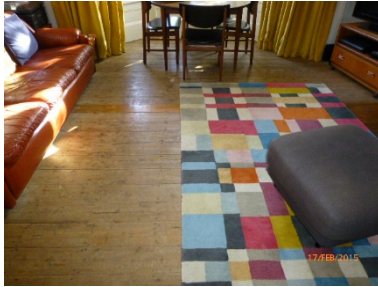
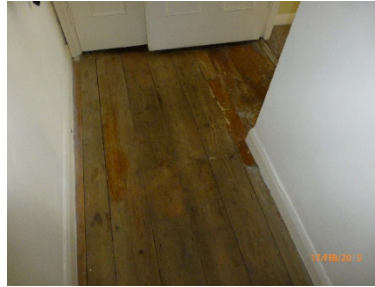
**Details/Defects/Issues:** At the time of the inspection unevenness was observed to the lounge and hallway floors. We are of the opinion that this is typical for a building of this age and type of construction. Nothing observed suggested that this represents significant movement or distortion.

Uneven floors to the lounge and hallway

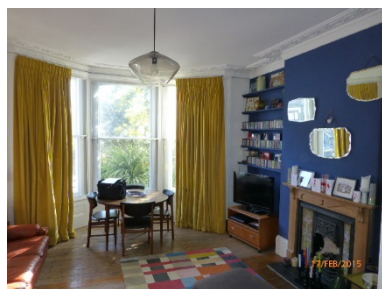
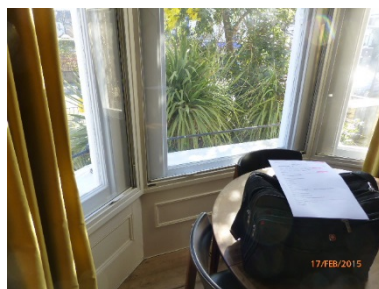
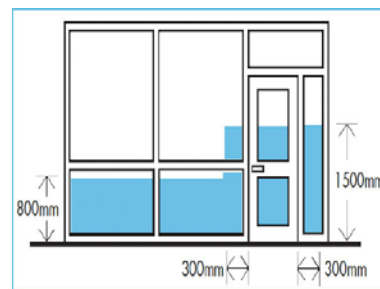
**Description of Defect:** The glazing to the front facing window is not toughened. This is a safety issue and in accordance with Approved Document N of The Building Regulations 2010, glass within a critical location should be toughened with each pane carrying the British Standard reference to confirm compliance.

Glass in a critical location

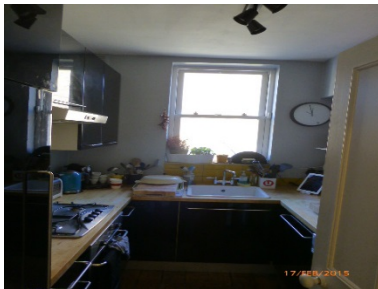
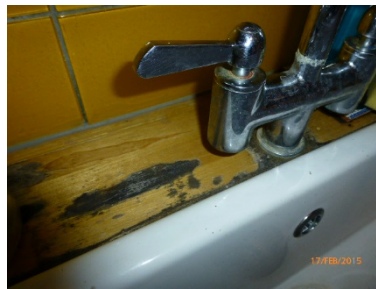
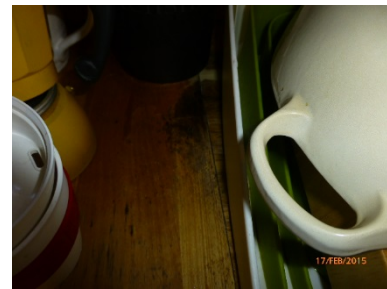
The worktop is wood block and oiled and around the sink there is water damage to the oiled finish which relates to a defective seal between the sink and the worktop. The seal should be raked out and replaced and the worktop will then require complete re-finishing including rubbing down and re-oiling.

Water damage to the woodblock worktops around the sink

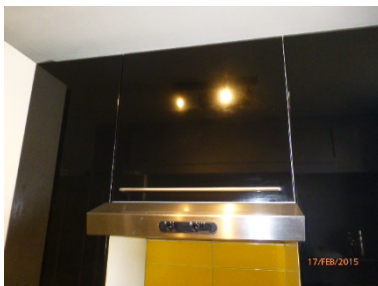
There is a cooker hood fitted above the hob but this does not duct through an external wall. Use of domestic appliances can create steam and moisture and you are advised to either duct the extractor fan through the rear facing external wall or install a mechanical means of ventilation in line with Approved Documents F and L of the Building Regulations 2010. This should be in the form of an extractor fan with a 15 minute overrun timer facility. A three pole isolation switch should also be installed.

Extractor not externally ducted

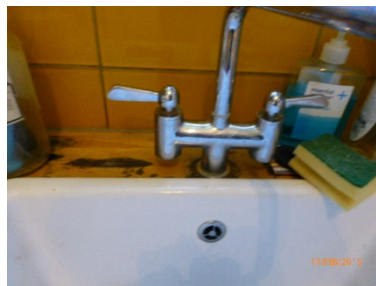
The mixer tap is fitted to the kitchen worktop and was loose at the time of the inspection. A plumbing contractor should attend and secure the tap to ensure that unnecessary pressure is not placed on the pipework which can result in leaks.

Tap is loose

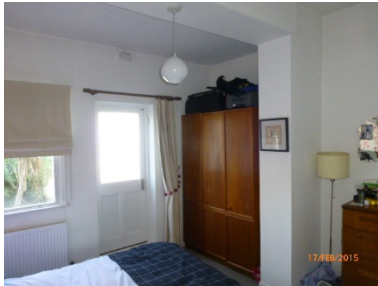
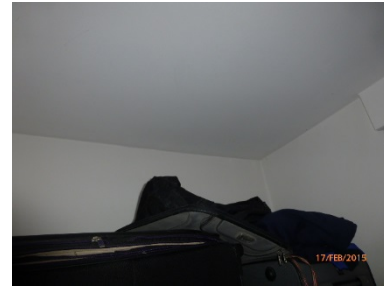
**Description of Defect:** The ceiling and walls are finished smooth and painted with emulsion. There is some cracking to the ceiling line and also to the wall above the rear facing window. None of the cracks suggest significant building movement or distortion and are more likely the result of general settlement and expansion. Prior to decoration the joint between the ceiling and the wall should be raked out, prepared and sealed with flexible acrylic sealant and the rear wall should be lined in Wallrock. 'Wallrock' is a non-woven material which is suitable for covering up untidy and poorly plastered surfaces including cracks.

Cracking to the ceiling line around the external walls

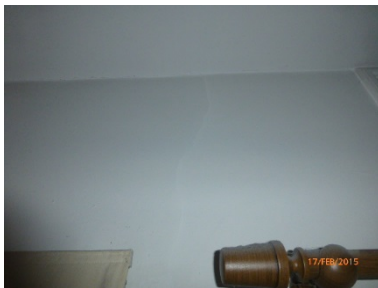
Crack to the rear external wall

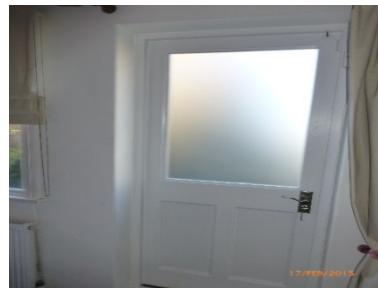
The external door to the rear which leads to the rear staircase is difficult to open and close and is binding on the frame. The door will need to be eased and adjusted prior to redecoration.

Door is sticking

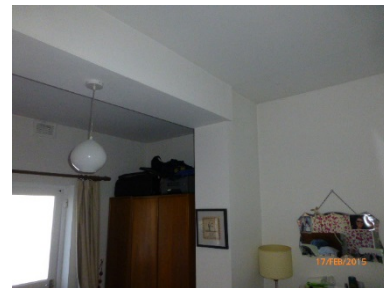
The structural wall has been removed. The method of support was fully boxed at the time of the inspection so we are unable to confirm if this is adequate. A detailed inspection was carried out to the walls and ceiling around the beams and no movement or distortion was observed. The only way to be certain of the method of support and its adequacy would be to remove a small section of plaster on both sides.

Drop down beam

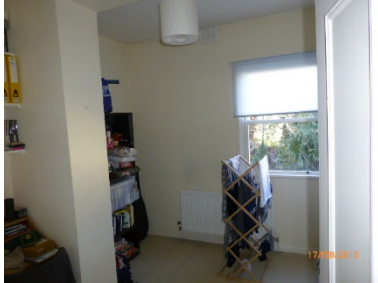
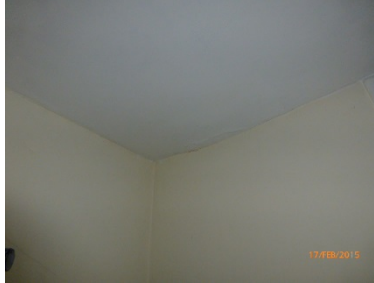
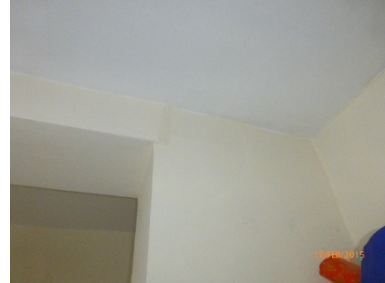
**Description of Defect:** The ceiling and walls are finished smooth and painted with emulsion. There is some minor distortion to the ceiling and cracking to the ceiling line of the external wall. There is also a small crack to the boxing around the drop down beam. None of the cracks suggest significant building movement or distortion and are more likely the result of general settlement and expansion. Prior to decoration the joint between the ceiling and walls should be raked out and sealed with flexible acrylic sealant. The wall around the boxing of the drop down beam should be lined in Wallrock.

Cracks to the ceiling line

Crack to the boxing around the beam

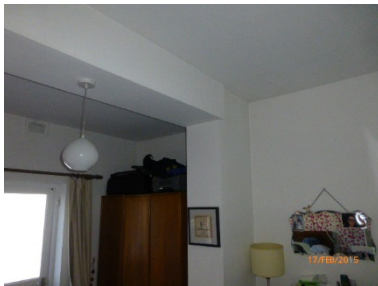
The structural wall has been removed. The method of support was fully boxed at the time of the inspection so we are unable to confirm if this is adequate. A detailed inspection was carried out to the walls and ceiling around the beams and no movement or distortion was observed. The only way to be certain of the method of support and its adequacy would be to remove a small section of plaster on both sides.

Drop down beam

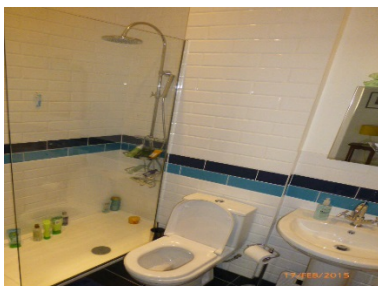
**Description of Defect:** This a wall mounted extractor fan which was not working at the time of the inspection. A qualified electrician should attend and repair or replace as necessary.

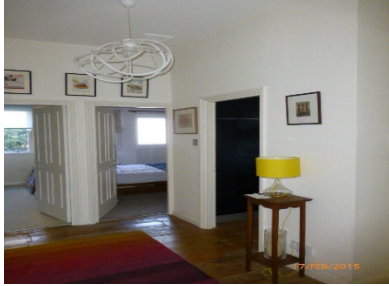
**Description of Defect:** There is no provision for smoke/heat detection within the property which falls below current standards set out in Approved Document F of The Building Regulations 2010. Provision should be made for the installation of a mains powered, fully linked smoke/heat detection system to the property.

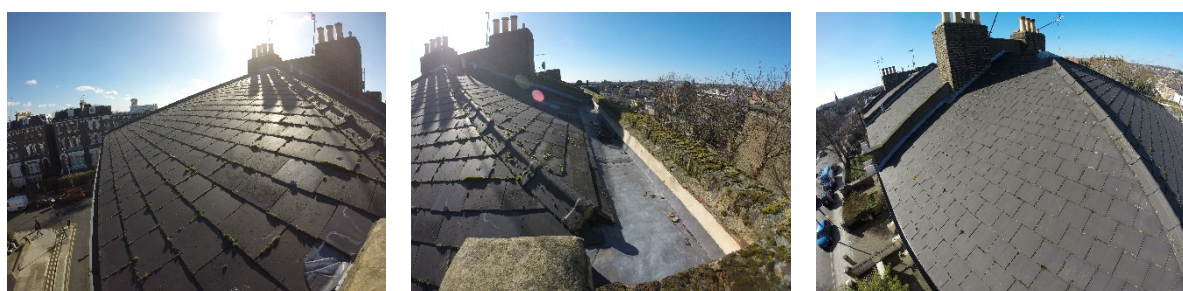
**Details/Defects/Issues:** There was no access to inspect the roof structure at the time of the inspection as the property is located on the ground floor. From an external inspection there was no evidence of the roof timbers being correctly ventilated. It is important to ensure that roof timbers are ventilated to reduce the effects of condensation and resulting rot damage to roof timbers. Tile ventilators should be fitted to the external roof slopes at high and low level on all sides of the pitch roofs to provide suitable cross ventilation to roof timbers.

No evidence of ventilation being provided to the roof timber

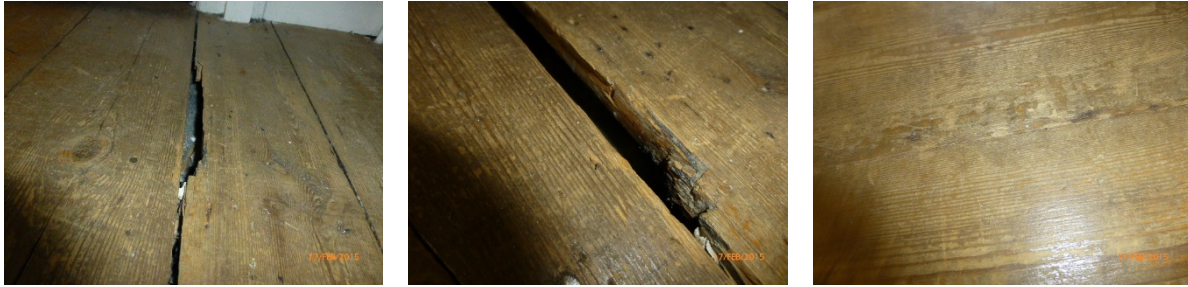
**Details/Defects/Issues:** The floors to the lounge, hallway and kitchen are finished in exposed floorboards. There was some evidence of wood boring insect infestation however it is not possible during one short inspection to establish if this activity is live or historical. Given the age of the property and the overall condition of the floors we would strongly advise that you seek further specialist advice from a contractor accredited to the Property Care Association (PCA) who would be best placed to advise further in regard to implications and costs.

Some evidence of wood boring insects to the exposed floorboards

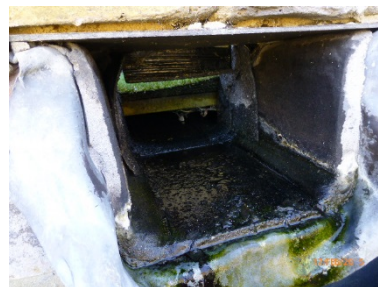
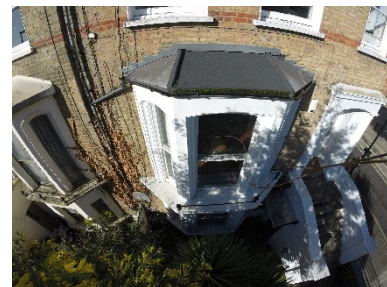
Poor repair to the front bay window

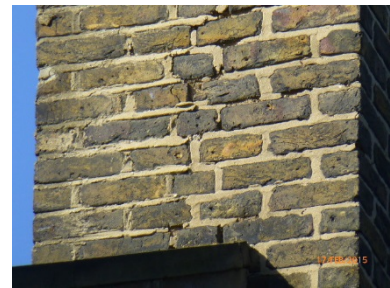
The pointing to the centre chimneys is loose and defective and will require complete repointing including raking out all mortar joints to a minimum depth of 20mm and re-pointing in new lime, sand and cement mortar.

Loose and defective pointing

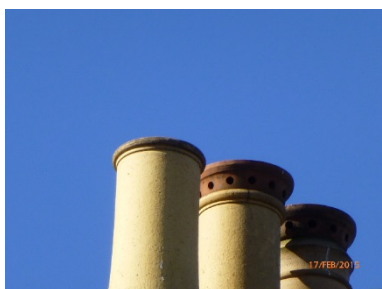
The chimney pots are open and vulnerable to weather ingress. All flues should be fitted with pots and vented cowls to aid and promote cross ventilation to the chimney flues and in turn reduce the potential for internal damage due to condensation and weather ingress.

Open flues

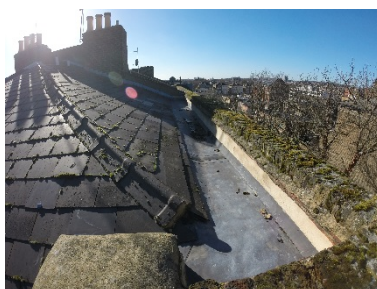
The cement bedding (flaunching) around the base of the side chimney is poor. This should be removed and replaced with new mortar.

Poor flaunching

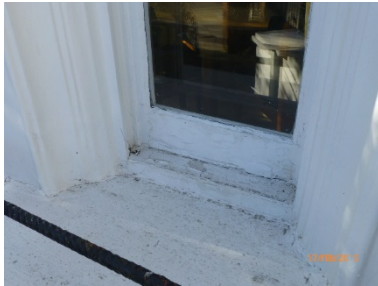
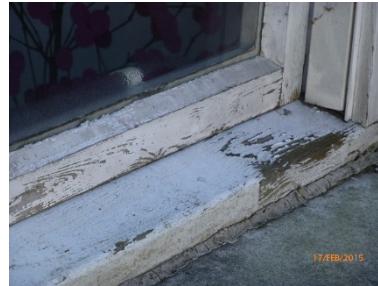
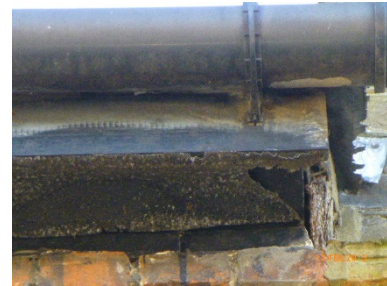
Decoration to the external joinery is in a state of disrepair and will require complete overhaul including burning off loose and defective paintwork, application of bare wood primer to any exposed timber and finishing in undercoat and gloss paint.

Window frames are in a poor state of repair particularly to the rear

Soffit and fascia decoration is poor

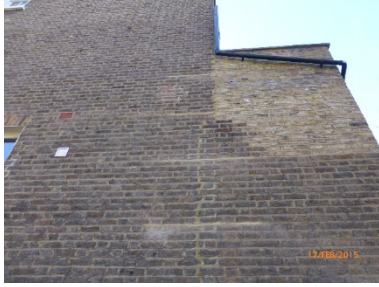
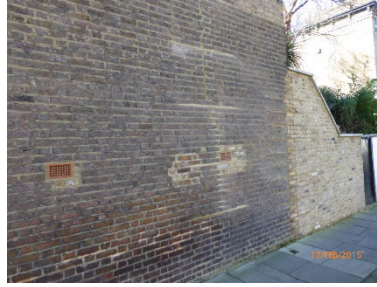
**Description of Defect:** The main walls are of a solid construction and do not benefit from any type of insulated cavity. To the side of the property there is evidence of structural repairs between the main building and the rear off-shoot. It is not known when these repairs were carried out but the condition of the pointing suggests that this work is recent. Your legal adviser should confirm the nature of the repair work and the reason this was carried out and ensure that any guarantees issued are fully transferrable on completion. Repairs appear to have been carried out to a good standard and there was no evidence of re-cracking to any joints.

Evidence of structural repairs to the rear section of the side wall

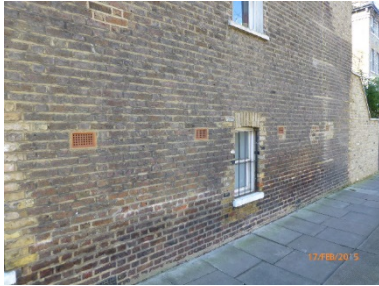
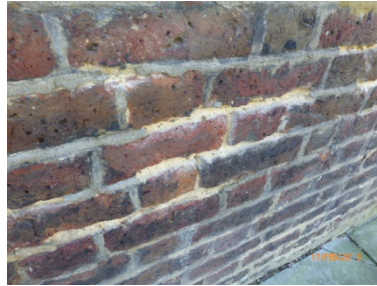
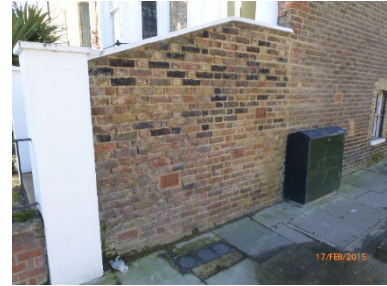
The mortar joints to the side elevation including the brick wall to the front staircase are in a poor state of repair and are loose and defective. All joints will need to be raked out and fully prepared to a minimum depth of 20mm and then re-pointed in new sand, lime and cement mortar.

Pointing to the base of the side wall and the front stairs is loose and defective

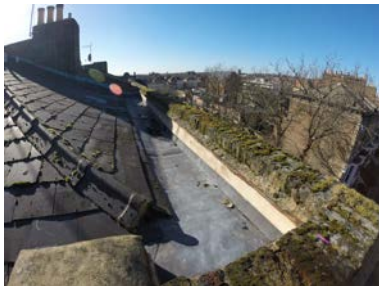
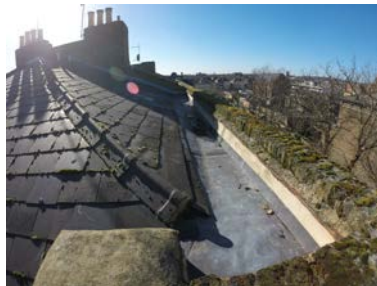
The mortar joints and flaunching to the coping of the rear parapet wall are loose and defective. The bricks are also not suitable for this type of installation as they are a stock brick and very porous. The bricks should be replaced with engineering bricks bedded onto and flaunching with 4:1 sand and cement mortar.

Copings to the rear parapet wall are poor

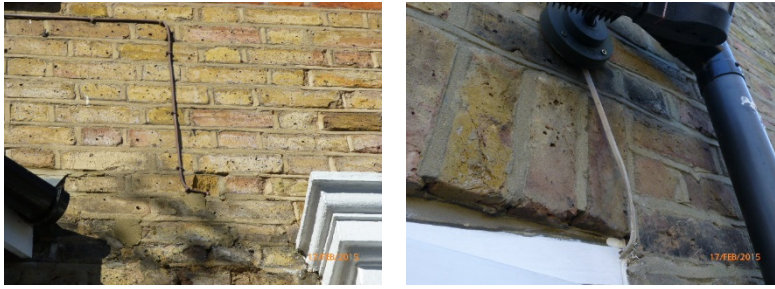
**Description of Defect:** There are a number of loose and poorly fitted cables to both front and rear. All cables should be securely clipped and at the point of entry should be looped downwards to prevent weather ingress and resulting internal damage.

Poorly fitted cables to the front and rear

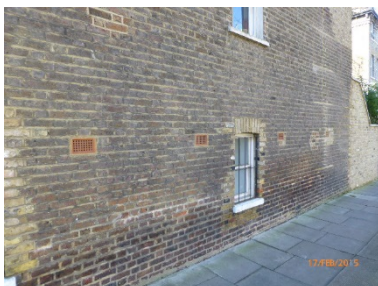
**Description of Defect:** No DPC was identified at the time of the inspection. Given the age of the property this is likely to be a bonded slate. However, there was evidence of an additional chemically injected DPC to the side elevation. Your legal adviser should confirm when this work was carried out and if a guarantee has been issued and ensure this is fully transferable on completion. The DPC does not affect the subject property as this is at the same level as the sub-basement property.

Drill holes to the side wall

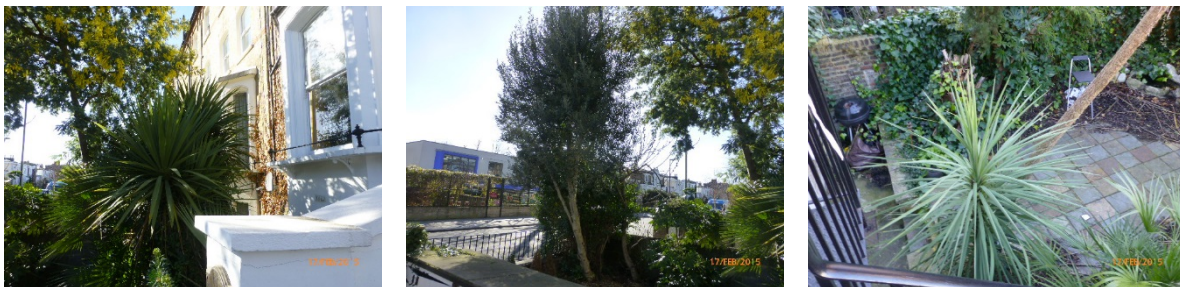
**Description of Defect:** There are a number of large trees to the front and a small tree to the rear which are in close proximity to the building. Trees and shrubs can cause damage to foundations and underground services such as drainage. Where there are trees or large shrubs in close proximity to the property it would be appropriate to draw up a programme of management to restrict future growth to prevent possible damage.

Trees planted in close proximity to the building in the front and rear gardens

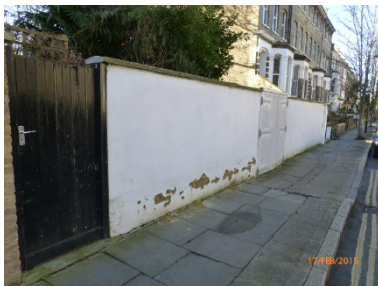
**Description of Defect:** There is a large brick wall to the rear side boundary which is finished in smooth render and painted with emulsion. There is saturation at low level which has caused damage to the render/paint finish. This is likely due to the wall not having any type of damp proof course and ground surface moisture therefore rising through the brickwork,. You should seek further advice from a specialist contractor in regard to the installation of a chemically injected DPC. Once this work is complete sections of the render will need to be cut out and patch repaired prior to complete decoration.

Saturation to the base of the render

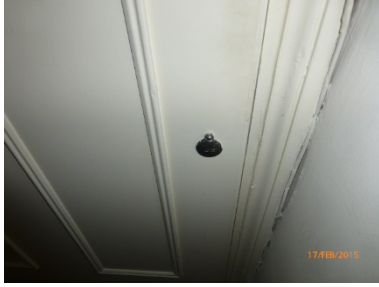
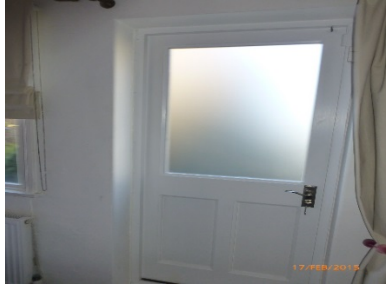
No thumb latches or overhead closer to the front and rear doors
