# Survey Report

**Inspection Date** 6 November 2018

**Inspection by** Matthew Brown AssocRICS MFPWS

Type of property	A Bungalow
Approximate year of construction	1960s
Purchase price	£667,500
The front of the property faces	West
Weather conditions during inspection	Showers
Condition of property when inspected	Owner Occupied
No of floors	1
Access to the property	By Vendor
Present during inspection	
What is the tenure	We assume the property is freehold
How many years if leasehold	Not Known
The roads are	Private
Access to site is	
Property listed or in a conservation area	No

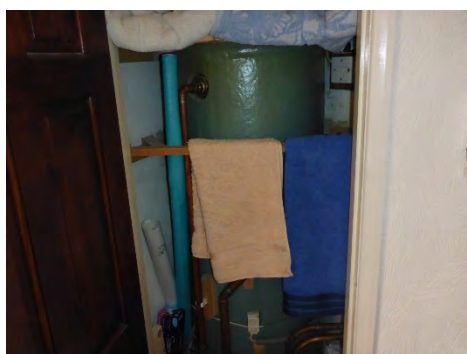
Hot water cylinder

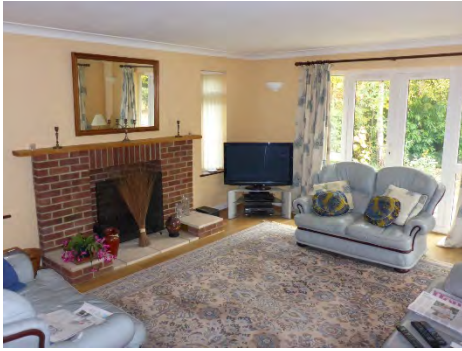
Wall crack

The walls are finished smooth and painted with emulsion. There is cracking above the chimney breast and above the double doors to the room. There is a Gyproc coving to the perimeter of the room, the joints to which have also cracked. None of the cracks suggest significant building movement or distortion and are more likely the result of general settlement and expansion. Prior to decoration the walls will need to be lined in Wallrock and the joints to the coving will need to be raked out, prepared and sealed with a flexible acrylic sealant. Wallrock is a non-woven material which is suitable for covering up untidy and poorly plastered surfaces including cracks.

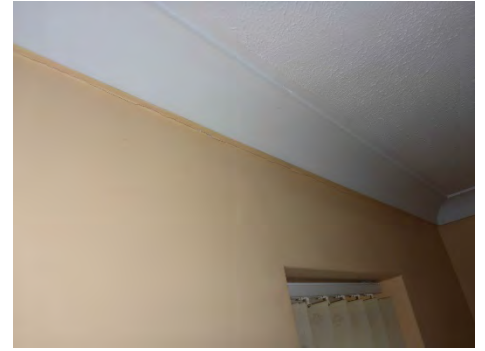
Cracks to coving joints

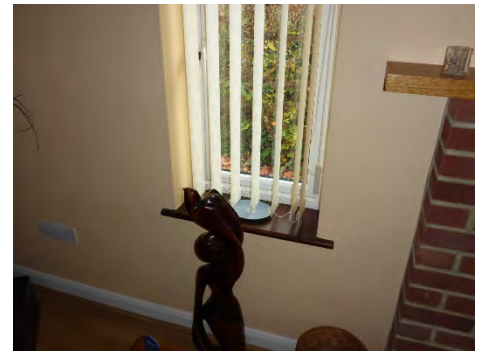
Glass to the internal doors and the side facing windows is in a critical location

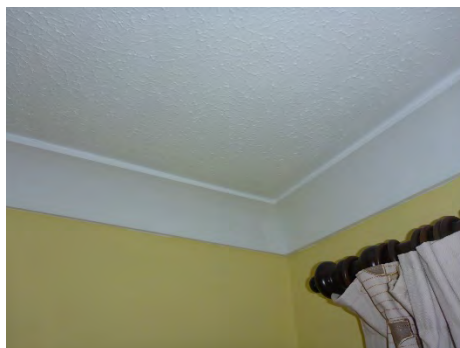
Cracks to the coving

There is a Gyproc coving to the perimeter the ceiling, the joints to which are cracked. None of the cracks suggest significant building movement or distortion and are more likely the result of general settlement and expansion. Prior to decoration the joints to the coving will need to be raked out, prepared and sealed with a flexible acrylic sealant.

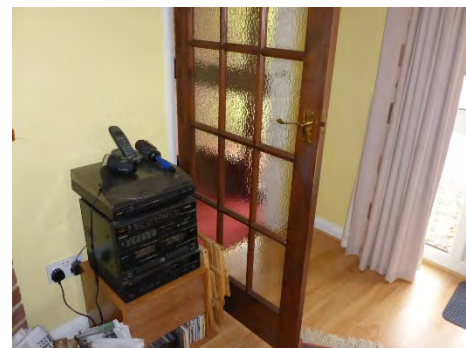
Glass in a critical location

The glazing to the internal door is not toughened. This is a safety issue and in accordance with Approved Document N of The Building Regulations 2010, glass within a critical location should be toughened with each pane carrying the British Standard reference to confirm compliance. Further information about alternatives to replacement of the glass panels is provided earlier in the report.

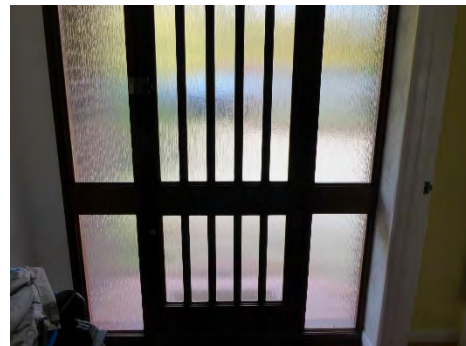
Glass in a critical location

The glazing to the three internal doors and the entrance door and side panels is not toughened. This is a safety issue and in accordance with Approved Document N of The Building Regulations 2010, glass within a critical location should be toughened with each pane carrying the British Standard reference to confirm compliance. Further information about alternatives to replacement of the glass panels is provided earlier in the report.

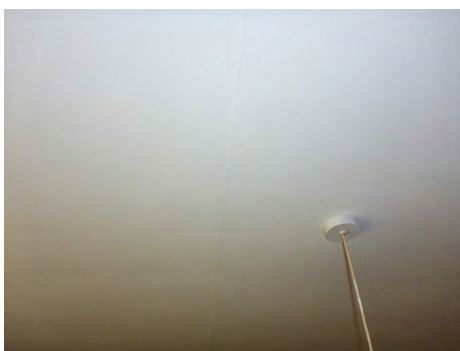
Ceiling cracks

The ceiling is finished smooth and painted with emulsion. There is cracking to the joints to the plasterboard, none of which suggests significant building movement or distortion and are more likely the result of general settlement and expansion. Prior to decoration the ceiling will need to be lined in Wallrock.

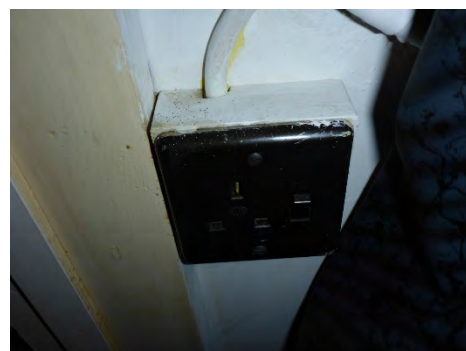
Dated electrical point

There is a Bakelite socket cover to the wall mounted socket in the wardrobe. This fitting is dated and a potential safety risk and will need to be replaced with a more modern plastic fitting.

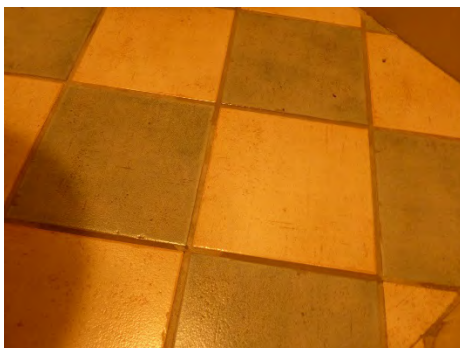
Floor tile joints are cracking

The floor is covered with ceramic tiles. A number of the joints are loose and cracked. This is an indication that the tiles have been fixed with a non-flexible material. The tiles will need to be lifted and replaced and any new ceramic tiles need to be fixed in place with flexible adhesive and the joints grouted with flexible grout.

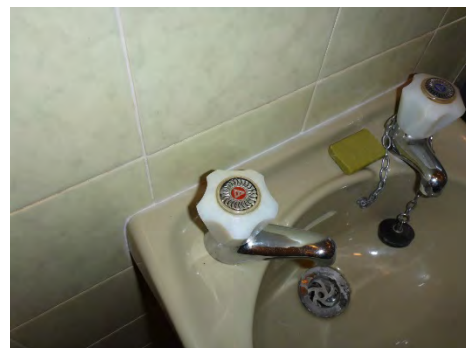
No sealant to the wash hand basin

There is no silicone sealant applied to the wash hand basin and shower. It is important to ensure that these areas are correctly sealed as water escaping often goes unnoticed and serious damage can be caused to walls, flooring and floor timbers. Silicone sealant needs to be applied in one continuous application.

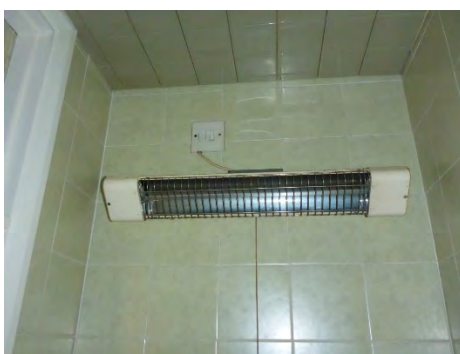
Dangerous heater

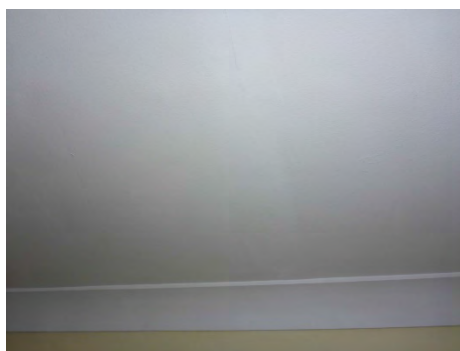
Ceiling cracks

The ceiling is finished smooth and painted with emulsion and there is cracking to the plasterboard joints. None of the cracks suggest significant building movement or distortion and are more likely the result of general settlement and expansion. Prior to decoration the ceiling will need to be lined in Wallrock.

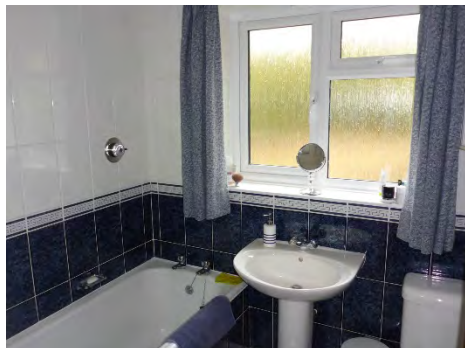
No mechanical extraction installed

No form of mechanical extraction is fitted within the room. Use of the shower or bath can create steam and moisture. You are advised to install a mechanical means of ventilation, in line with Approved Documents F and L of The Building Regulations 2010. This should be in the form of an extractor fan with a 15 minute overrun timer facility. A 3-pole isolation switch will also need to be installed. You are advised to seek further advice from an electrician and undertake remedial work as recommended.

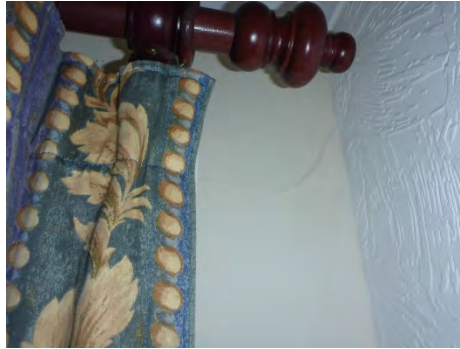
Wall crack

The walls are finished smooth and painted with emulsion and there is cracking to the wall to the upper right side of the right side window. None of the cracks suggest significant building movement or distortion and are more likely the result of general settlement and expansion. Prior to decoration the wall will need to be lined in Wallrock.

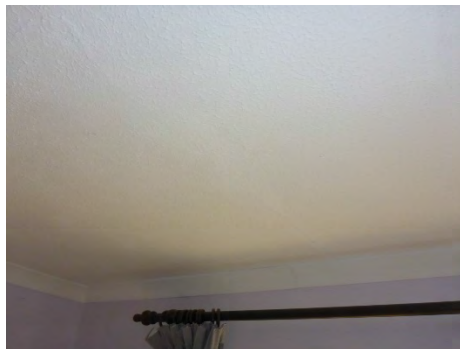
Ceiling cracks

The ceiling and walls are finished smooth and painted with emulsion and there is cracking to both surfaces. None of the cracks suggest significant building movement or distortion and are more likely the result of general settlement and expansion. Prior to decoration the walls and ceiling will need to be lined in Wallrock.

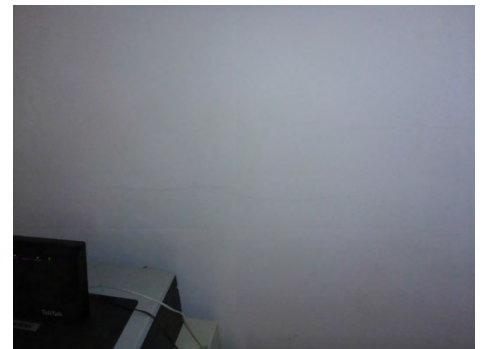
Wall cracks

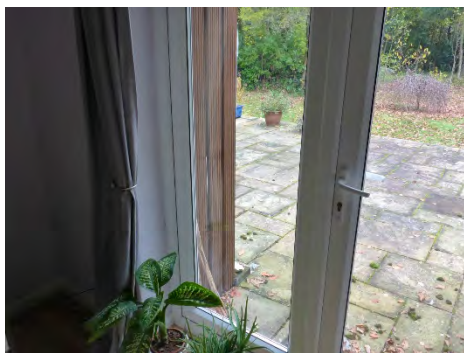
Glass in a critical location

The glazing to the left side door panel is not toughened. This is a safety issue and in accordance with Approved Document N of The Building Regulations 2010, glass within a critical location should be toughened with each pane carrying the British Standard reference to confirm compliance. Further information about alternatives to replacement of the glass panels is provided earlier in the report.

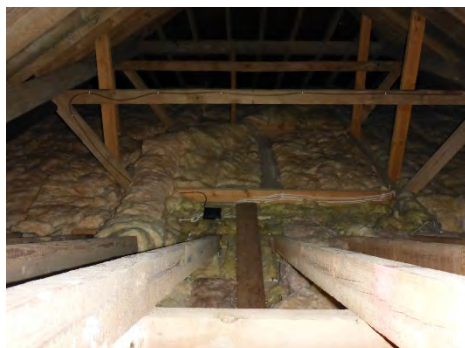
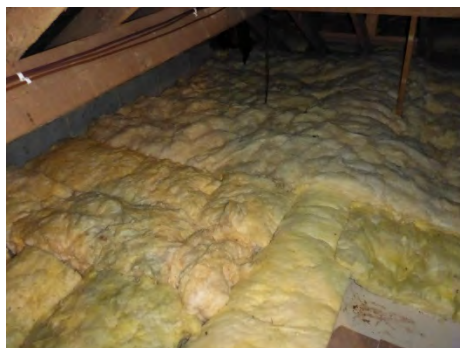
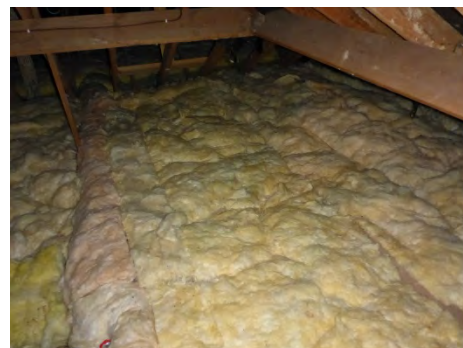
Insulation in the loft space is inadequate

The insulation to the loft space of the main dwelling is inadequate. Approved Document L1B of The Building Regulations 2010 advises an insulation thickness of a minimum 270mm over the entire roof area with an allowance at the eaves for continuous airflow. This should also include insulation to the loft hatch in the form of compressed foam or similar.

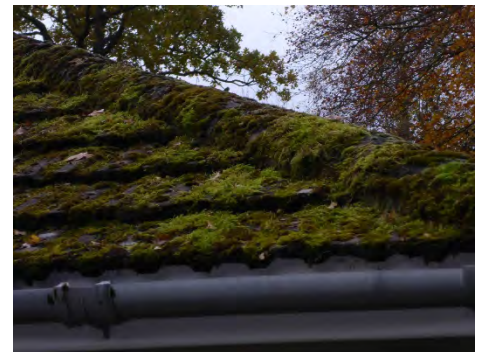
Bottom tile course has dropped

There are signs of the front tiles above the front entrance and window to the right side having dropped which is likely due to where the replacement fascia boards have been installed and they are slightly smaller than the original timber.

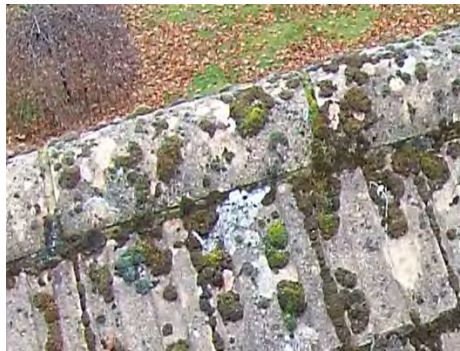
Mortar to the ridge and hip tiles is loose and cracking

The mortar to the ridge and hip tiles is loose and defective. The tiles need to be stripped, cleaned and then re-bedded on to new sand and cement mortar finished smooth. It is the practice of unscrupulous contractors to point over the existing mortar joints. This is not an acceptable form of repair.

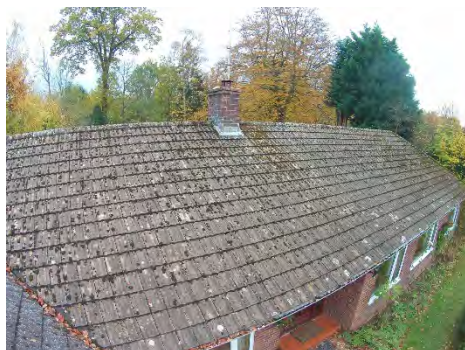
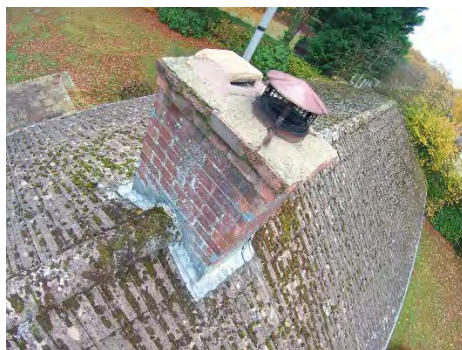
Spalled bricks, capped flue and poor flaunching

The pointing to the brickwork of the chimney is loose and defective in several places and there are a number of spalled bricks. The defective bricks will need to be cut out and replaced and the joints will need to be raked out, prepared and re-pointed.

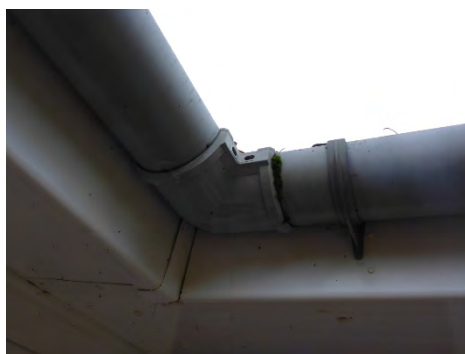
Leaky gutter joint to the front

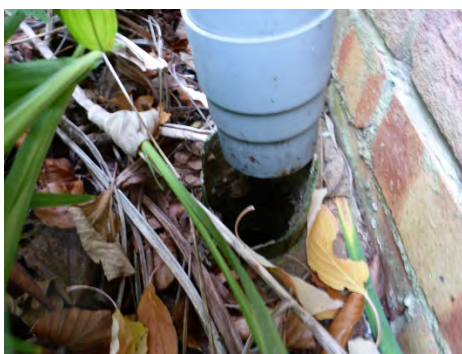
Broken rainwater connection

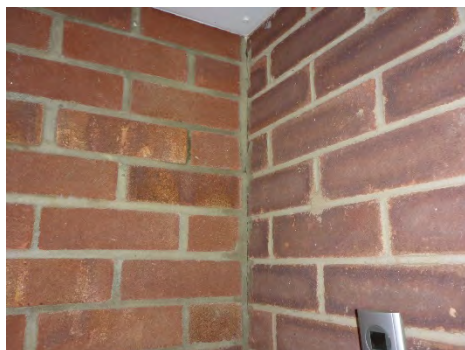
Vertical crack at junction

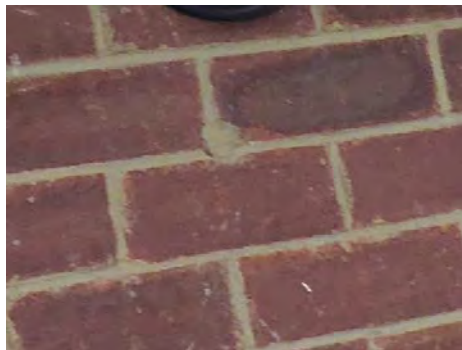
Evidence of retrospective cavity insulation having been injected

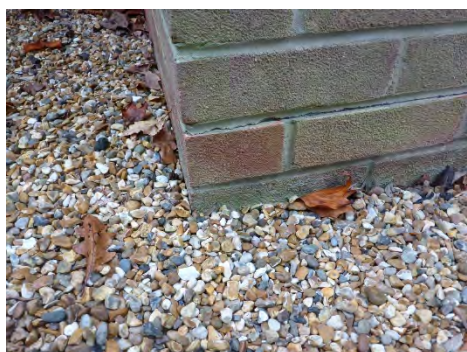
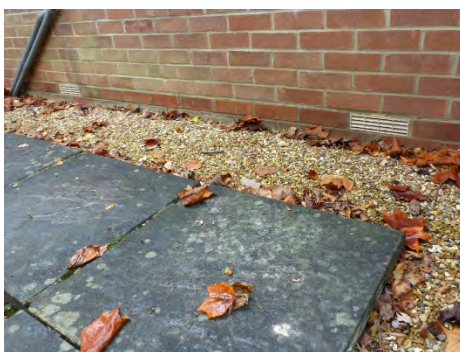
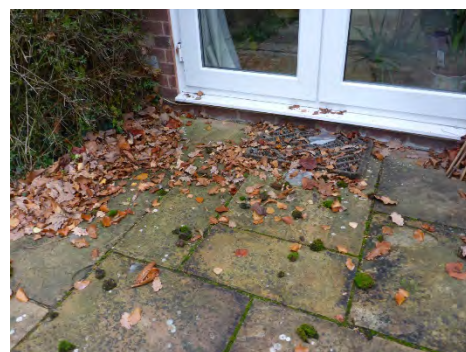
Ground levels to the front side and rear are too high

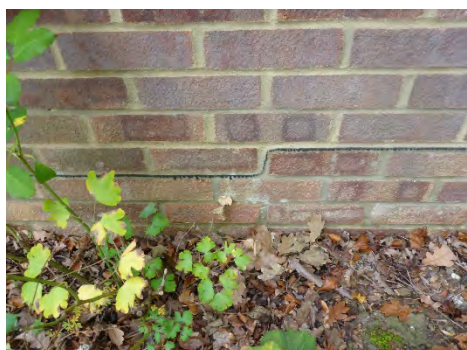
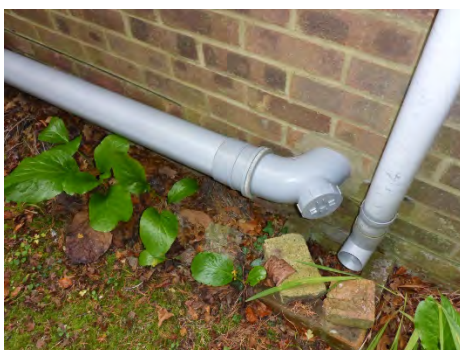
DPC steps to the front and right side

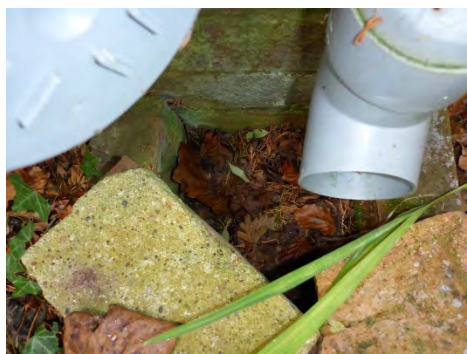
Blocked and open hoppers to the side and rear

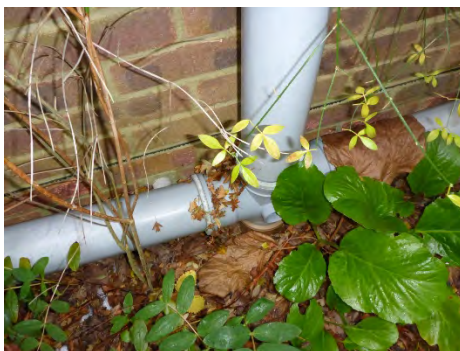
Inadequate rodding to the drainage

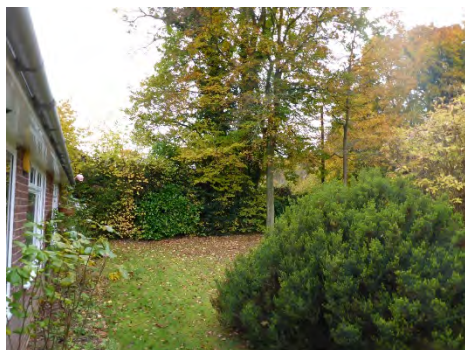
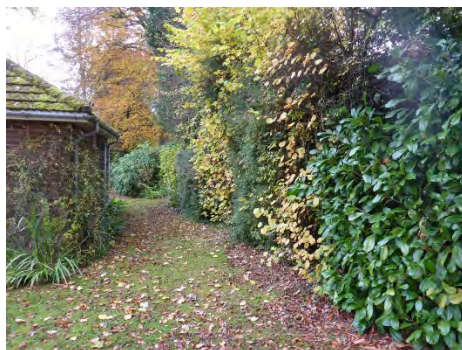
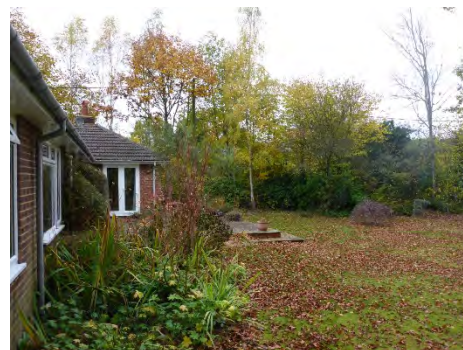
Trees and shrubs in close proximity to the property
