# Survey Report

[REDACTED]  
[REDACTED]

Inspection Date 18 January 2019

Inspection by Matthew Brown AssocRICS MFPWS

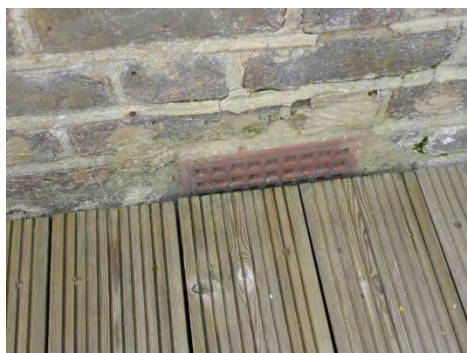
Air bricks are too small and few

There is a lack of ventilation to the suspended timber floor as the air bricks are either too small, blocked by debris, broken or too few in number. Ventilation needs to be improved in line with Approved Document C of The Building Regulations 2010. The openings should be not less than either  $1500\text{mm}^2$  per meter run of an external wall or  $500\text{mm}^2$  per meter<sup>2</sup> of floor area, whichever gives the greater.

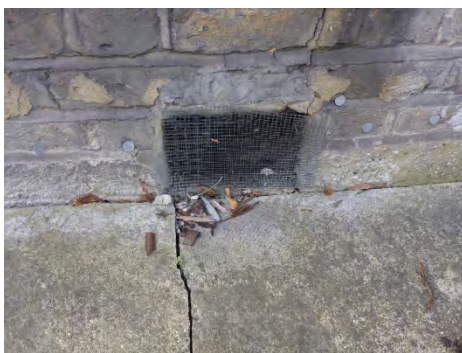
Front air bricks are damaged

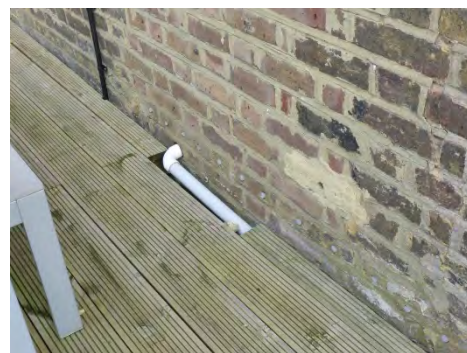
No ventilation through the solid floor

Where the bathroom, bedroom 1 and hallway floors have been constructed in concrete there are no ventilation ducts installed to continue ventilation to the original suspended flooring. Ducts need to be installed and connected through to the original suspended timber floor and terminate through the external wall of the bedroom/bathroom. This work will involve the lifting and relaying/replacement of the existing floor coverings.

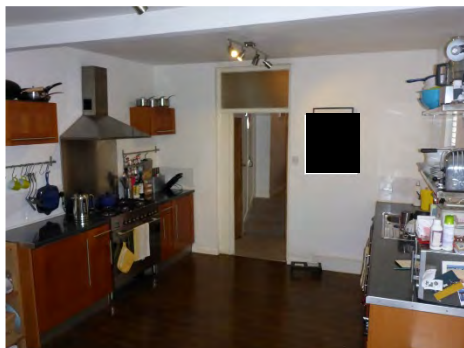
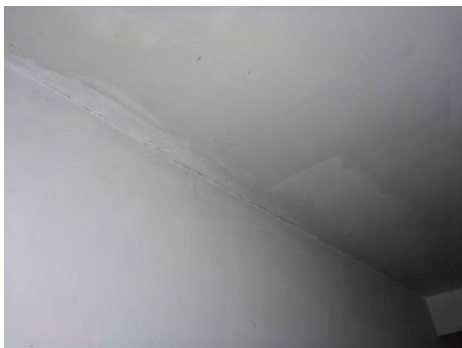
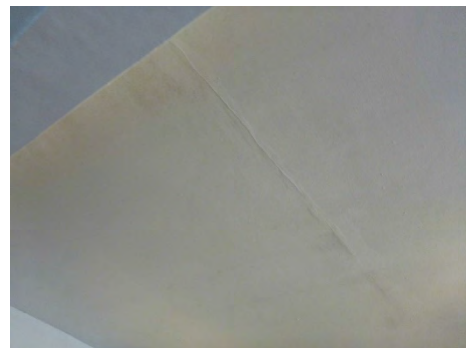
Ceiling line cracks

Ceiling cracks

The walls and ceiling are finished smooth and painted with emulsion. There is cracking to the ceiling line which is the joint between the ceiling and the walls and also to the ceiling. None of the cracks suggest significant building movement or distortion and are more likely the result of general settlement and expansion. Prior to decoration the joints to the ceiling line will need to be raked out, prepared and sealed with a flexible acrylic sealant and the ceiling will need to be lined in Wallrock. Wallrock is a non-woven material which is suitable for covering up untidy and poorly plastered surfaces including cracks.

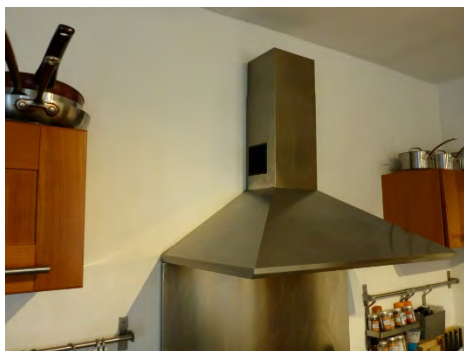
Extractor is not externally ducted

There is a cooker hood fitted above the hob but this does not duct through an external wall. Use of domestic appliances can create steam and moisture and you are advised to either duct the extractor fan through an external wall or install a mechanical means of ventilation in line with Approved Documents F and L of the Building Regulations 2010. This will need to be in the form of an extractor fan with a 15 minute overrun timer facility. A three pole isolation switch will also need to be installed.

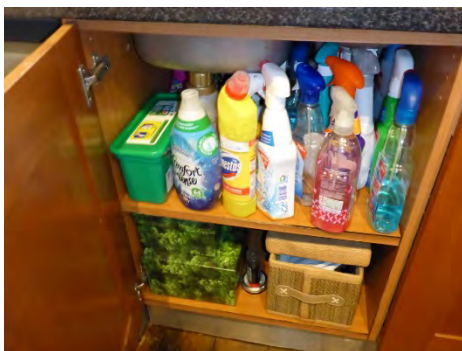
Possible leak under the sink

There was moisture on the shelf under the sink and the vendor advised that there was a leak which was due to be fixed by a plumbing contractor. Your legal adviser will need to confirm that these works have been carried out.

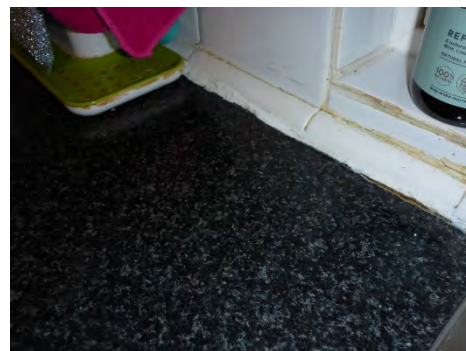
Poor sealant to the worktops

The silicone sealant to the edges and abutments of the tiling around the worktops has been poorly applied and will need to be replaced. The existing silicone will need to be completely removed prior to applying the new sealant in one continuous application. It is important to ensure that these areas are correctly sealed as water escaping often goes unnoticed and serious damage can be caused to walls, flooring and floor timbers.

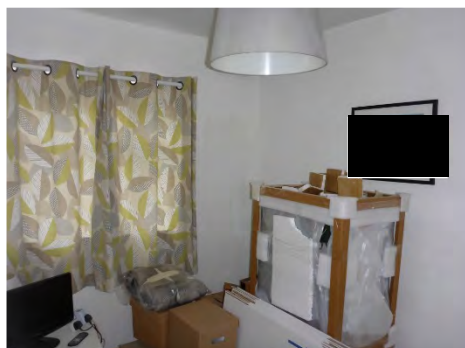
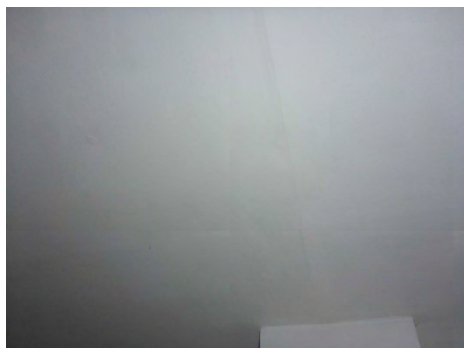
Ceiling cracks

The ceiling and walls are finished smooth and painted with emulsion. There is cracking to the ceiling, the walls and to the ceiling lines. None of the cracks suggest significant building movement or distortion and are more likely the result of general settlement and expansion. Prior to decoration the ceiling line joints will need to be raked out, prepared and sealed and the walls and ceiling will need to be lined in Wallrock.

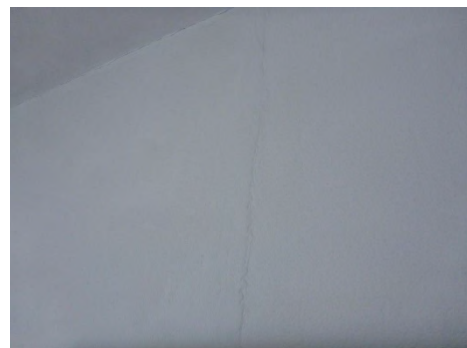
Wall cracks

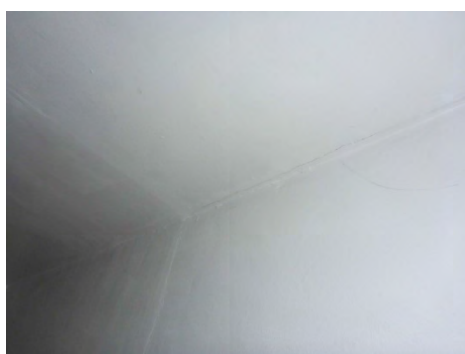
Ceiling line cracks

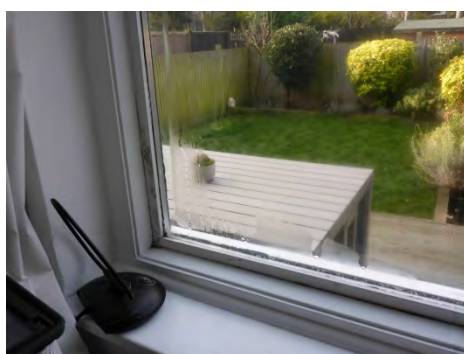
Failed glazing panel

The double glazed unit to the window has failed and condensation is forming between the two glass panels. It is not possible to repair and the double glazed unit will need to be replaced.

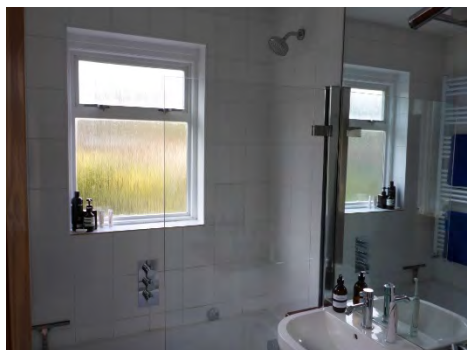
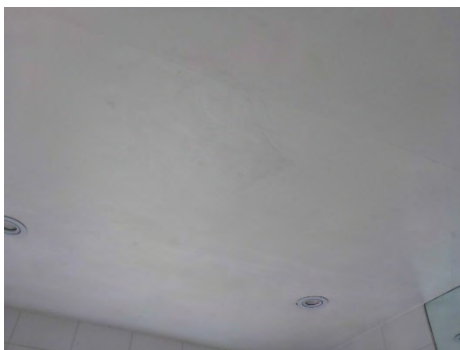
Ceiling cracks and staining

The ceiling is finished smooth and painted with emulsion and there is cracking and staining. None of the cracks suggest significant building movement or distortion and are more likely the result of general settlement and expansion. The staining is consistent with high levels of condensation. Prior to decoration the ceiling will need to be fully prepared and sealed with an alkaline based sealer and then lined in Wallrock. In regard to the staining the current extractor fan will need to be checked and a qualified electrician should advise in regard to improvements by installing a larger capacity extractor.

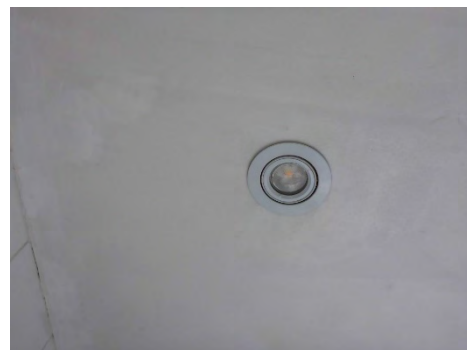
Lights are not IP rated

The lighting is not suitably IP rated and presents a safety issue. As part of any electrical repairs and upgrades the lights will need to be replaced with IP rated fittings.

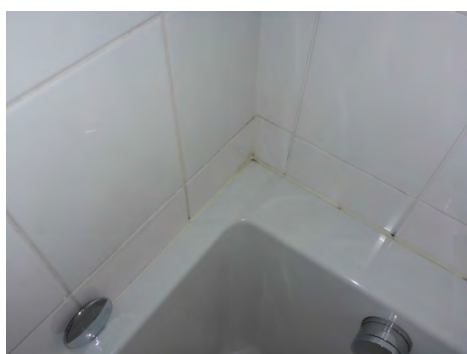
Bath sealant is poor

The silicone sealant to the edges and abutments of the tiling around the bath has been poorly applied and will need to be replaced. The existing silicone will need to be completely removed prior to applying the new sealant in one continuous application. It is important to ensure that these areas are correctly sealed as water escaping often goes unnoticed and serious damage can be caused to walls, flooring and floor timbers.

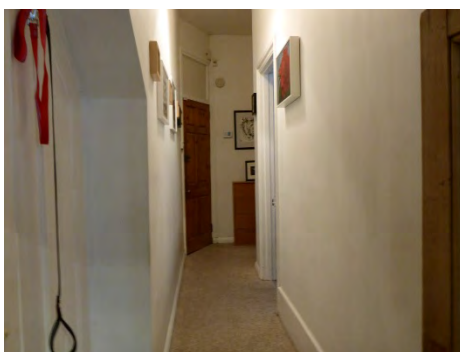
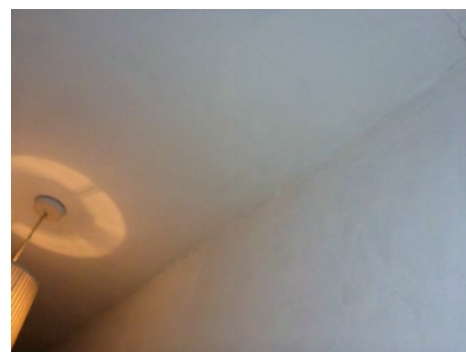
Ceiling line cracks

The ceiling and walls are finished smooth and painted with emulsion. There is cracking to the ceiling, the skirting and to the ceiling line. None of the cracks suggest significant building movement or distortion and are more likely the result of general settlement and expansion. Prior to decoration the ceiling line and skirting cracks will need to be raked out, prepared and sealed with a flexible acrylic sealant and the ceiling will need to be lined in Wallrock.

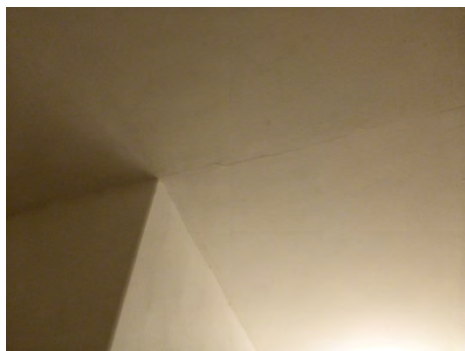
Ceiling cracks

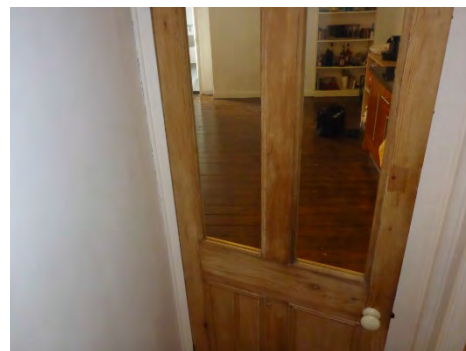
Glass in a critical location

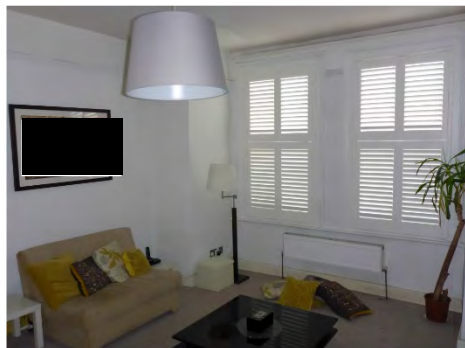
Ceiling line cracks

There is cracking to the ceiling, ceiling line and walls. None of the cracks suggest significant building movement or distortion and are more likely the result of general settlement and expansion. Prior to decoration the ceiling line cracks will need to be raked out, prepared and sealed with a flexible acrylic sealant and the walls and ceiling will need to be lined in Wallrock.

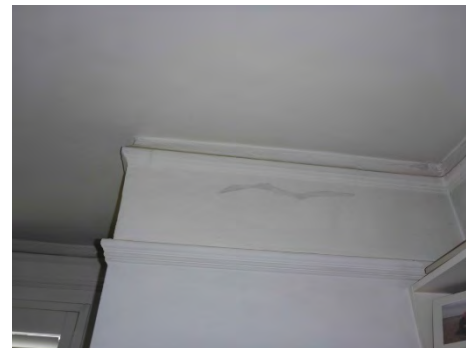
Wall cracks

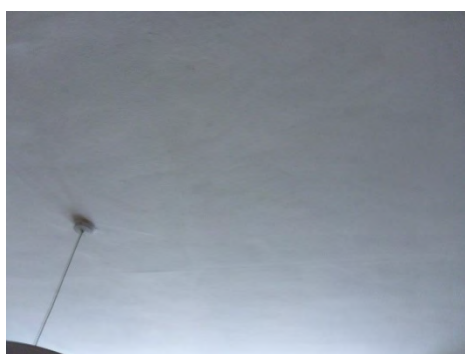
Ceiling cracks

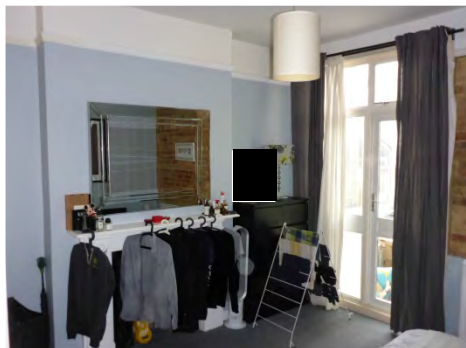
Ceiling line cracks

The ceiling and walls finished smooth and painted with emulsion. There is cracking to the ceiling and the ceiling line. None of the cracks suggest significant building movement or distortion and are more likely the result of general settlement and expansion. Prior to decoration the ceiling line joints will need to be raked out, prepared and sealed with a flexible acrylic sealant and the ceiling will need to be lined in Wallrock

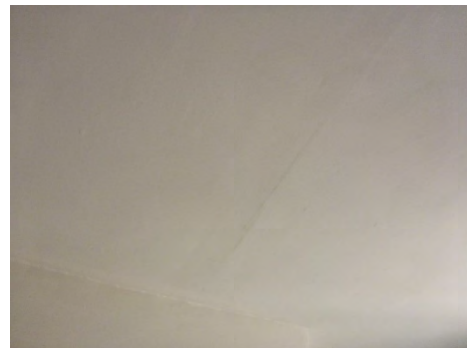
Ceiling cracks

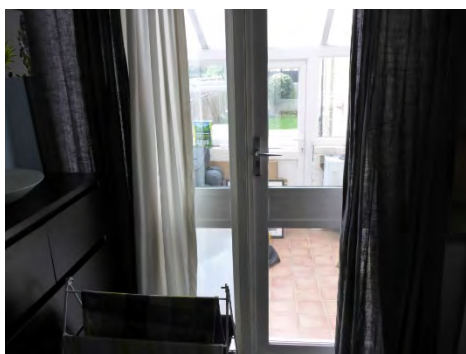
Glass in a critical location

The glazing to the rear facing doors and window is not toughened. This is a safety issue and in accordance with Approved Document N of The Building Regulations 2010, glass within a critical location should be toughened with each pane carrying the British Standard reference to confirm compliance. Further information about alternatives to replacement of the glass panels is provided earlier in the report.

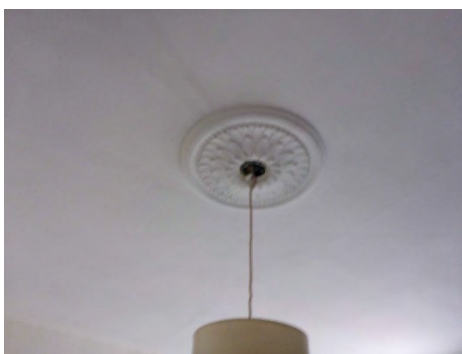
Poorly fitted light

The connection to the light fitting is poor and dangerous as there are exposed cables. A qualified electrician will need to attend and carry out repairs as necessary

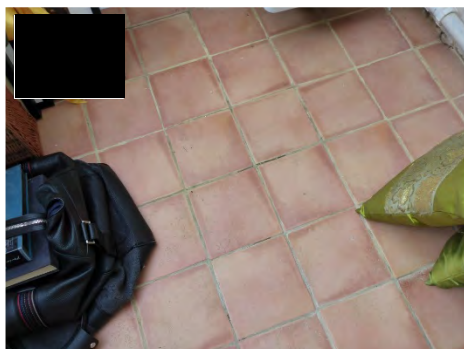
The floor is covered with ceramic tiles. A number of the tiles are loose. This is an indication that the tiles have been fixed with a non-flexible material. The tiles will need to be lifted and replaced and any new ceramic tiles need to be fixed in place with flexible adhesive and the joints grouted with flexible grout.

Loose floor tiles

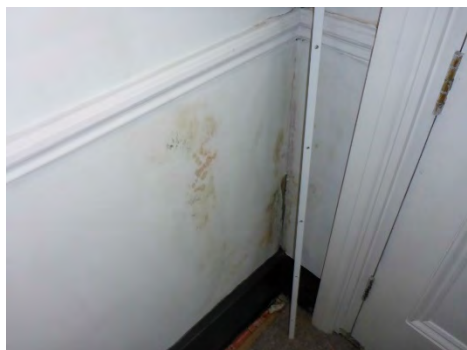
Saturation and damage to walls

There is saturation and staining to the wall and we believe this relates to defective flashings and guttering externally. Once the external issues are addressed internally there will be a need to cut out and patch repair the wall plaster before complete redecoration is carried out.

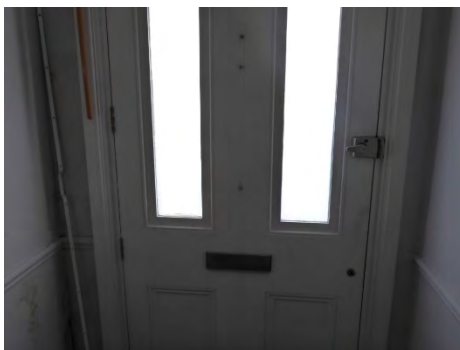
Glass in a critical location

The glazing to the door is not toughened. This is a safety issue and in accordance with Approved Document N of The Building Regulations 2010, glass within a critical location should be toughened with each pane carrying the British Standard reference to confirm compliance. Further information about alternatives to replacement of the glass panels is provided earlier in the report.

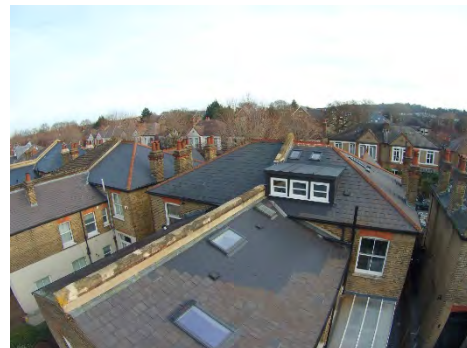
Ventilation to the roof timber is inadequate

Tile ventilators were noted to the roof slopes, however these were only located at high and mid level of the roof slopes. It is important to ensure that there is adequate cross ventilation to the roof timbers to prevent issues with condensation and prevent issues with resulting rot damage to roof timbers. Tile ventilators will need to be fitted to the external roof slopes at low level and additional ventilation at high level on all sides of the roof to provide suitable cross ventilation to the roof timbers.

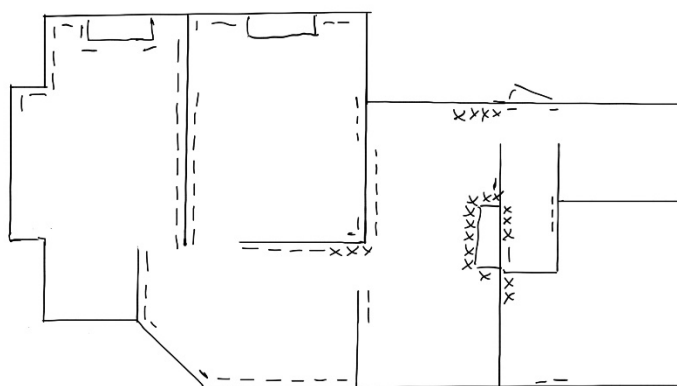
The walls to the kitchen, hallways and bedroom one provided high moisture readings. Without further investigatory work, it is not possible to be certain of the cause of the problem but in our view, it is likely to be due to the high ground levels and possibly a failure in the DPC.

It is strongly recommended you seek advice from a contractor accredited to the Property Care Association (PCA) who can determine the cause of any issue, most effective method of treatment and the associated costs.

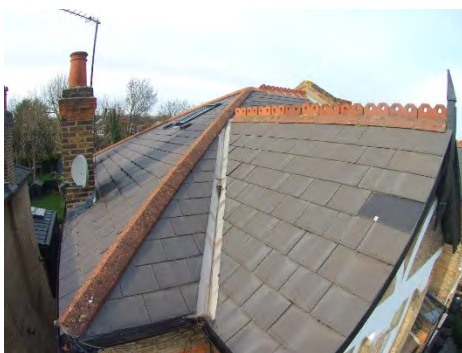
Poorly repaired slate to the front

A slate repair has been carried out to the front off-shoot and this has been completed to a poor standard where the old slate has not been removed fully prior to the installation of the new slate. Both the new and the old slate will need to be removed and then the new slate correctly re-fitted.

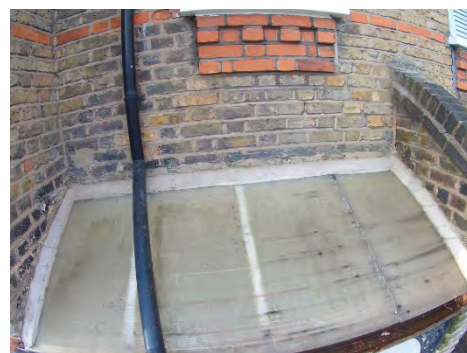
Cement fillets to the porch

The edges and abutments to the front porch are currently sealed with cement/tiled fillets. These are inadequate and need to be replaced with a more flexible material such as lead. The lead should be cut, wedged and pointed into the building.

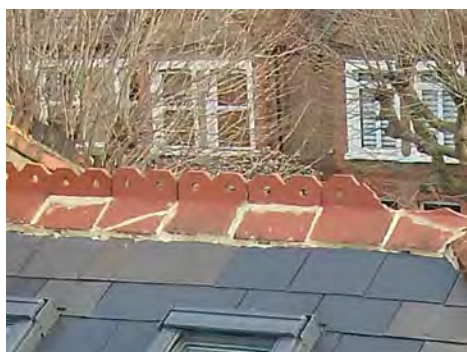
Broken ridge tiles to the main roof

The ridge tiles to the main roof are broken and have been bedded onto new mortar in several pieces. Over time it is likely that the mortar will crack and there is potential for water ingress. The ridge tiles will need to be stripped and replaced.

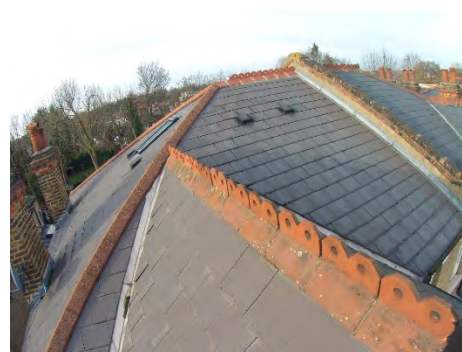
Loose and defective mortar to the ridge/hip tiles

The mortar to the ridge and hip tiles is loose and defective. The tiles need to be stripped, cleaned and then re-bedded on to new sand and cement mortar finished smooth. It is the practice of unscrupulous contractors to point over the existing mortar joints. This is not an acceptable form of repair.

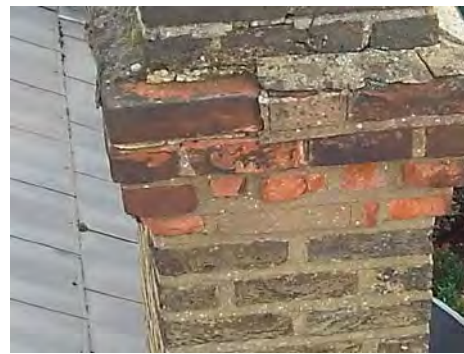
Spalled bricks and loose pointing

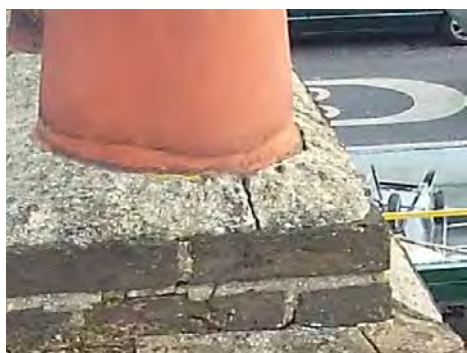
Cracked and defective flaunching

The cement bedding (flaunching) around the base of the chimney pot is defective. This will need to be removed and replaced with new mortar.

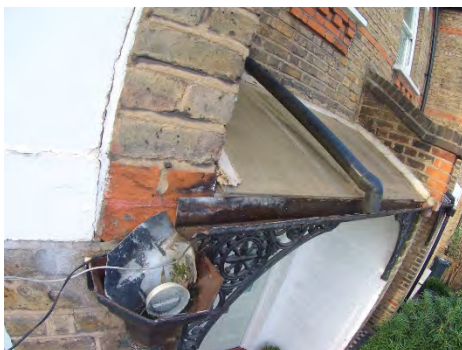
Porch guttering is blocked and in a poor state of repair

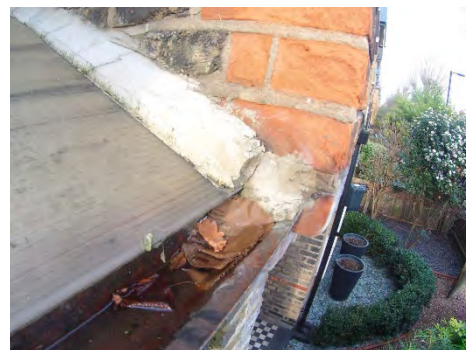
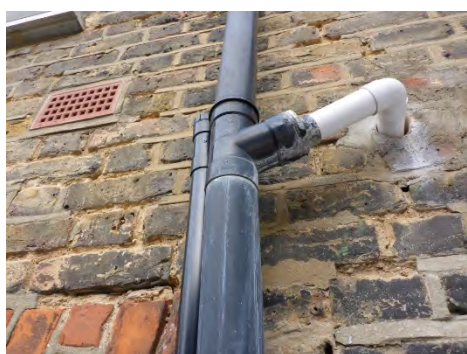
Grey waste into the rainwater pipe

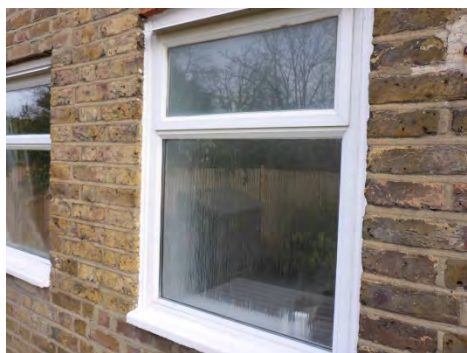
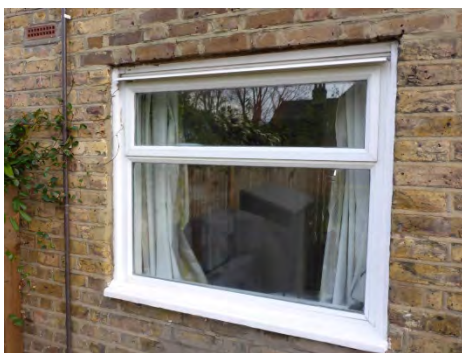
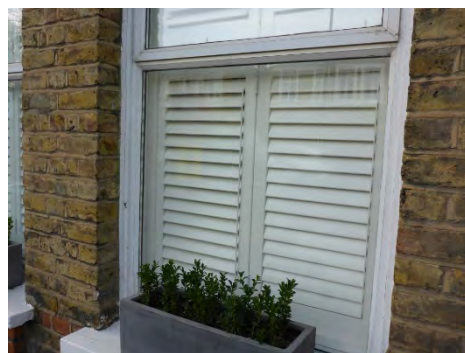
Windows are dated and in need of replacement

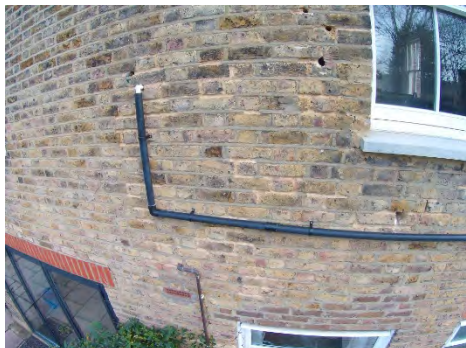
Loose and defective pointing to the rear walls

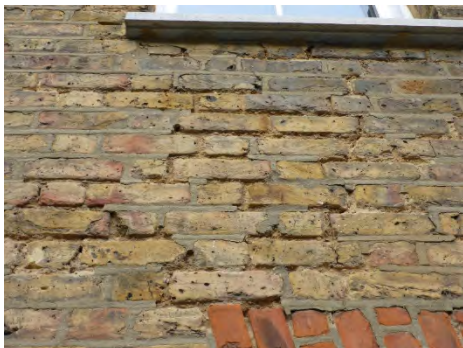
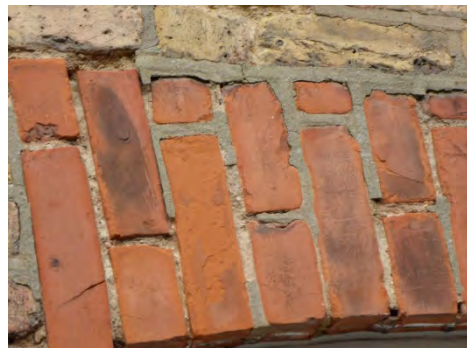
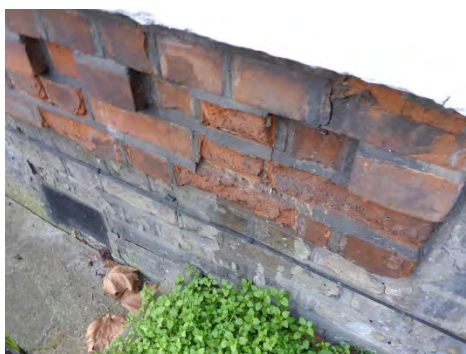
Spalled bricks to the front bay window

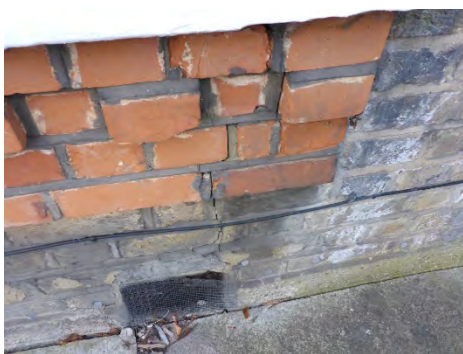
Cracks to the brickwork around the front bay window

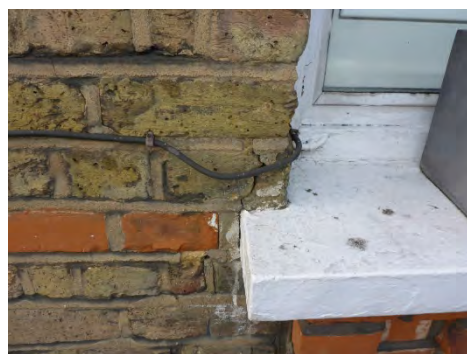
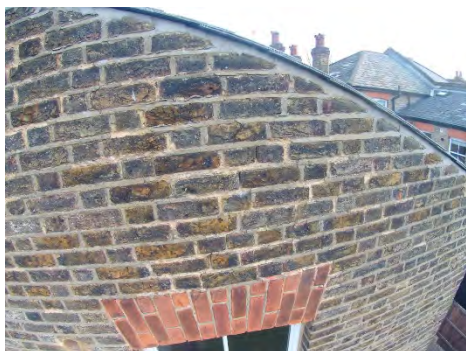
Cracks above rear off shoot window

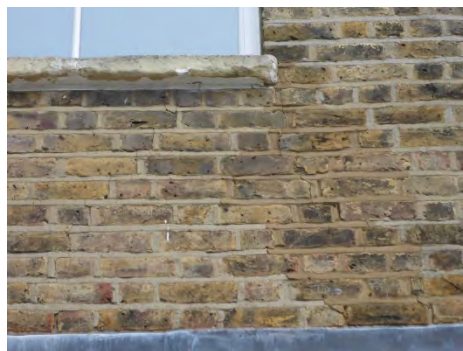
Cracks above conservatory

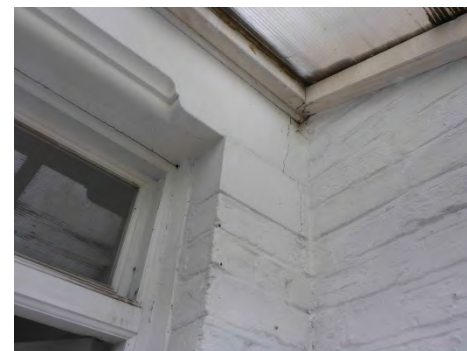
Cracks inside the front porch

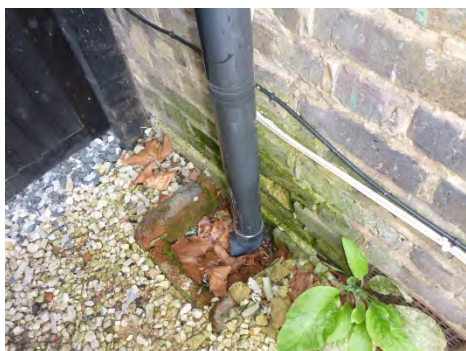
Spalled bricks around the base of both front rainwater pipes

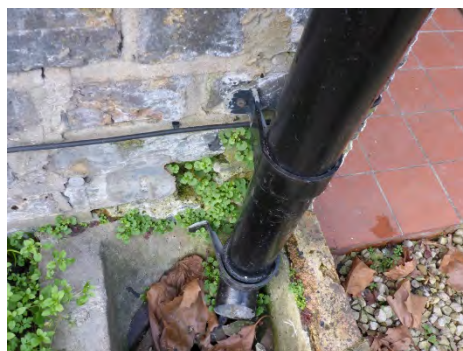
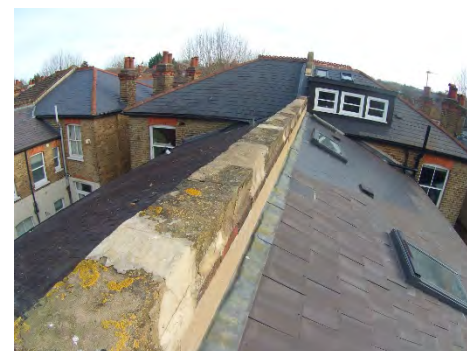
Rear parapet wall in a poor condition

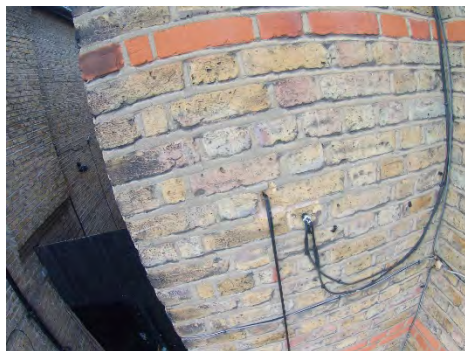
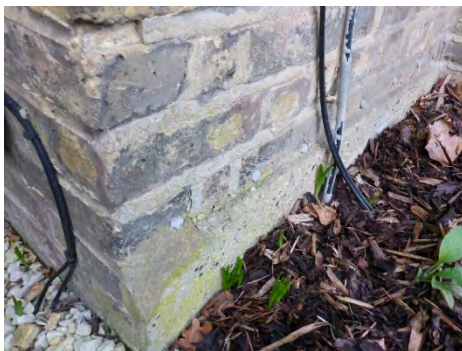
Poorly fitted cables to the front

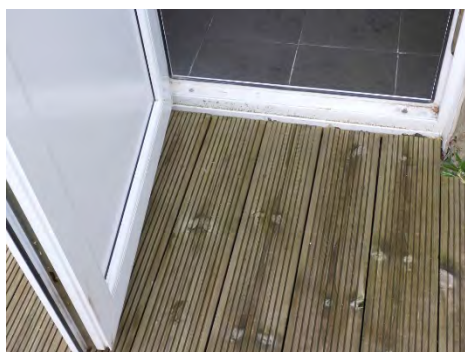
Rear decking is finished too high against the building

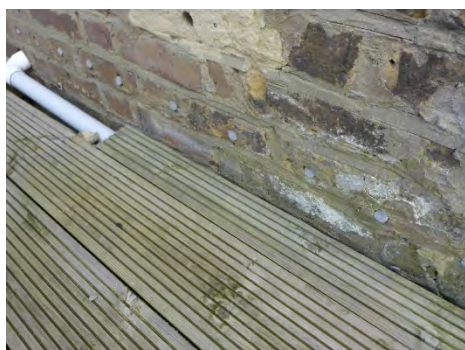
DPC injection to the rear

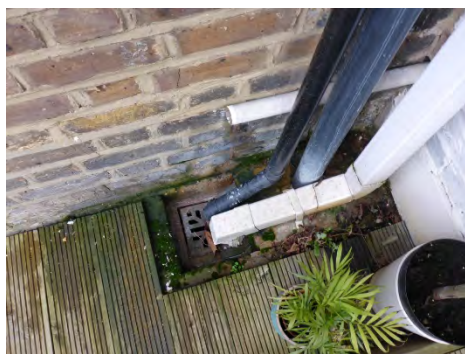
Kitchen waste is poorly fitted

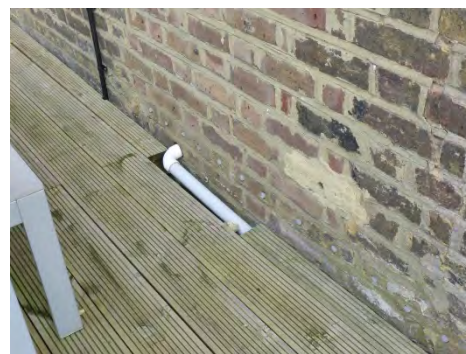
No access to bathroom hopper/connection

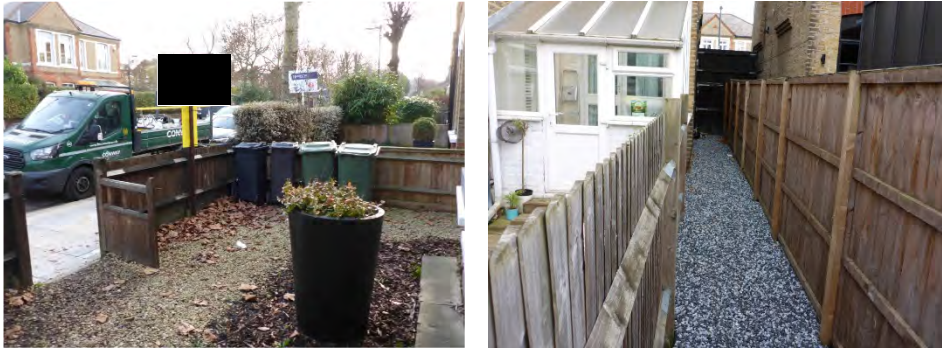
Shared access to the front and the side/rear

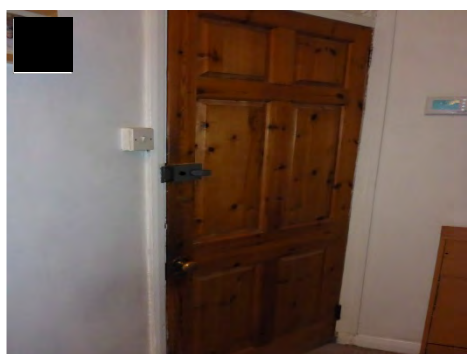
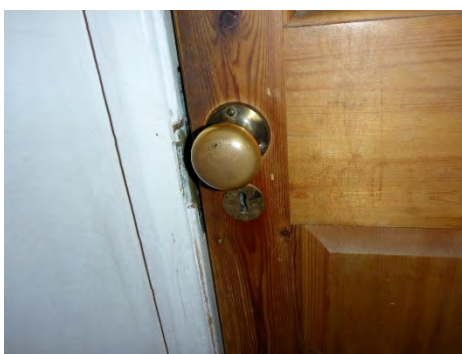
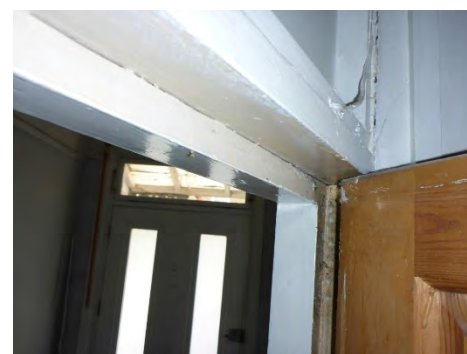
Entrance door is not correctly fire rated
