Home-Approved

Survey Report

Inspection Date 9 January 2019

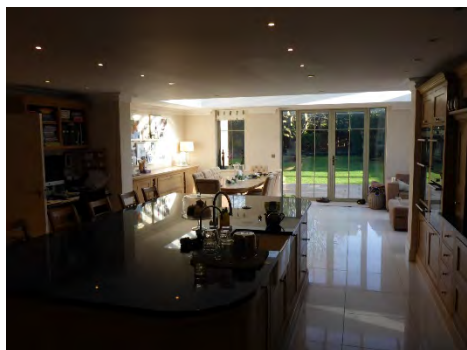
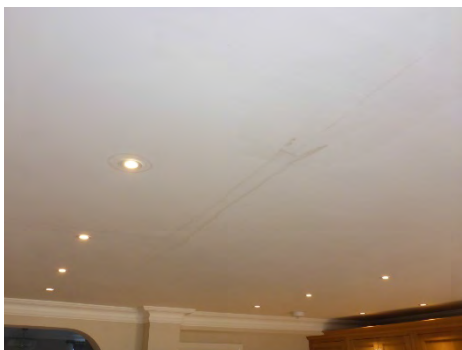
Water stains on ceiling

There is staining to the centre of the kitchen ceiling above the island unit. At the time of the inspection the areas were dry and there was no indication of this being a progressive issue. Prior to any decoration work suggested above the areas will need to be prepared and sealed with an alkaline based sealer.

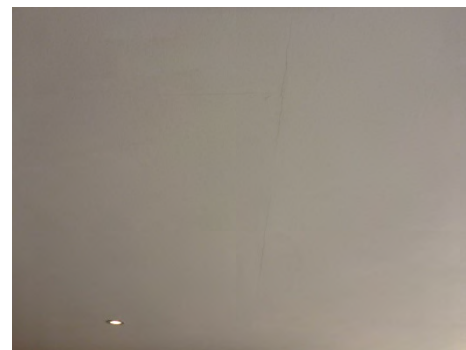
Ceiling cracks

The ceiling and walls are finished smooth and painted with emulsion and there is a decorative cornice to the perimeter of the ceiling. There is cracking to the ceiling, to the corner wall on the rear left side and to the wall beneath the side facing window at the rear of the room. None of the cracks suggest significant building movement or distortion and are more likely the result of general settlement and expansion. Prior to decoration the wall and ceiling will need to be lined in Wallrock and the corner joint will need to be raked out, prepared and sealed with a flexible acrylic sealant. Wallrock is a non-woven material which is suitable for covering up untidy and poorly plastered surfaces including cracks.

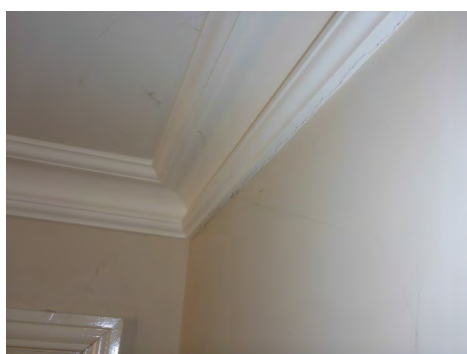
Cornice cracks

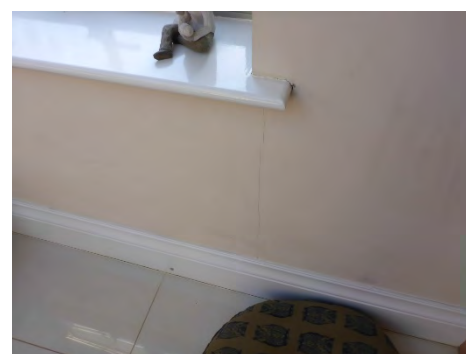
Wall cracks

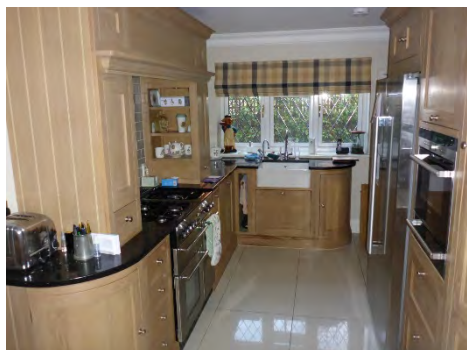
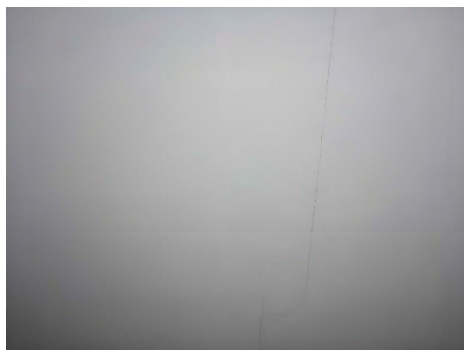
Ceiling cracks

The ceiling is finished smooth and painted with emulsion. There is cracking to the ceiling at the joint to the hallway and also to the skeiling inside the cupboard. None of the cracks suggest significant building movement or distortion and are more likely the result of general settlement and expansion. Prior to decoration the ceiling will need to be lined in Wallrock and the joints to the skeiling will need to be raked out, prepared and sealed with a flexible acrylic sealant.

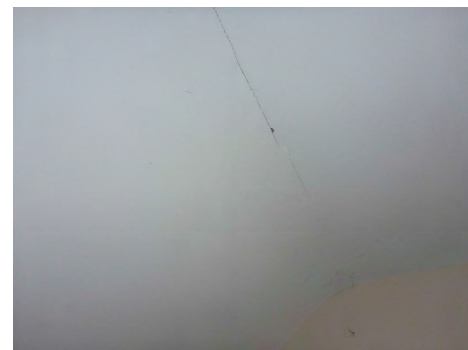
Skeiling cracks inside the cupboard

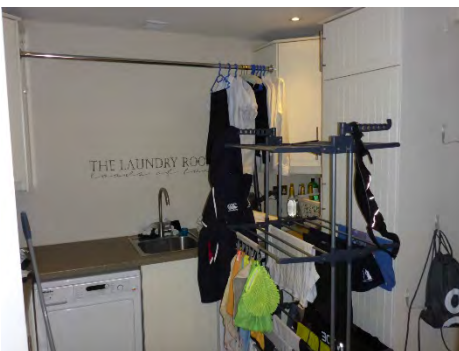
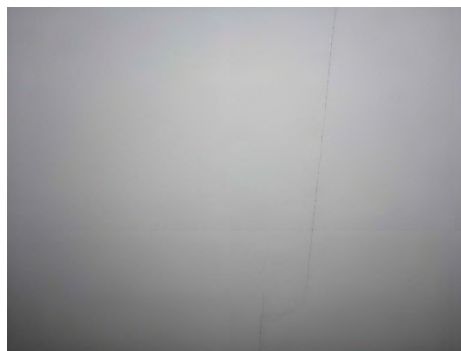
Water stain on the ceiling

The ceiling is finished smooth and painted with emulsion. There is a stain to the centre of the ceiling and there was nothing observed at the time of the inspection to suggest that this issue was progressive and all areas were dry. Prior to decoration the affected area will need to be sealed with an alkaline based sealer to prevent re-staining.

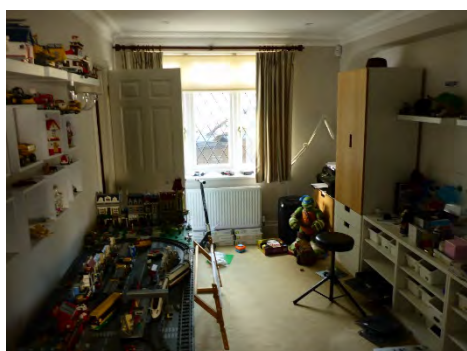
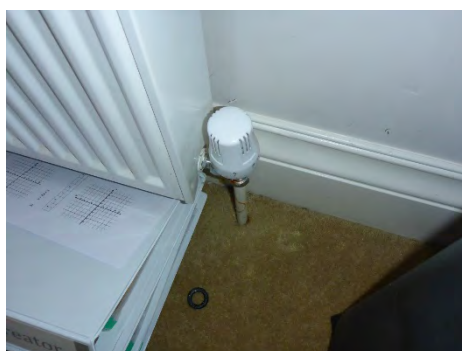
Leak from radiator valve

There is evidence of a leak from the thermostatic radiator valve and a plumbing contractor will need to attend and carry out repairs as necessary.

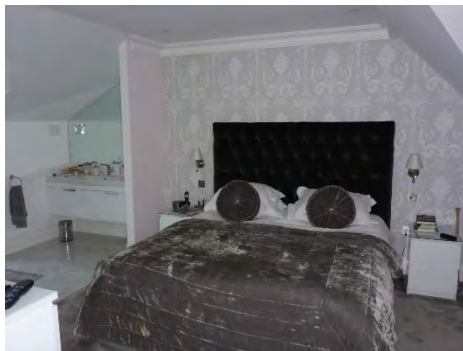
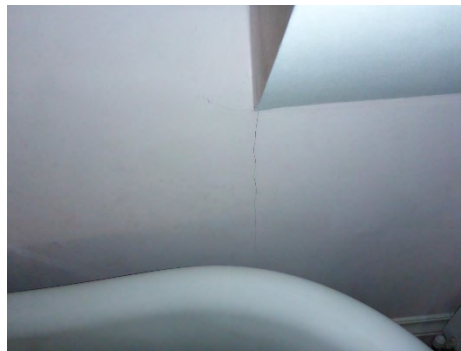
Wall crack

The ceiling and walls are finished smooth and painted with emulsion and there is a decorative cornice to the perimeter of the ceiling. There is cracking to the wall to the right side of the bath and to the internal left side front facing corner. None of the cracks suggest significant building movement or distortion and are more likely the result of general settlement and expansion. Prior to decoration the wall will need to be lined in Wallrock and the corner joint raked out, prepared and sealed with a flexible acrylic sealant.

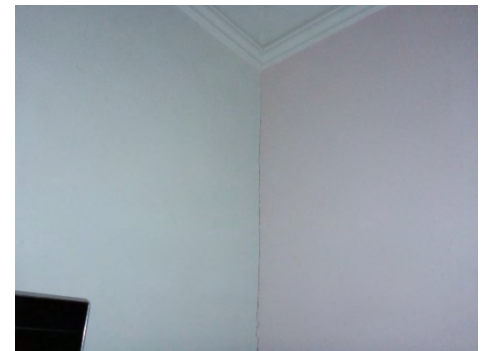
Corner crack

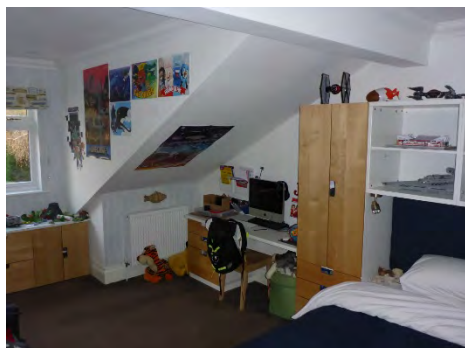
No ventilation to the chimney flue

There is no permanent ventilation provided to the chimney breast. The chimney flue will need to be fitted with permanent ventilation by way of a 225mm x 225mm air brick permanently open to prevent condensation issues within the chimney flue and potential internal damage to the property.

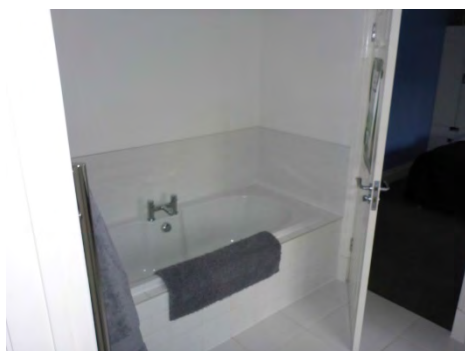
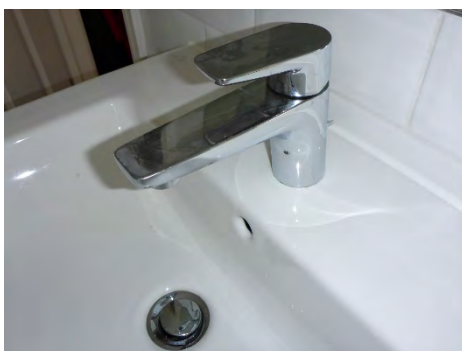
Loose tap

The tap to the wash hand basin is loose which can cause issues with undue pressure being placed on the water connections which may result in a leak. A plumbing contractor will need to attend and carry out repairs as necessary.

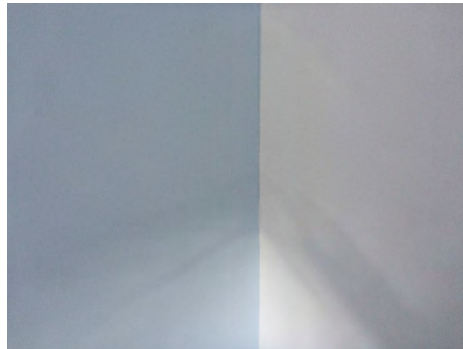
Corner cracks

The ceiling and walls are finished smooth and painted with emulsion and there is a decorative cornice to the perimeter of the ceiling. There is cracking to both front facing corners, to the skelings on both sides of the dormer window, to the wall above the front facing window and to the wall behind the door. None of the cracks suggest significant building movement or distortion and are more likely the result of general settlement and expansion. Prior to decoration the cracks to the skelings and the corners will need to be raked out, prepared and sealed with a flexible acrylic sealant and both the wall behind the door and above and around the window will need to be lined in Wallrock.

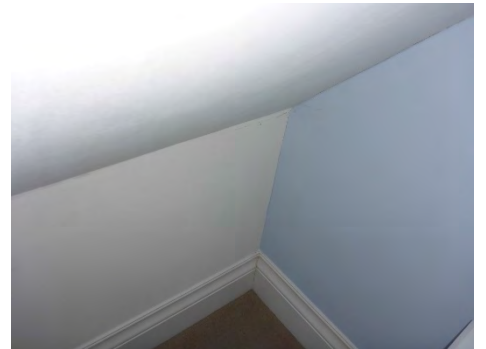
Skirting cracks

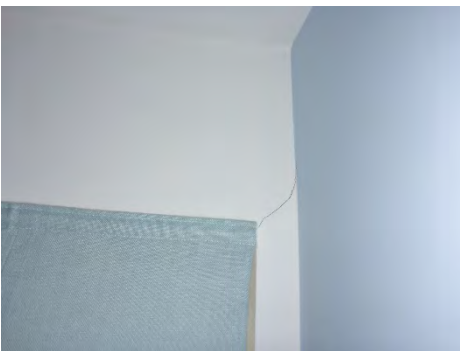
Wall crack above window

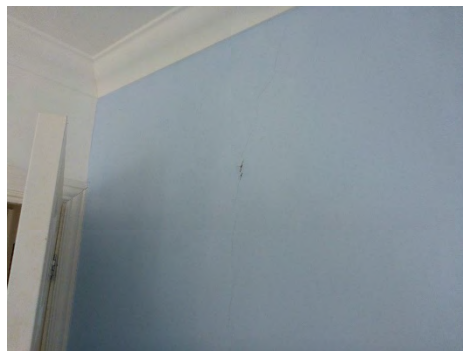
Wall crack behind door

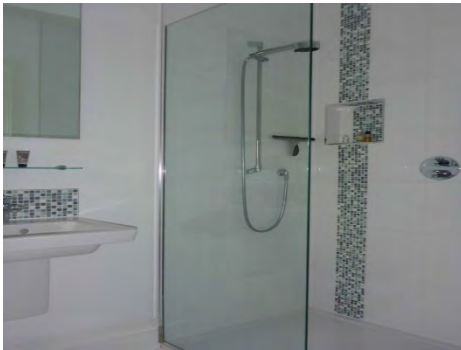
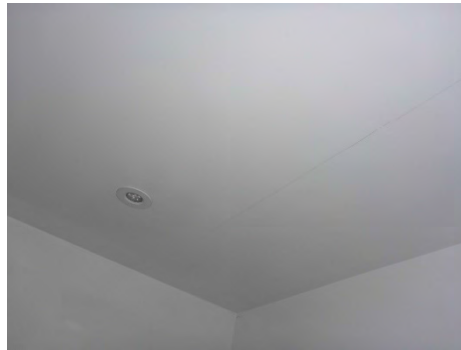
Ceiling crack

The ceiling is finished smooth and painted with emulsion. There is a crack to the ceiling which does not suggest significant building movement or distortion and is more likely the result of general settlement and expansion. Prior to decoration the ceiling will need to be lined in Wallrock.

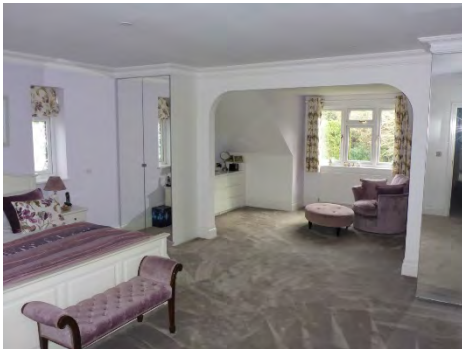
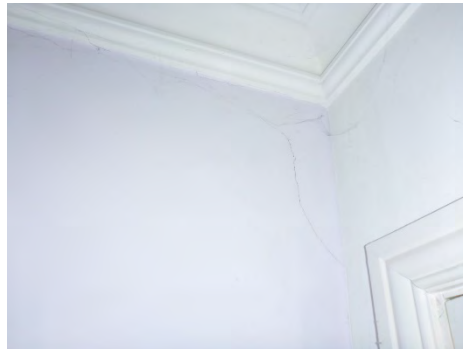
Wall cracks

The ceiling and walls are finished smooth and painted with emulsion and there is a decorative cornice to the perimeter of the ceiling. There is cracking to the wall behind the door to the hallway and also to the centre of the wall on the left side. The joints between the wall and the cornice are also cracked. None of the cracks suggest significant building movement or distortion and are more likely the result of general settlement and expansion. Prior to decoration both walls will need to be lined in Wallrock and the joints to the cornice will need to be raked out, prepared and sealed with a flexible acrylic sealant.

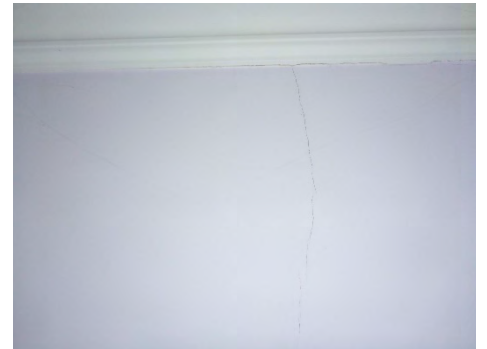
Wall cracks

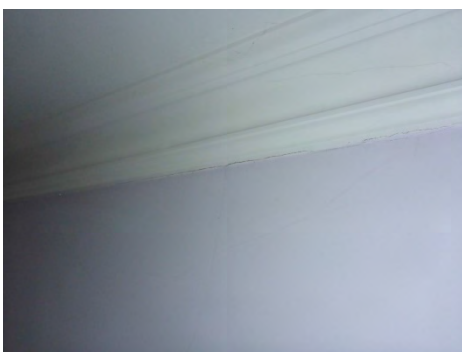
Cornice joint cracks

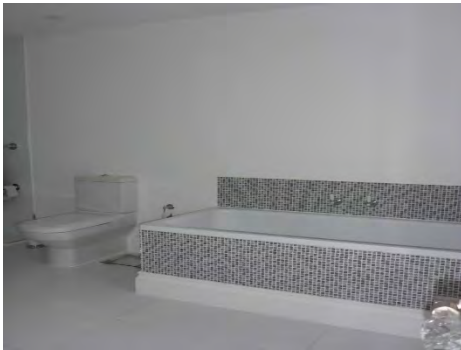
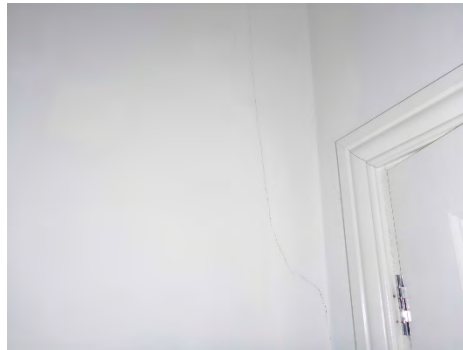
Wall crack

The ceiling and walls are finished smooth and painted with emulsion. There is cracking to the wall behind the door, to the internal corner and to the ceiling. None of the cracks suggest significant building movement or distortion and are more likely the result of general settlement and expansion. Prior to decoration the wall behind the door will need to be lined in Wallrock, the vertical joint will need to be raked out, prepared and sealed with a flexible acrylic sealant and the ceiling will need to be filled, prepared and lined in Wallrock.

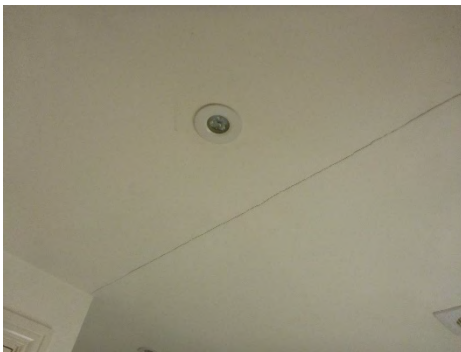
Ceiling crack

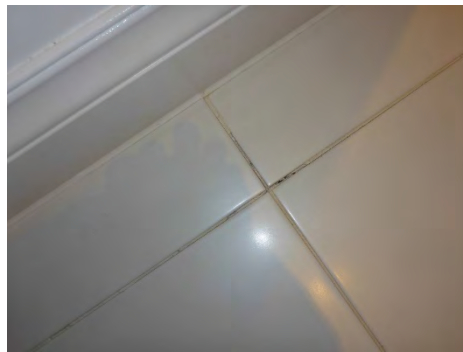
Loose floor tile grout

The floor is covered with ceramic tiles. One of the tiles is cracked and there is loose grout in various areas. This is an indication that the tiles have been fixed with a non-flexible material. The tile will need to be lifted and replaced and fixed in place with flexible adhesive and then all joints will need to be raked out and re-grouted with flexible grout.

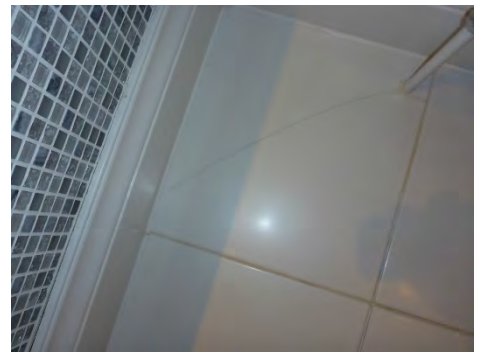
Cracked floor tile

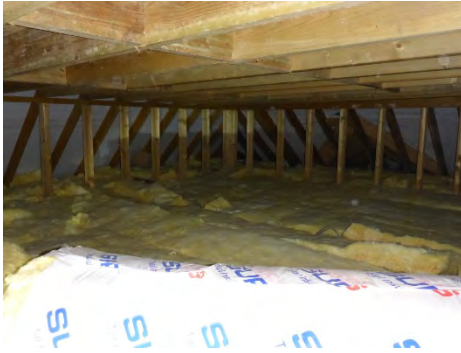
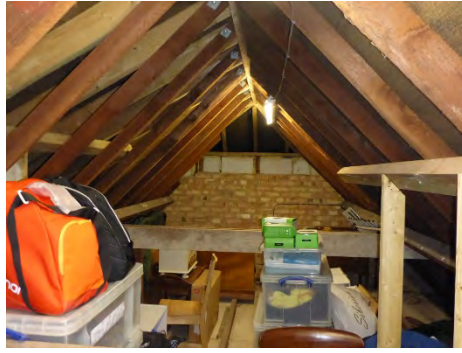
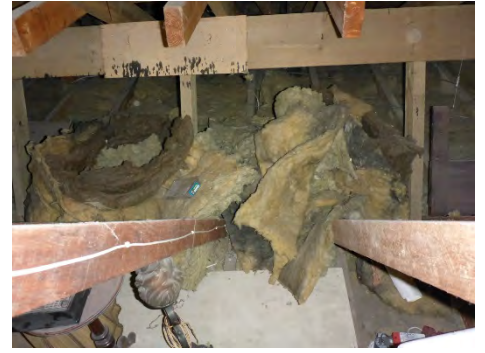
Insulation to the loft areas is inadequate

The insulation to the loft space is inadequate. Approved Document L1B of The Building Regulations 2010 advises an insulation thickness of a minimum 270mm over the entire roof area with an allowance at the eaves for continuous airflow. This should also include insulation to the loft hatch in the form of compressed foam or similar.

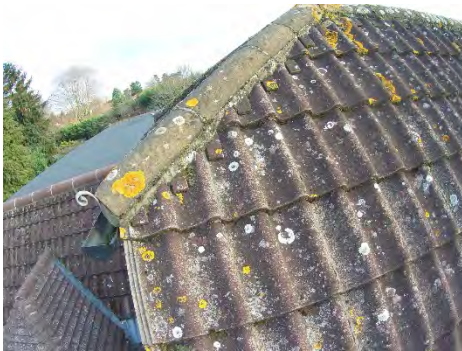
Loose and defective mortar to the ridge and hip tiles, valley tiling and verge tiling

The mortar to the ridge, hip, verge and valley tiles is loose and defective. The tiles need to be stripped, cleaned and then re-bedded on to new sand and cement mortar finished smooth. It is the practice of unscrupulous contractors to point over the existing mortar joints. This is not an acceptable form of repair.

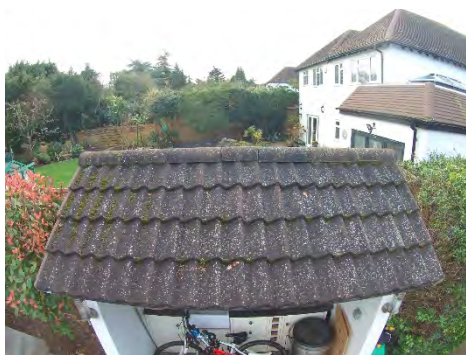
Loose ridge tiles to garden building

There is an outbuilding to the rear with a dual pitched roof covered with the same concrete interlocking tiles. The ridge tiles are loosely fitted and this is an issue as they can be easily displaced during adverse weather. The ridge tiles will need to be bedded onto mortar.

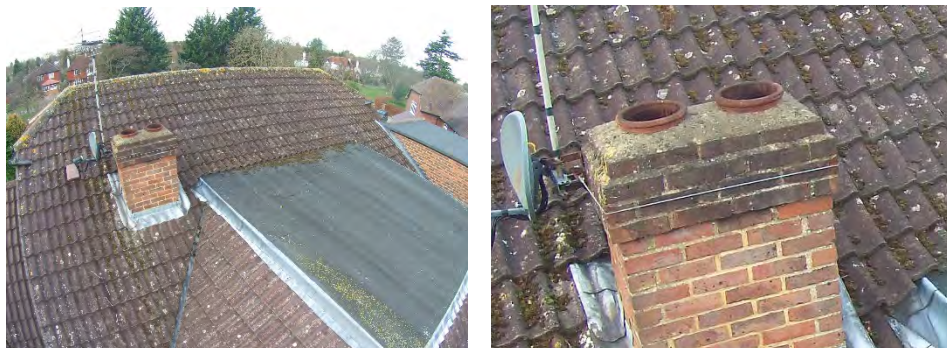
Open flues

The chimney flues are open and vulnerable to weather ingress. All flues should be fitted with pots and vented cowls to aid and promote cross ventilation to the chimney flues and in turn reduce the potential for internal damage due to condensation and weather ingress. At the same time all flues need to be vented internally with permanently open vented air bricks a minimum of 225x225mm.

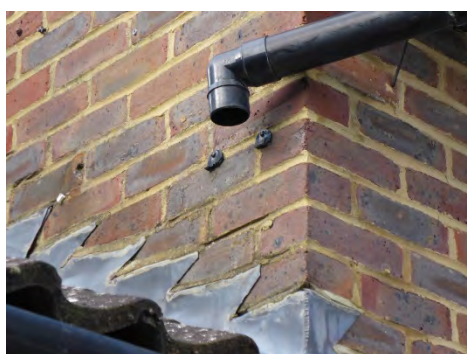
Missing rainwater pipe

A small section of rainwater pipe is missing from the rear roof and this will need to be fitted.

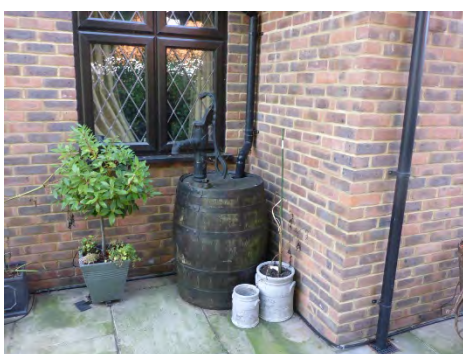
Water butt to side

Rainwater from the left side single storey roof discharges into a water butt. It is important to ensure that water butts are regularly emptied as overflowing water butts can result in damage to the fabric and foundations of the building.

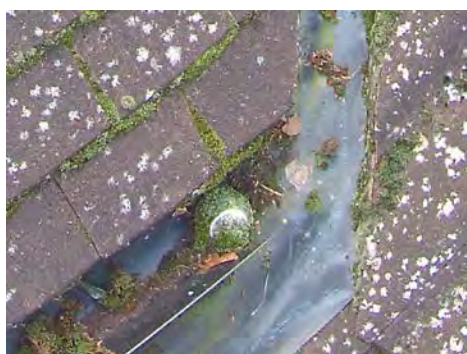
Tennis ball blocking the gutter

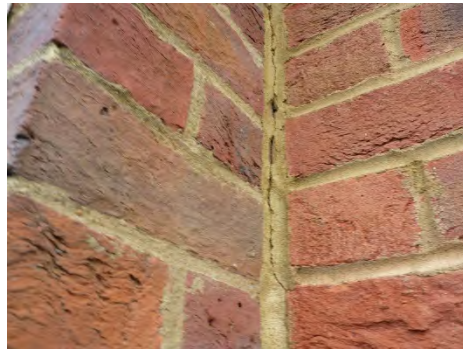
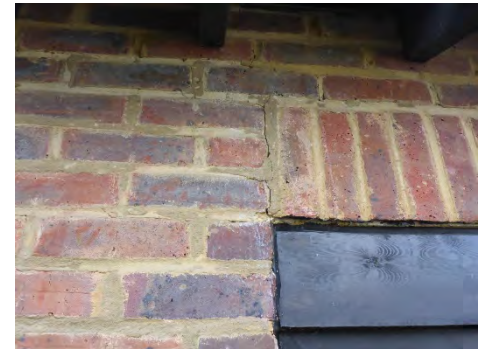
Cracks around window/door heads

The various vertical junctions between the original building and the extensions and the joints to the brickwork around the lintels to some of the windows to the front and rear are showing signs of cracking. None of the cracks suggest significant building movement or distortion and are more likely the result of general settlement and expansion and differential movement between the different parts of the construction. The mortar joints will need to be raked out and re-pointed.

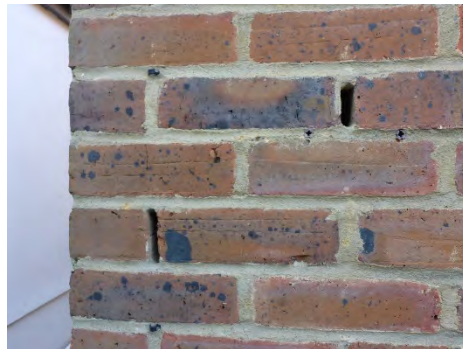
Holes in the rear wall

There are several loose and missing mortar joints to the right side and holes in the mortar joints to the rear. These joints will need to be raked out and re-pointed in new mortar.

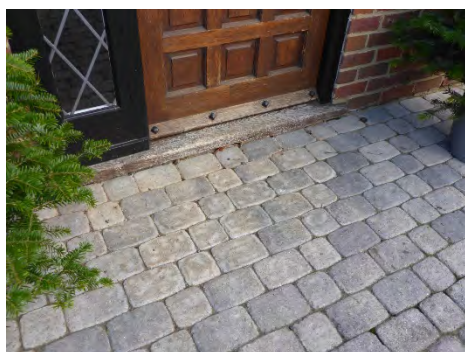
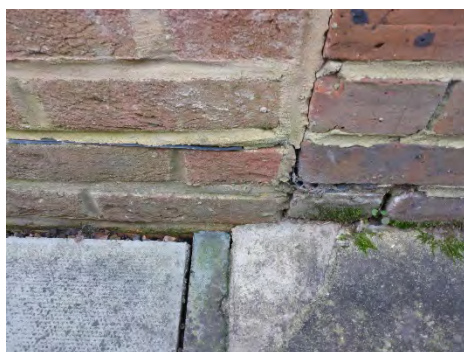
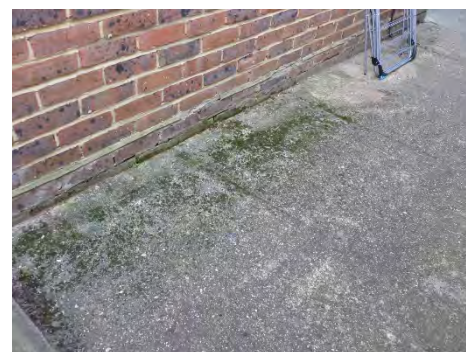
Ground levels to the front sides and rear are finished too high compared to the DPC

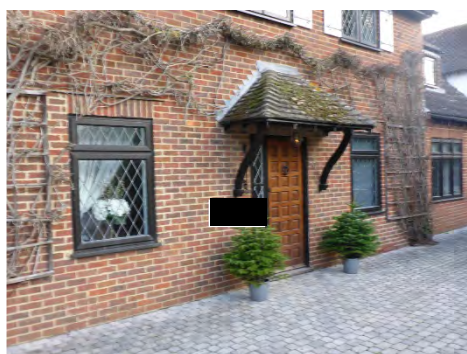
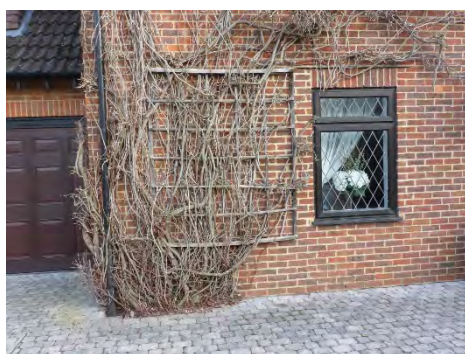
Creeping plants to the front wall
