Home-Approved

Survey Report

Inspection Date 9 January 2019

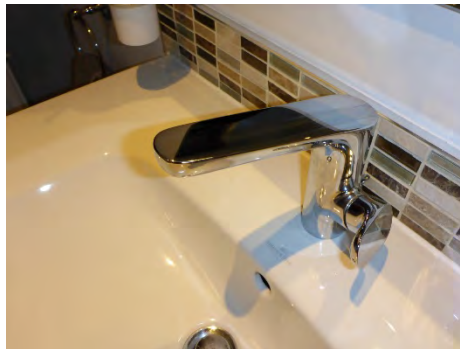
Tap to wash hand basin is loose

The tap to the wash hand basin is loose which can cause issues with undue pressure being placed on the water connections which may result in a leak. A plumbing contractor will need to attend and carry out repairs as necessary.

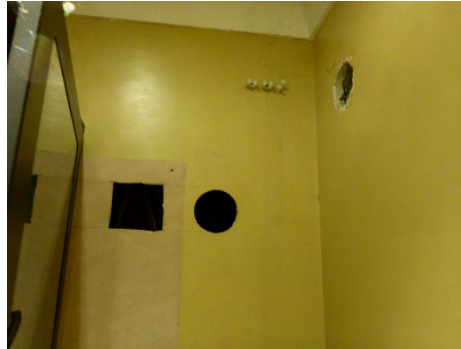
Holes in the wall board

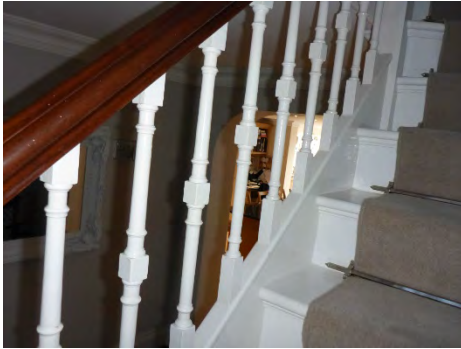
Stair guarding is spaced too wide

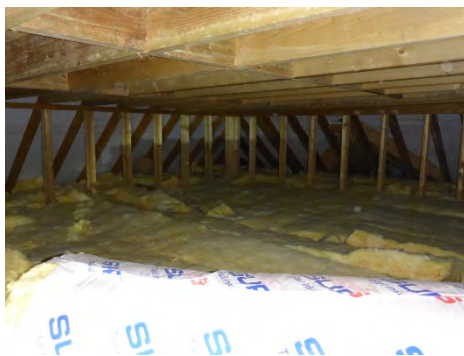
Extension roof has no central bracing

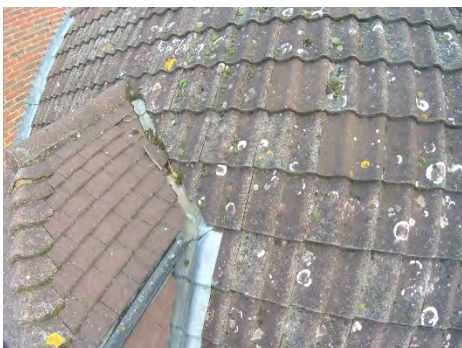
Slipped tile to the right side front dormer

There are slipped and displaced tiles to the right side front and rear dormer windows. These tiles will need to be re-fitted/replaced.

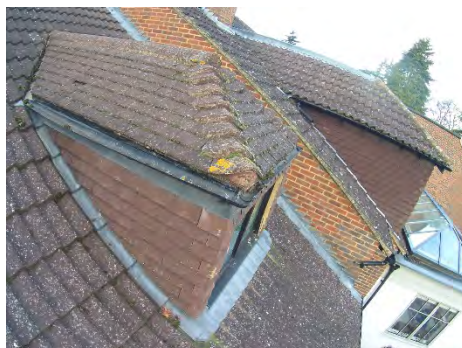
Slipped tile to the right side rear dormer

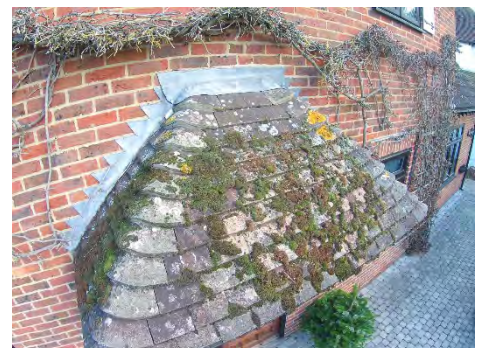
Moss on porch roof tiles

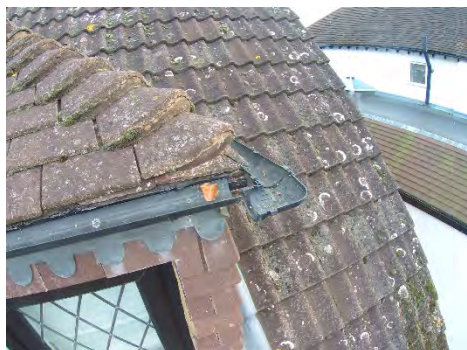
Detached fitting to dormer

To the front right side dormer the guttering has split and will need to be repaired/replaced.

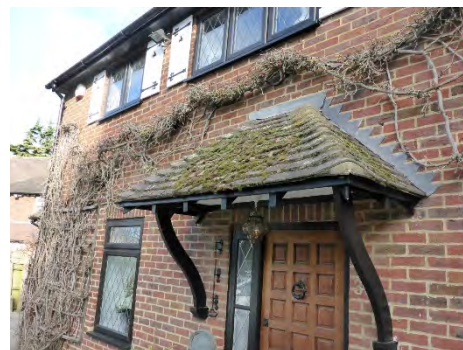
No gutters to the porch

There is no guttering installed to the right side barn hip of the roof and the porch. This means that rainwater is able to discharge directly onto the ground which in turn can cause issues with damage to the fabric and foundations of the building. Guttering and rainwater pipes will need to be installed.

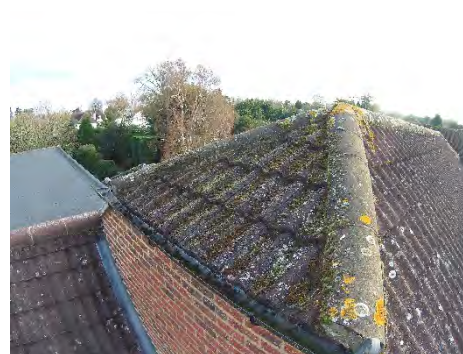
Moss and debris in gutters

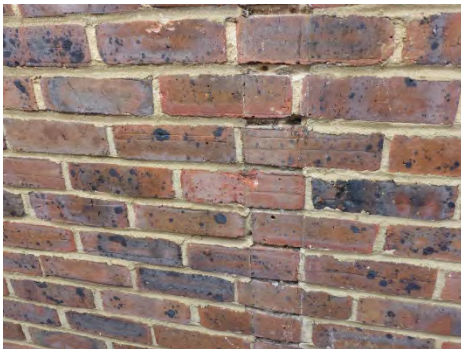
Loose and missing pointing to the side

The various vertical junctions between the original building and the extensions and the joints to the brickwork around the lintels to some of the windows to the front and rear are showing signs of cracking. None of the cracks suggest significant building movement or distortion and are more likely the result of general settlement and expansion and differential movement between the different parts of the construction. The mortar joints will need to be raked out and re-pointed.

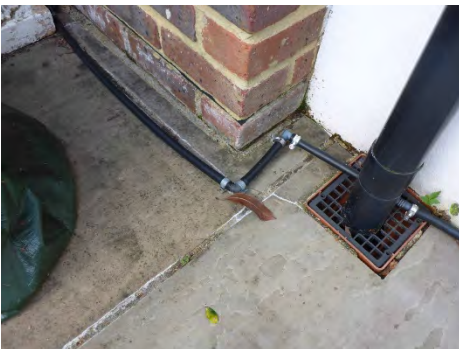
Open rainwater hoppers
