home-approved®

your survey report

████████████████████ **Gerrards Cross, Bucks, SL9** ██████████

Client	████████████████████
Date of Inspection	2 June 2015
Inspection Completed by	Matthew Brown AssocRICS

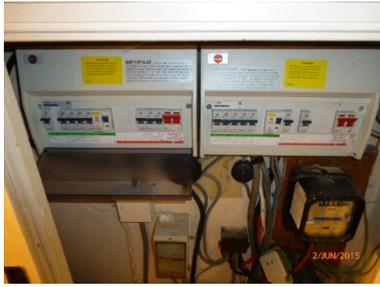
Fuse-boards

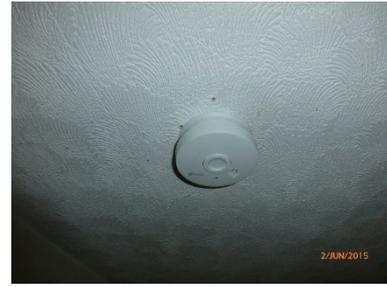
Battery powered smoke detection

Estimated costs £600-700.00 (smoke & heat detection)

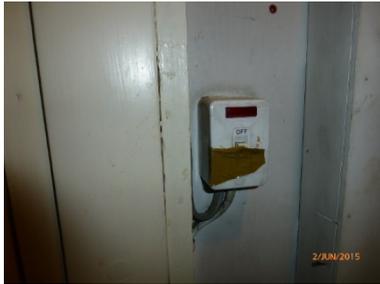
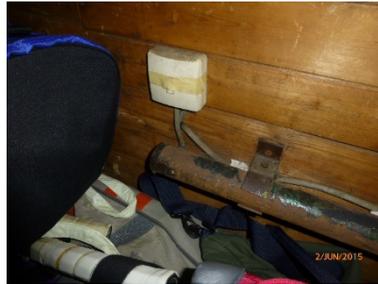
Details/Defects/Issues: There are a number of taped switches and sockets. A qualified electrician should attend and establish the reason for this and carry out repairs or upgrades as necessary so as to ensure electrical safety through the installation.

Some of the wiring and switch/socket faces are dated

- Replacement fuse-board
- Mains powered smoke/heat detection system
- Replacement sockets and switch faces
- Improvement to the wiring installation

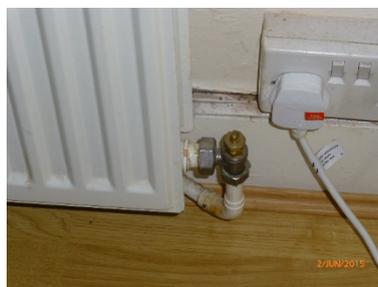
Not all radiators are fitted with TRV's

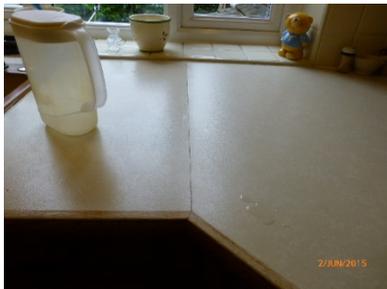
The joint between the worktops to the right side of the sink is swollen which is an indication that moisture has been able to penetrate the joints over time and cause swelling to the chipboard below the laminate. The only effective way to address the issue would be to remove and replace the worktops.

Swollen joint to the worktop

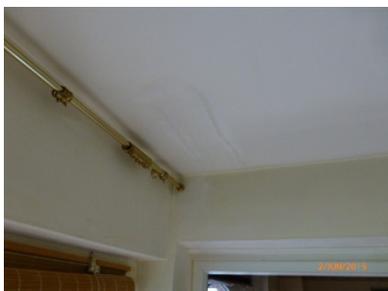
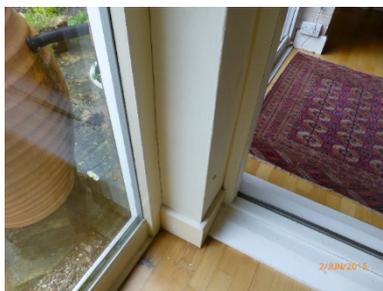
The ceiling and walls are finished smooth and painted with emulsion. There is water staining to the ceiling and blistering to the wall above the window and to the right side of the door. The vendor advised there had been an issue with a blocked gutter which had caused an overflow and saturation to the walls and this in turn had leaked through the ceiling. She advised that the water butt had been relocated and the areas were now drying. Moisture readings were taken in these areas and none of the readings were high or abnormal. Prior to decoration the affected areas should be fully prepared and sealed with an alkaline based sealer to prevent re-staining.

Water mark to the ceiling and blistering to the wall paint

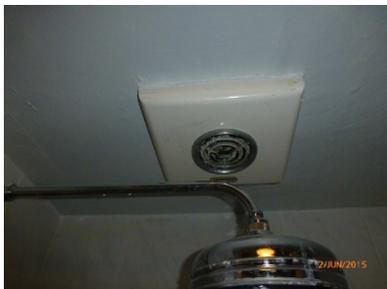
Ceiling mounted extractor

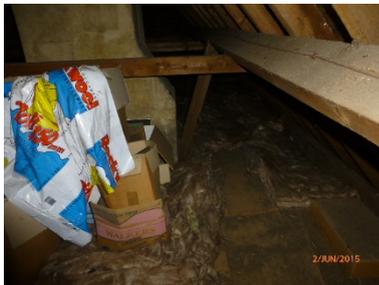
Front loft fully insulated

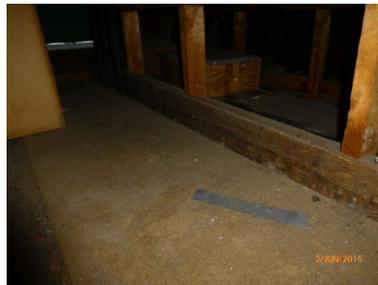
Details/Defects/Issues: The front section of the roof has recently been insulated and upgraded however the rear section remains fully boarded and the insulation in this area is inadequate. A small area behind the water storage tank provided access to the floor void where there was no evidence of insulation. Insulation should be upgraded in line with Approved Document L1B of The Building Regulations 2010 advises an insulation thickness of a minimum 270mm over the entire roof area with an allowance at the eaves for continuous airflow. This should also include insulation to the loft hatch in the form of compressed foam or similar.

Rear loft is fully boarded and not adequately insulated

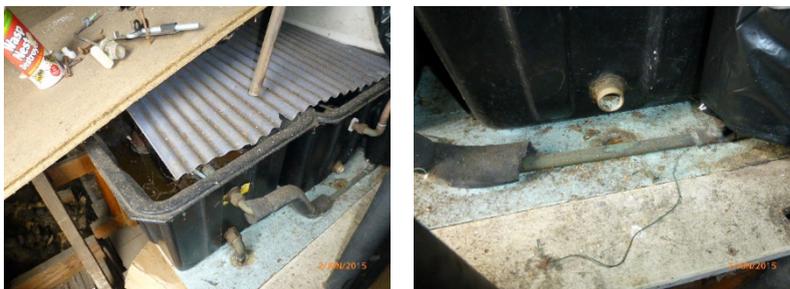
Expansion tanks covered in plastic Pipes are not fully insulated

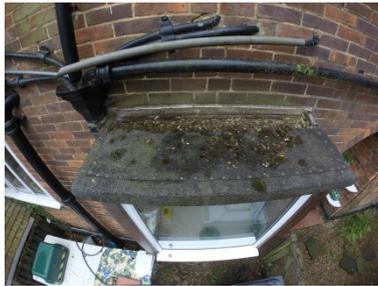
Side bay roof is worn

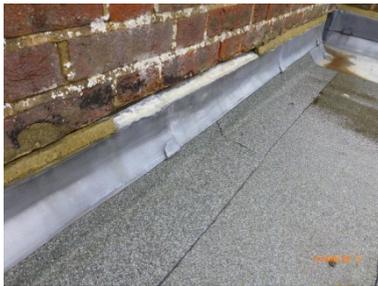
Loose and defective pointing to the rear flat roof flashings

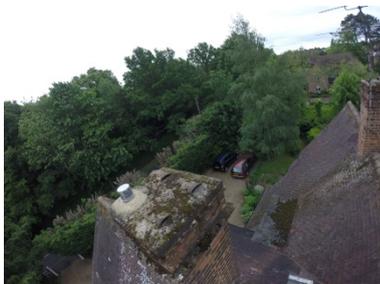
Loose and defective flaunching

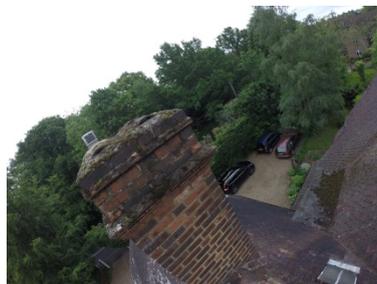
The chimney flues to both chimneys have been capped with ridge tiles which are likely to restrict ventilation to the chimney flues and may result in internal issues due to condensation forming within the flues. The ridge tiles should be replaced with pots fitted with weather directional cowls to aid and promote cross ventilation to the chimney flues.

Poorly capped flues

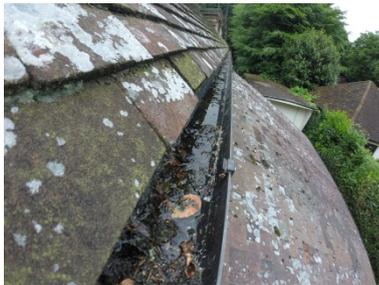
Gutters contain moss and debris

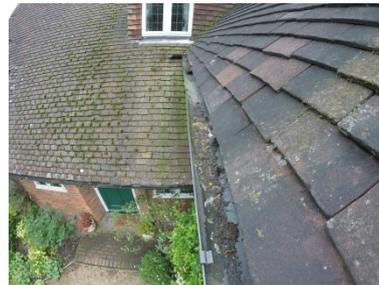
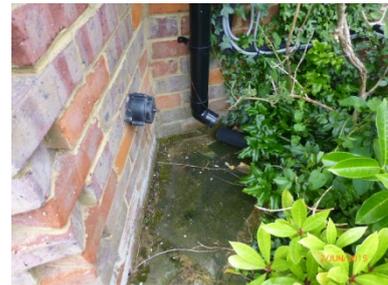
Rainwater pipe not connect to soakaway

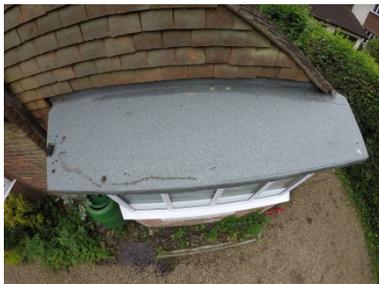
No gutter to study bay window

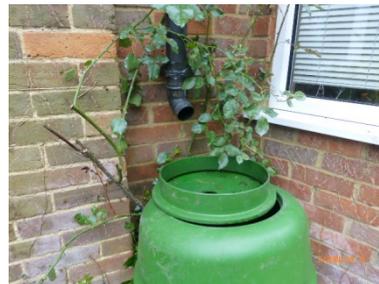
The guttering/water butt to the left side of the study window is poorly installed and the rainwater pipe does not connect directly to the water butt which means water is able to escape during rainfall. Evidence of this can be seen by saturation and staining to the brickwork on both sides of the water butt. The gutter pipe needs to be extended so as to connect directly into the water butt which should also be fitted with a secure lid.

Pipe cut short of water butt

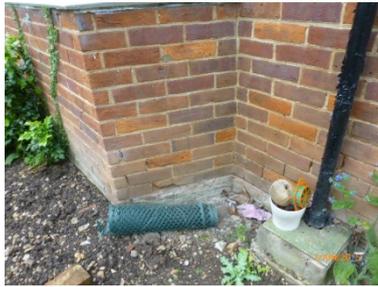
Loose pointing and spalled brickwork to the front and left side

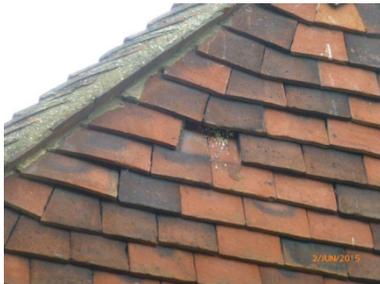
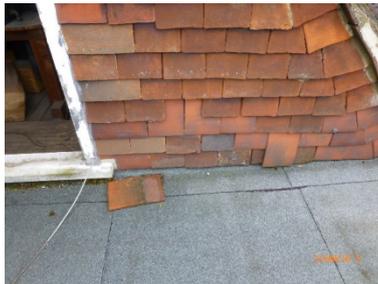
Missing hanging tiles to the various elevations

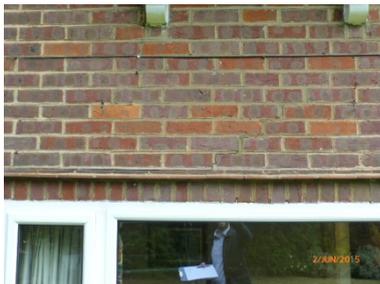
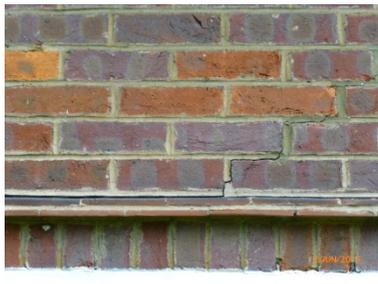
Deflection to the brickwork above the rear facing window

Crack to the side rear parapet wall

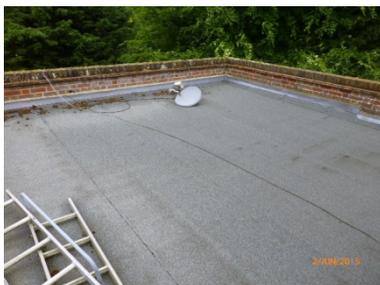
The balcony to the rear is protected by the parapet walls which are finished approximately 400-500mm from the level of the roof. This does not provide adequate guarding and there is a significant risk of falling. In line with Approved Document K of The Building Regulations 2010 the parapet wall guarding should be improved.

Parapet walls are too low

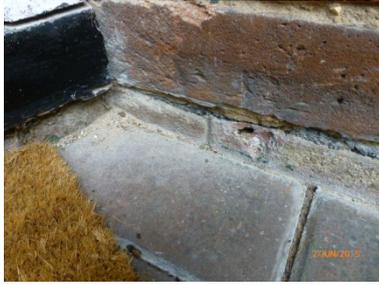
Ground levels should finish at a level 150mm below the level of the damp proof course which is usually to the underside of the door sills or to the top of air bricks in the case of suspended timber floors. In the case of the front, sides and rear the ground levels finish above this minimum requirement and should be reduced accordingly. Where it is not possible to reduce the ground level then a French drain should be installed which consists of a channel being cut between the ground surface and the main building to a depth and width of 150mm, a perforated land drain should then be installed discharging to a water course or soak away and the channel filled with shingle.

Bitumen DPC to the front and sides

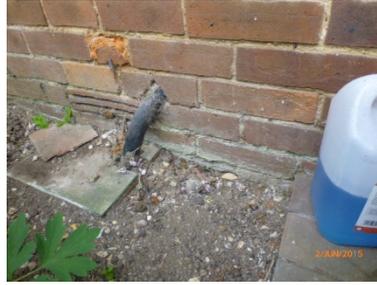
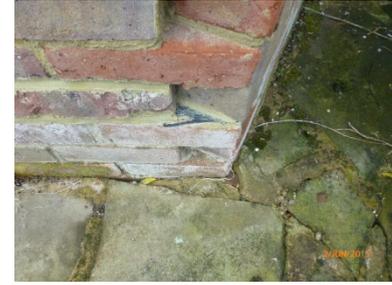
Details/Defects/Issues: A bitumen DPC was visible to the original building and a plastic DPC to the extended section.

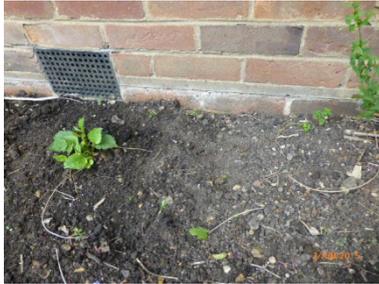
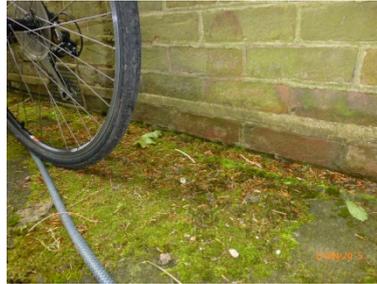
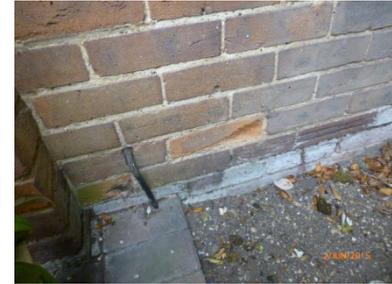
Plastic DPC to the rear and side

Ground levels to the front side and rear are finished too high compared to the DPC

Estimated costs £2500-3000.00

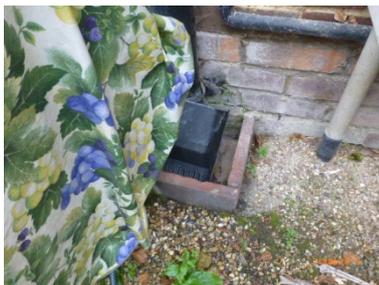
Details/Defects/Issues: There are a number of open hoppers to all sides which are exposed to blockage by leaves and debris. All hoppers should be fitted with concrete shrouds and removable covers.

Open hoppers to the front, sides and rear

Estimated costs £100.00
