**home-approved®**

## your survey report

██████████, ██████████, Tadley, RG26 ██████████

<b>Client</b>	██████████
<b>Date of Inspection</b>	2 April 2015
<b>Inspection Completed by</b>	Matthew Brown AssocRICS

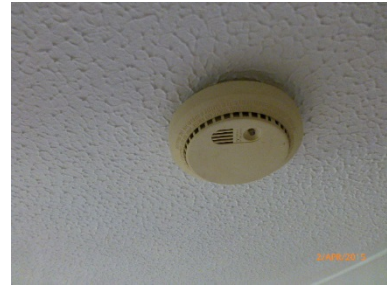
Battery powered smoke detection

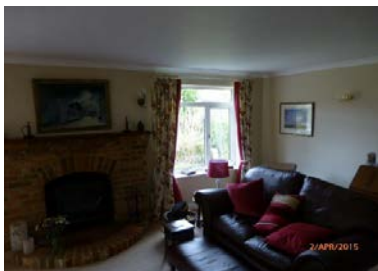
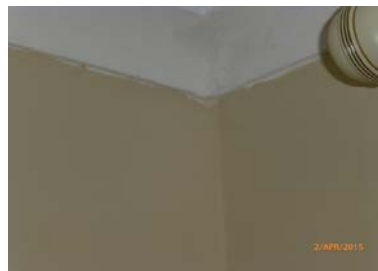
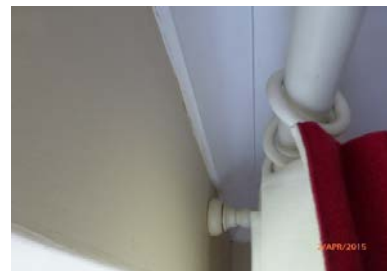
**Details/Defects/Issues:** The ceiling and walls are finished smooth and painted with emulsion. There is coving fitted to the perimeter of the ceiling. There is some cracking to the joints between the walls and ceiling. None of the cracks suggest significant building movement or distortion and are more likely the result of general settlement and expansion. Prior to decoration the joints should be raked out and sealed with flexible acrylic sealant.

Cracks to the coving joints

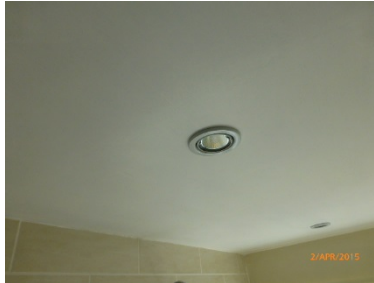
**Details/Defects/Issues:** The lighting is not suitably IP rated and presents a safety issue. As part of any electrical repairs and upgrades the lights should be replaced with IP rated fittings.

Lights are not IP rated

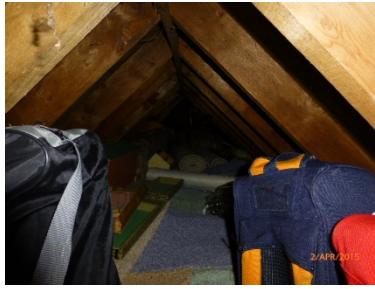
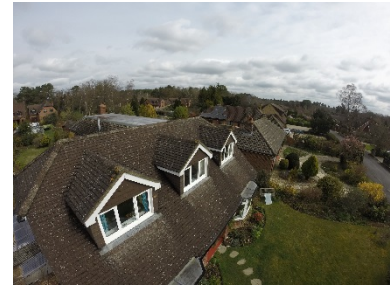
No means of ventilation to the timber

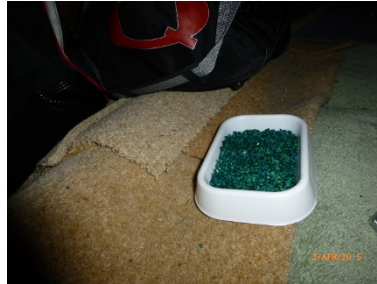
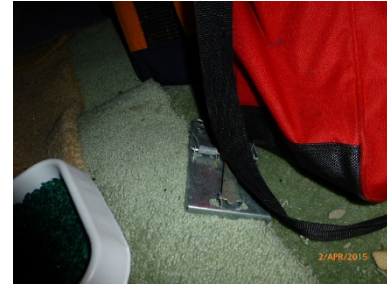
Rodent trap in the loft

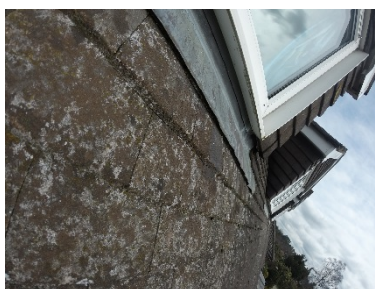
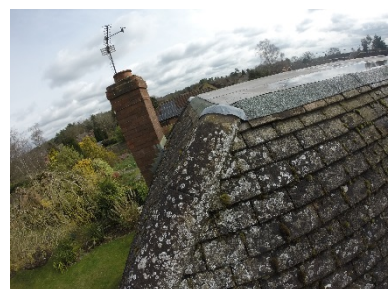
Poorly fitted lead to rear hips

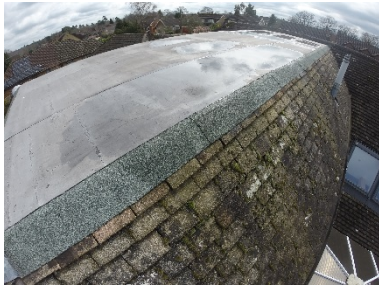
Apron has been laid in felt

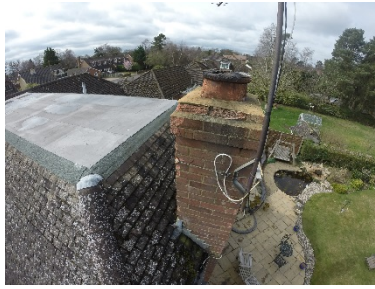
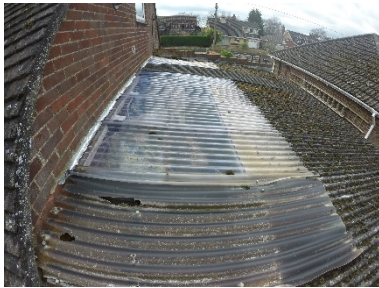
Poor flashing to garage roof

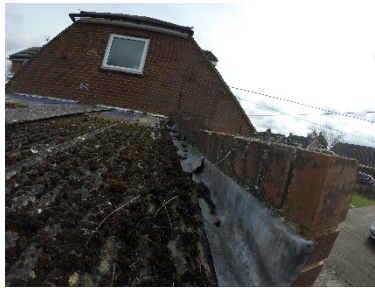
Poor flashing to garage parapet wall

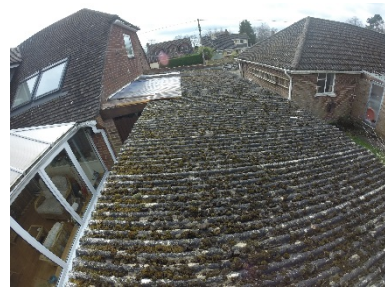
Potential ACM to garage roof

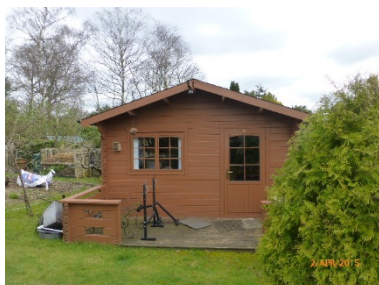
**Details/Defects/Issues:** There is a timber building in the rear garden which is connected to the power supply to the main property. The roof is finished dual pitched and covered with felt shingles. The doors and windows are timber fitted with single glazed panels.

Log cabin in the rear garden

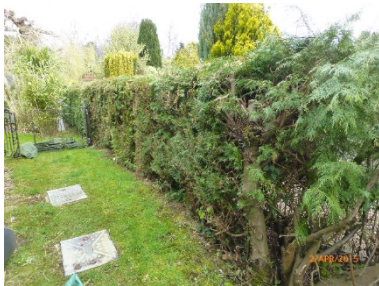
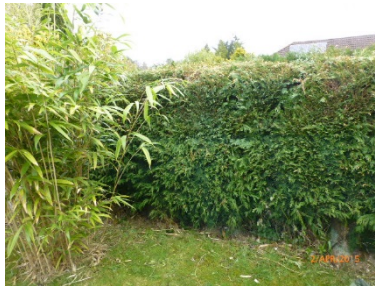
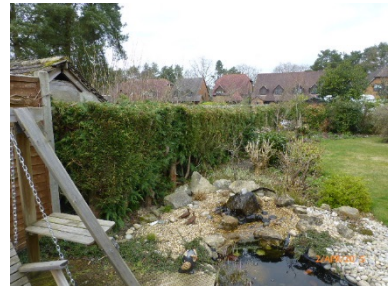
**Details/Defects/Issues:** There are a number of shrubs, small trees and creeping plants planted in the front flower beds and in close proximity to the building. To the left and right side the boundaries are divided with conifer trees/bushes, some of which are planted in close proximity to the main building. Trees and shrubs can cause damage to foundations and underground services such as drainage. Where there are trees or large shrubs in close proximity to the property it would be appropriate to draw up a programme of management to restrict future growth to prevent possible damage.

Conifer trees planted to the left and right side boundaries are close to the house
