# Survey Report

**Inspection Date** 6 November 2018

**Inspection by** Matthew Brown AssocRICS MFPWS

Type of property	A Bungalow
Approximate year of construction	1960s
Purchase price	£667,500
The front of the property faces	West
Weather conditions during inspection	Showers
Condition of property when inspected	Owner Occupied
No of floors	1
Access to the property	By Vendor
Present during inspection	
What is the tenure	We assume the property is freehold
How many years if leasehold	Not Known
The roads are	Private
Access to site is	
Property listed or in a conservation area	No

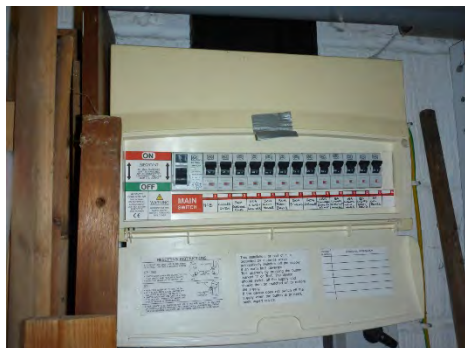
Fuse board

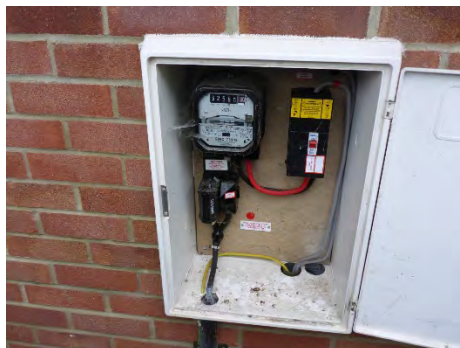
Main fuse &amp; meter

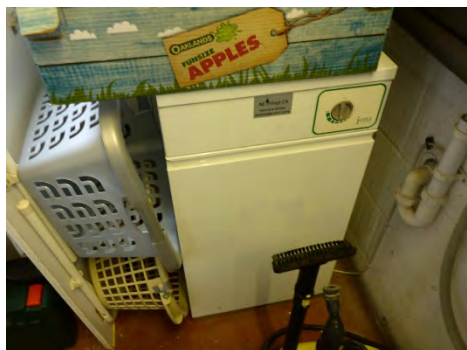
Floor standing oil fired boiler

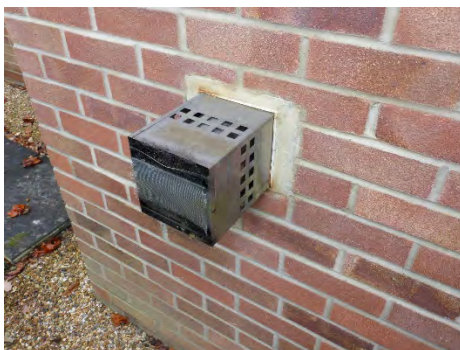
Boiler flue

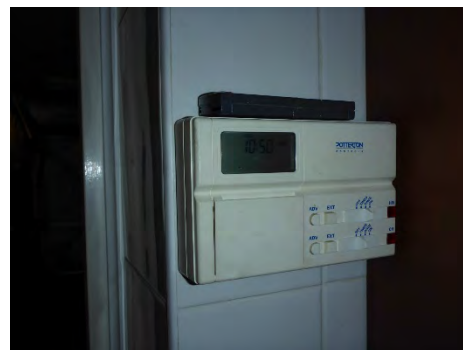
Boiler programmer

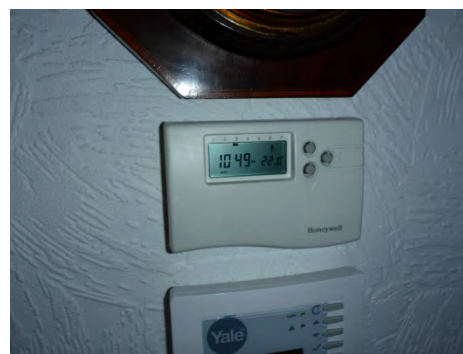
Thermostatic control

**Details / Defects / Issues:** The thermostatic control is located in the hallway and there is thermostatic radiator valve (TRV) fitted to the radiator. The two fittings will cause confusion between the boiler controls and the TRV will need to be removed.

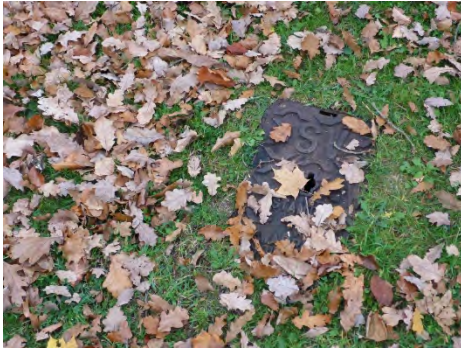
External stopcock and water meter

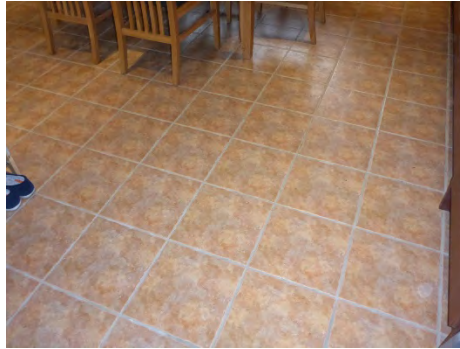
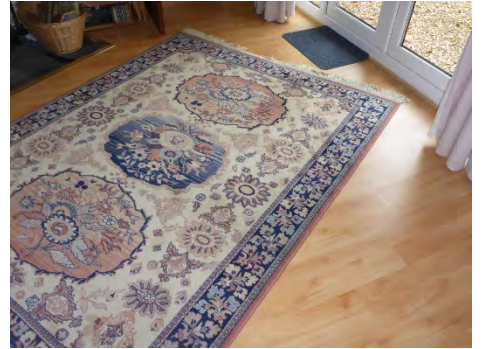
Floors are covered with carpet, ceramic tiles and laminate flooring

**Details / Defects / Issues:** At the time of the inspection no visible defects were observed.

The floors were covered with carpet, laminate and ceramic tiles at the time of the inspection. This prevented an inspection of the floor structure, however no defects with movement or distortion were observed at the time of the inspection.

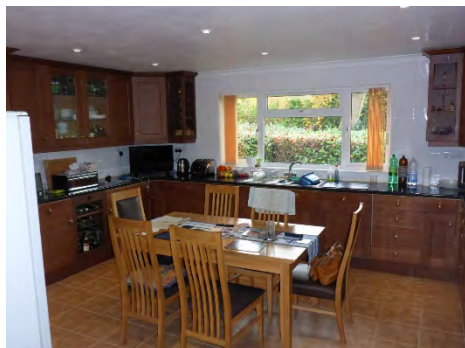
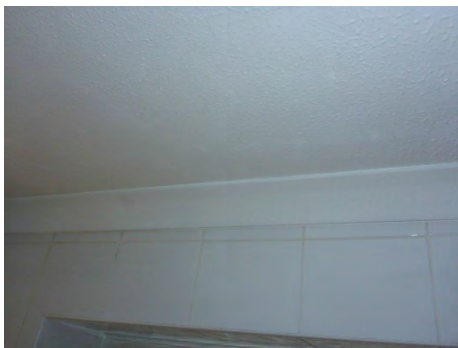
The ceiling is finished smooth and painted with emulsion and there is a Gyproc coving to the perimeter of the ceiling, the joints to which are cracked. None of the cracks suggest significant building movement or distortion and are more likely the result of general settlement and expansion. Prior to decoration the joints will need to be raked out, prepared and sealed with a flexible acrylic sealant.

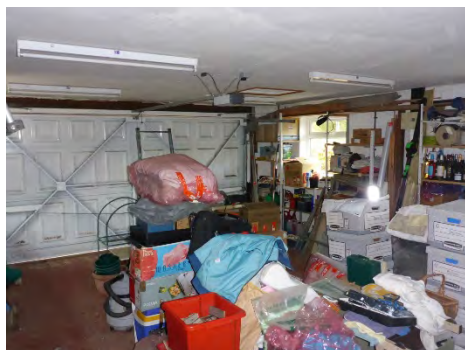
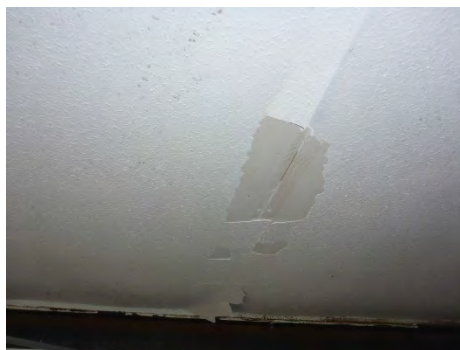
Textured coating is peeling

The ceiling is finished in a textured coating. Textured coatings are known to potentially contain asbestos and further information is provided later in the report. Areas of the textured coating to the joints of the plasterboard have peeled and given that this is just a garage, then repairs to the textured coating in these areas will suffice prior to complete redecoration.

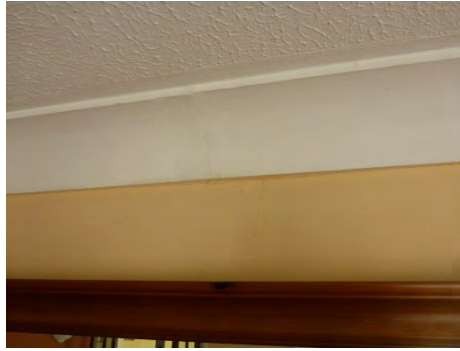
Wall crack

The walls are finished smooth and painted with emulsion. There is cracking above the chimney breast and above the double doors to the room. There is a Gyproc coving to the perimeter of the room, the joints to which have also cracked. None of the cracks suggest significant building movement or distortion and are more likely the result of general settlement and expansion. Prior to decoration the walls will need to be lined in Wallrock and the joints to the coving will need to be raked out, prepared and sealed with a flexible acrylic sealant. Wallrock is a non-woven material which is suitable for covering up untidy and poorly plastered surfaces including cracks.

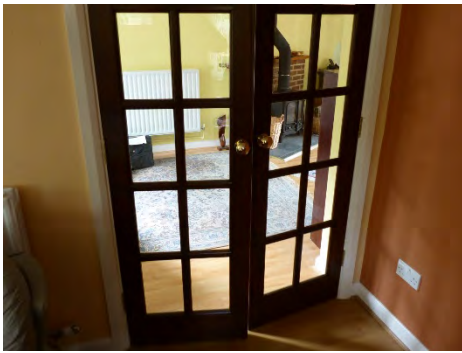
Glass to the internal doors and the side facing windows is in a critical location

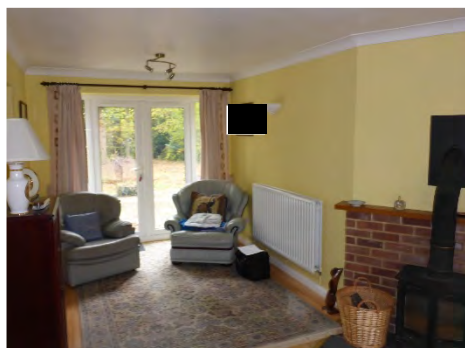
Cracks to the coving

There is a Gyproc coving to the perimeter the ceiling, the joints to which are cracked. None of the cracks suggest significant building movement or distortion and are more likely the result of general settlement and expansion. Prior to decoration the joints to the coving will need to be raked out, prepared and sealed with a flexible acrylic sealant.

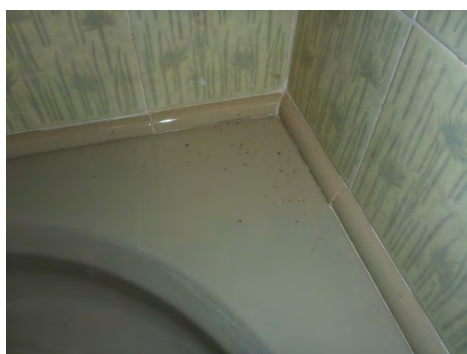
No sealant around the shower

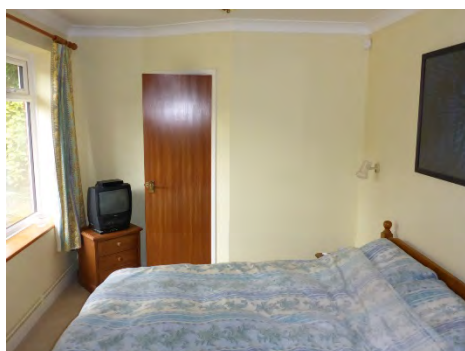
Ceiling cracks

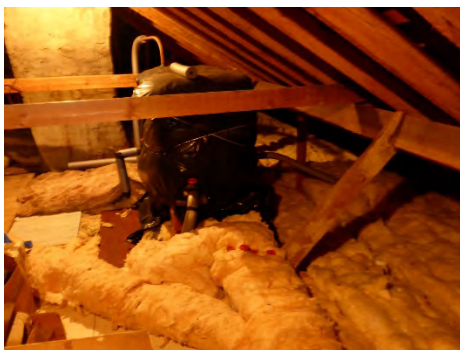
Insulation beneath the tank stand

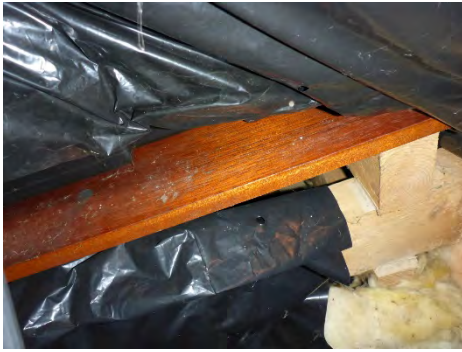
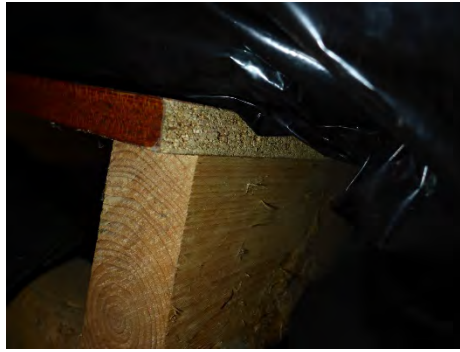
Water tank is supported on to chipboard

**Tank Support/Stand:** The cold water storage tank is housed on a sheet of chipboard.

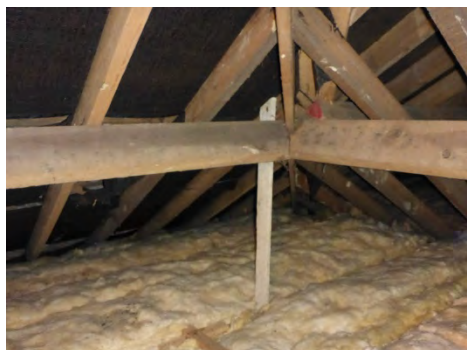
Hand cut roof is well braced and supported to the main building

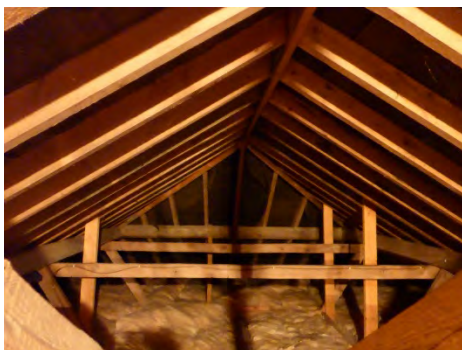
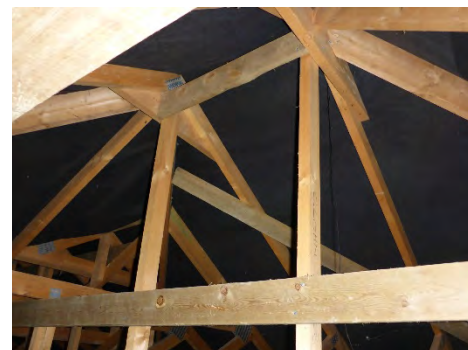
Trussed timber roof above extension

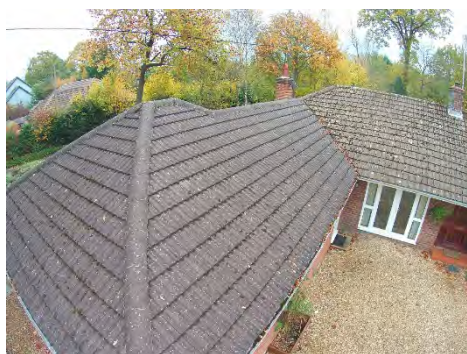
No visible means of ventilation to the roof timbers

Ventilation within the loft space is poor with no provision for ventilation provided either to the roof slopes or to the eaves. Cross ventilation at high and low level of the loft space is important to reduce the effects of condensation and resulting rot damage to roof timbers. Tile ventilators will need to be fitted to the external roof slopes at high and low level on all sides of the pitch roofs to provide suitable cross ventilation to roof timbers.

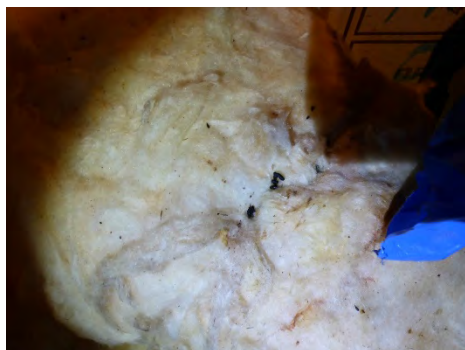
Rodent droppings on the insulation in the roof space

Rodent droppings were observed in the roof space. You are advised to seek advice from a specialist contractor and instigate a programme of eradication in relation to the rodents. Rodents can cause significant damage to the fabric of the building and in particular electrical cables in the loft space.

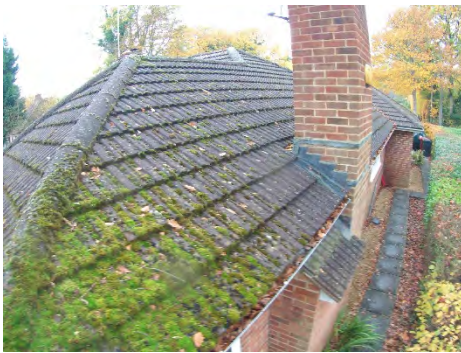
Heavy moss covering to the roof tiles

There is a heavy moss covering to the roof slopes. This moss will need to be brushed clear and under no circumstances should the roof be jet washed or cleaned with the use of harsh chemicals as this will undoubtedly accelerate wear and cause significant damage to the granular finish of the tiles.

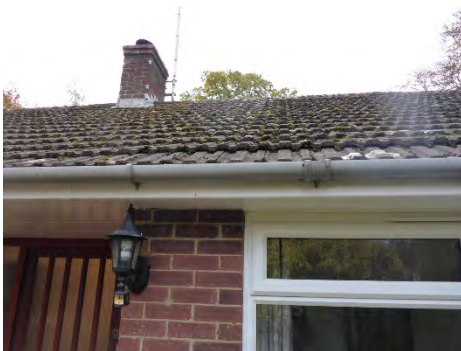
Bottom tile course has dropped

There are signs of the front tiles above the front entrance and window to the right side having dropped which is likely due to where the replacement fascia boards have been installed and they are slightly smaller than the original timber.

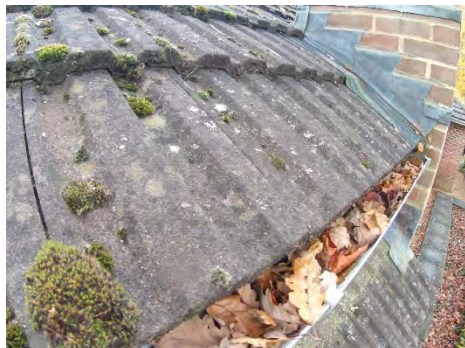
Gutters are full of leaves, moss and debris

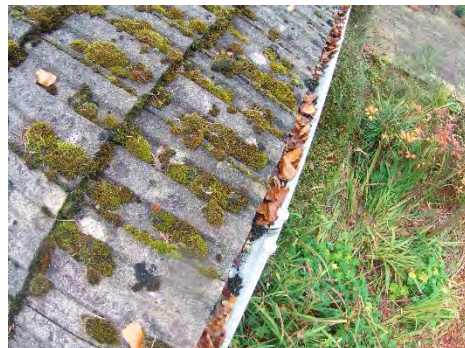
Leaky gutter joint to the front

A joint to the left side of the front entrance is leaking. The defective parts will need to be replaced.

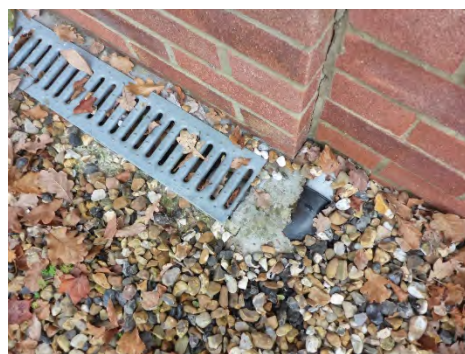
Rainwater pipe connected to gulley

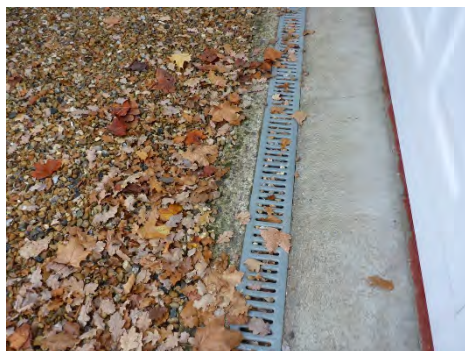
Rainwater gulley full of leaves and shingle

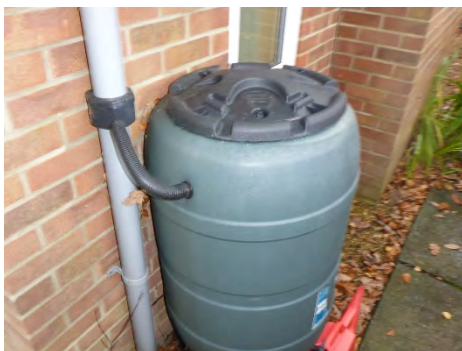
Water butt

The left side rainwater rear pipe is connected to a water butt and whilst this is an environmentally friendly way of collecting rainwater, it is important to ensure that the water butts are regularly emptied as leaking and overflowing water butts have the potential to cause damage to the fabric and foundations of the building.

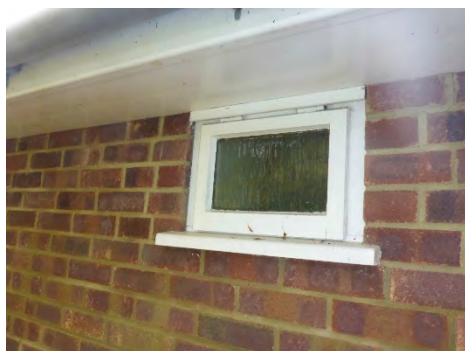
Wooden window to the right side

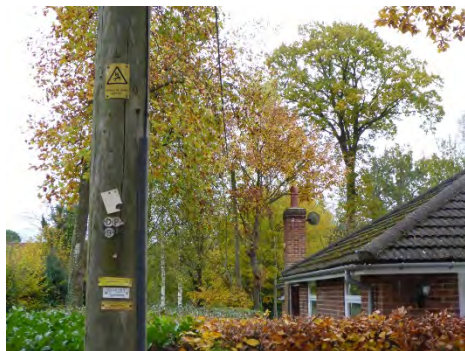
Overhead power supplies

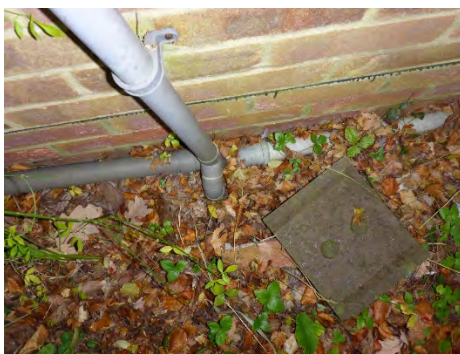
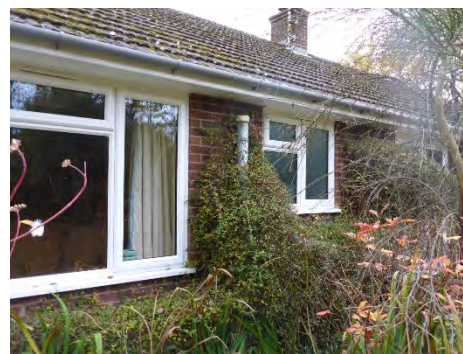
Durgo fitted to rear drainage vent pipe

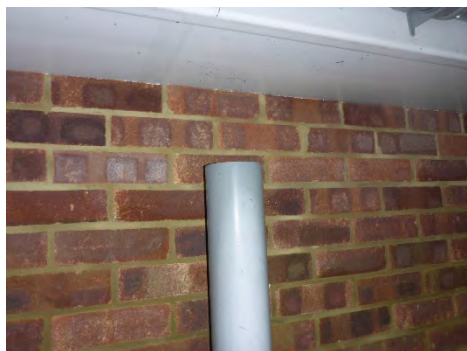
No cap to side vent pipe

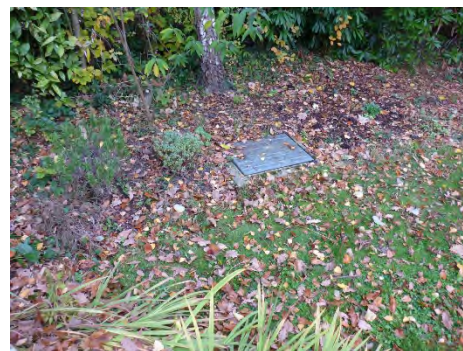
Cesspit inspection chamber cover to the rear
