# Survey Report

[REDACTED]  
[REDACTED]

Inspection Date 18 January 2019

Inspection by Matthew Brown AssocRICS MFPWS

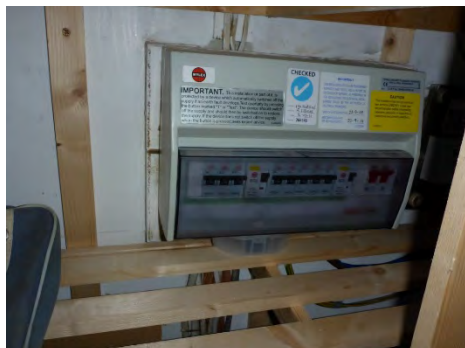
Fuse board

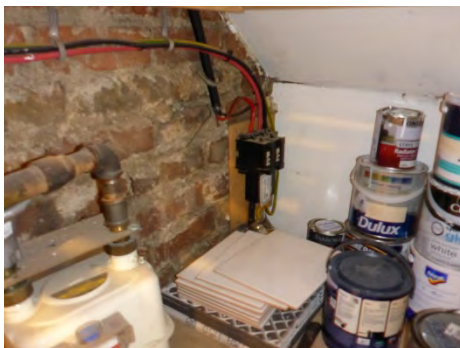
Main fuse

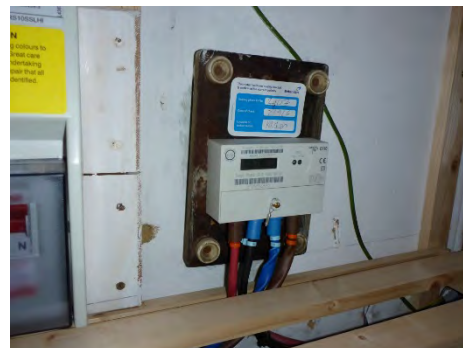
Electricity meter

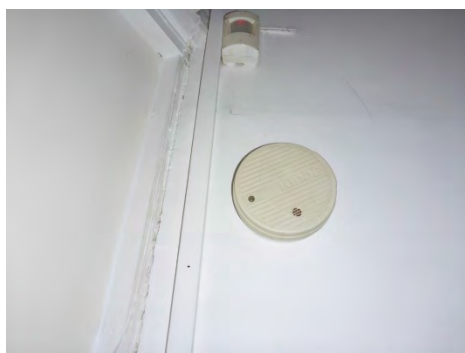
Battery powered smoke detection

| <input type="checkbox"/> Replacement fuse board | ✓ Mains powered smoke/heat detection system |

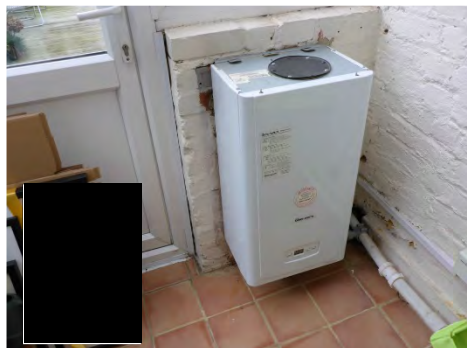
Wall mounted boiler

**At the time of the inspection, no certification of gas/oil safety or compliance was provided. Where this is not provided, our recommendation is to have the installation checked and certified by a qualified engineer as soon as practical after completion.**

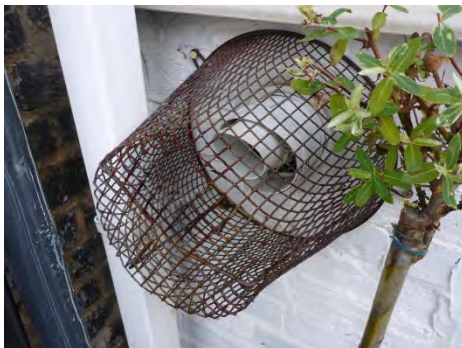
Fan assisted flue

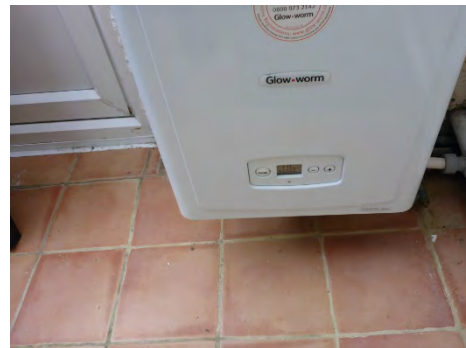
Boiler programmer

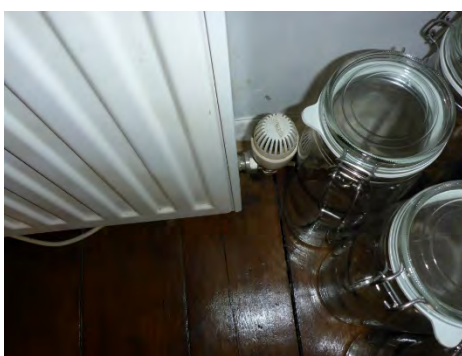
TRV's fitted to one radiator

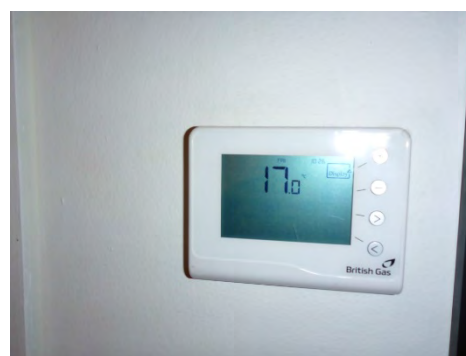
Thermostatic control

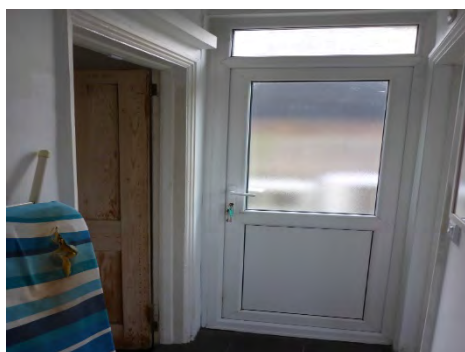
No heat installed to the front or rear hallways

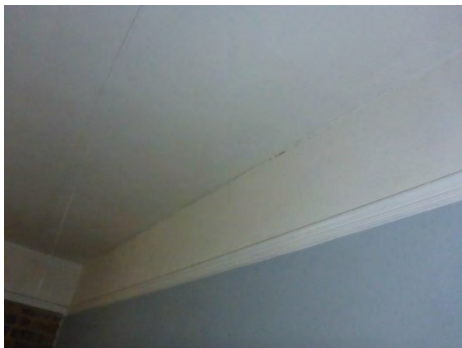
Ceiling line cracks

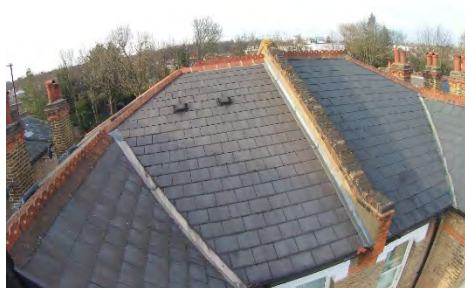
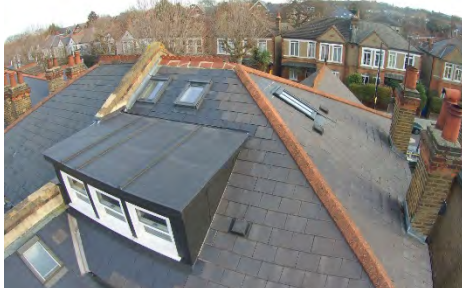
Ventilation to the roof timber is inadequate

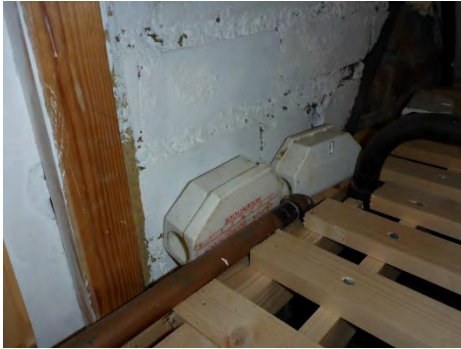
Rodent bait traps in the hall cupboard

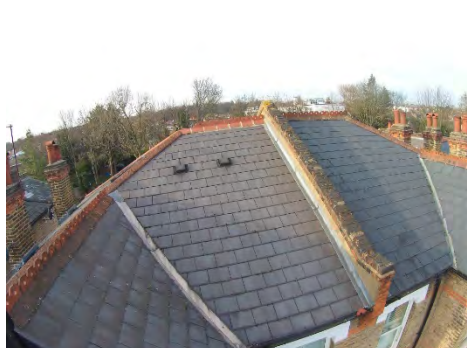
Front roof slopes

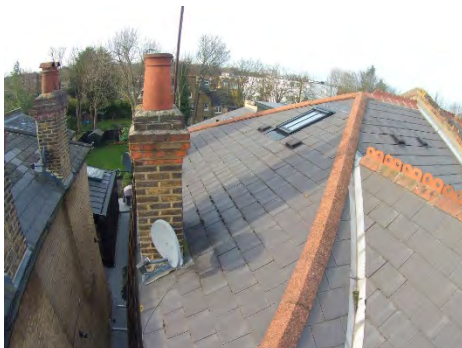
Side roof slopes

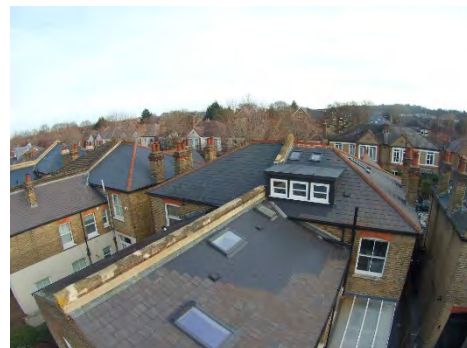
Rear roof slopes

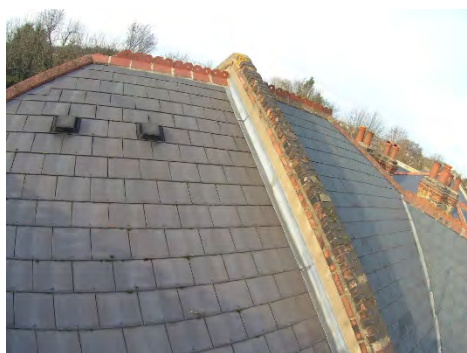
Lead flashing are longer than 1.5m

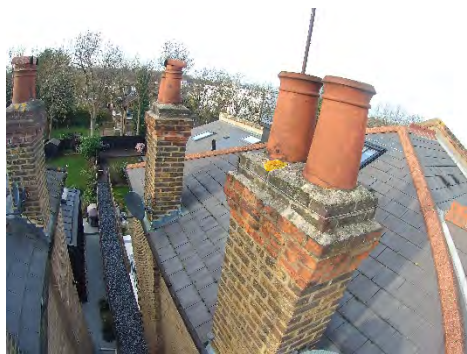
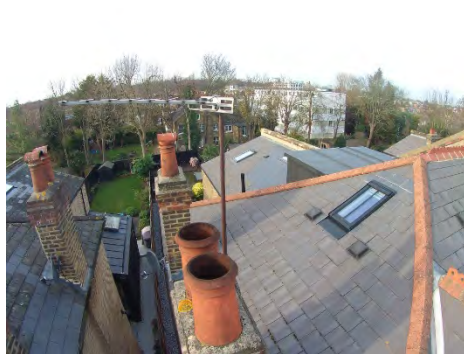
Open flues
