Home-Approved

Survey Report

Inspection Date 9 January 2019

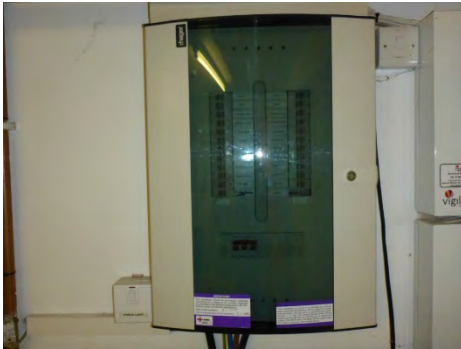
Fuse board

Details / Defects / Issues: The vendor advised that an inspection had been carried out the day before my inspection and certification had been provided to the building control department. Your legal adviser will need to confirm that the necessary building regulation approval or certification has been provided.

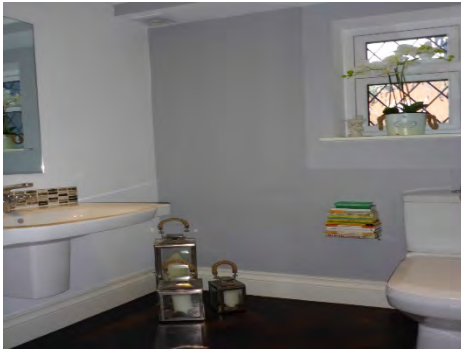
Tap to wash hand basin is loose

The tap to the wash hand basin is loose which can cause issues with undue pressure being placed on the water connections which may result in a leak. A plumbing contractor will need to attend and carry out repairs as necessary.

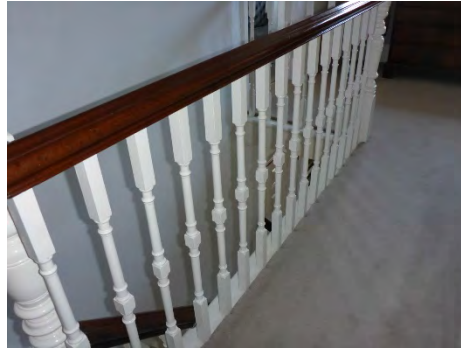
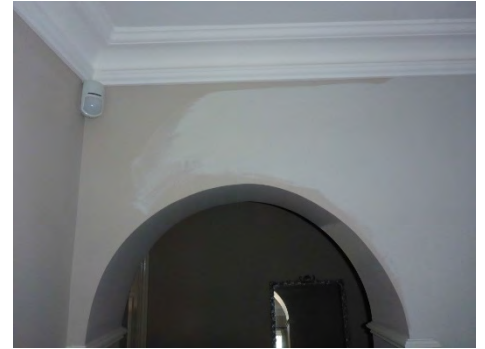
Decoration is poor

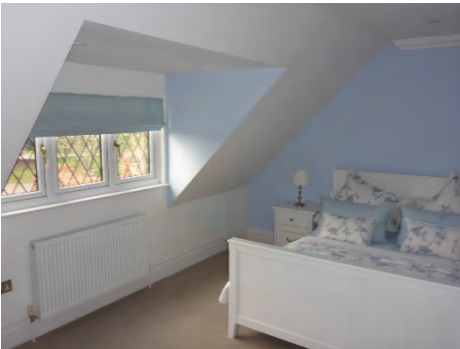
Corner cracks

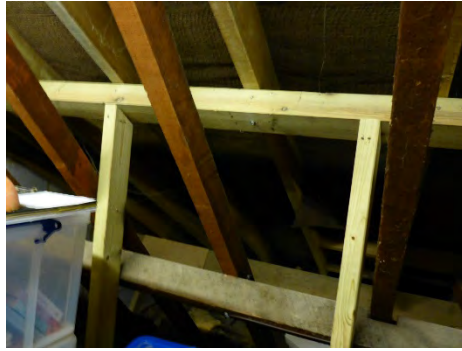
Additional supports installed to front and rear slopes

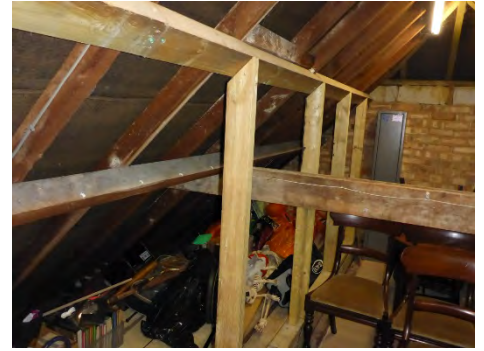
Extension roof has no central bracing

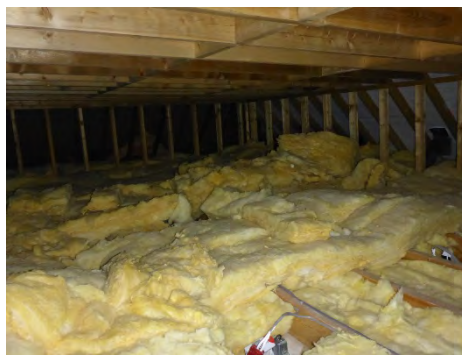
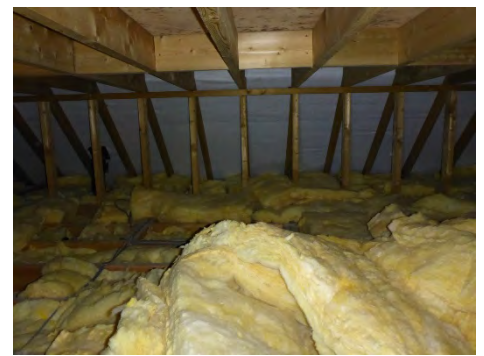
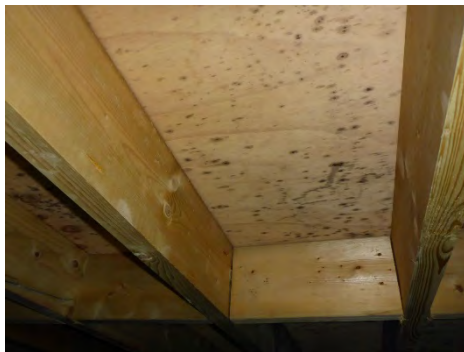
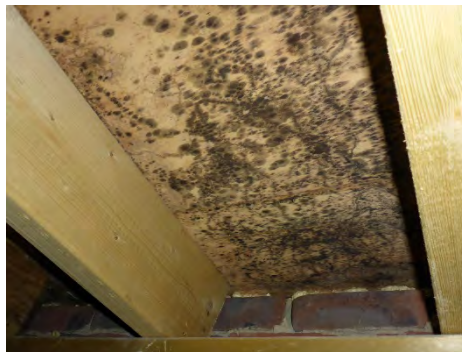
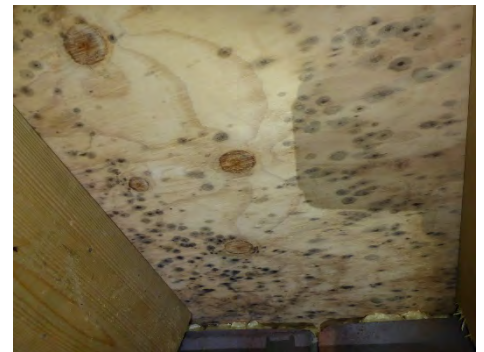
Mildew and mould growth to the underside of the flat roof decking

Ventilation within the loft space is poor with no provision for ventilation provided either to the roof slopes or to the eaves. In addition the ventilation to the flat roof extension is inadequate as it does not provide any means of cross ventilation. This has resulted in extensive mildew and mould growth on the underside of the flat roof decking.

Cross ventilation at high and low level of the loft space is important to reduce the effects of condensation and resulting rot damage to roof timbers. Tile ventilators will need to be fitted to the external roof slopes at high and low level on all sides of the pitched roofs to provide suitable cross ventilation to roof timbers.

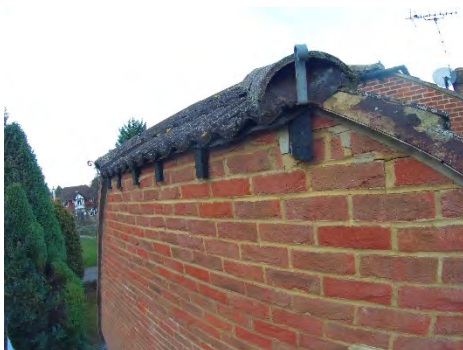
No gutter to side barn hip

There is no guttering installed to the right side barn hip of the roof and the porch. This means that rainwater is able to discharge directly onto the ground which in turn can cause issues with damage to the fabric and foundations of the building. Guttering and rainwater pipes will need to be installed.

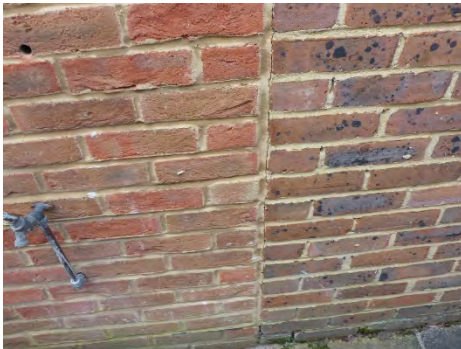
Vertical cracking at the junction between the original and extended walls

The various vertical junctions between the original building and the extensions and the joints to the brickwork around the lintels to some of the windows to the front and rear are showing signs of cracking. None of the cracks suggest significant building movement or distortion and are more likely the result of general settlement and expansion and differential movement between the different parts of the construction. The mortar joints will need to be raked out and re-pointed.

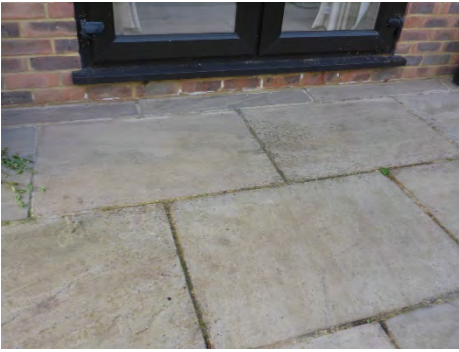
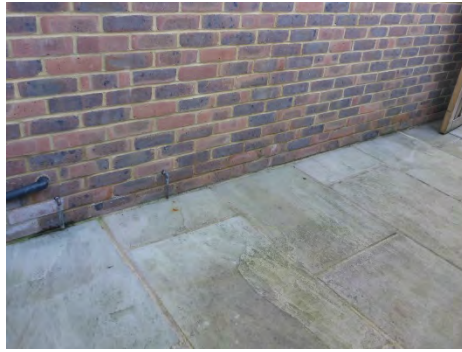
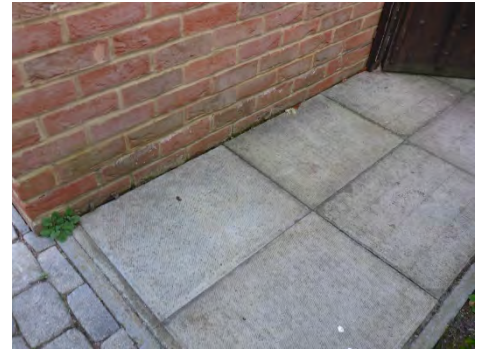
Ground levels to the front sides and rear are finished too high compared to the DPC

A felt DPC was identified to the original and the extended parts of the building but not to all sides as some of the mortar joints are fully pointed.

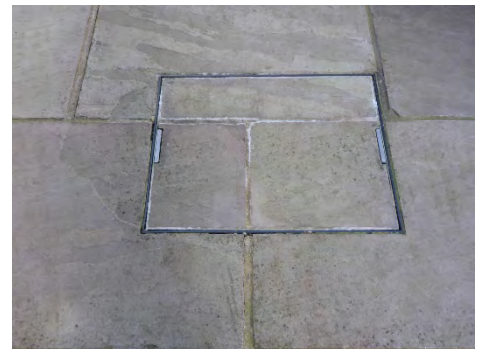
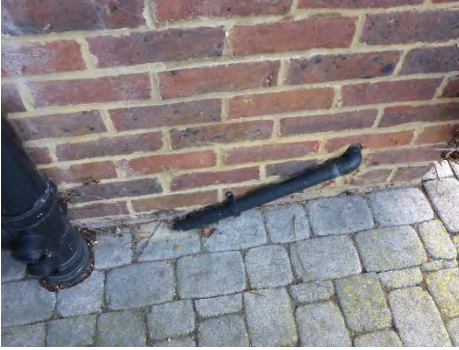
Poor connection and no rodding point

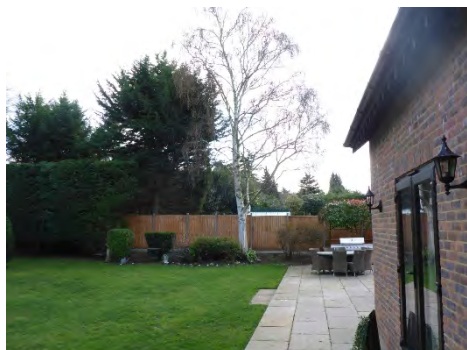
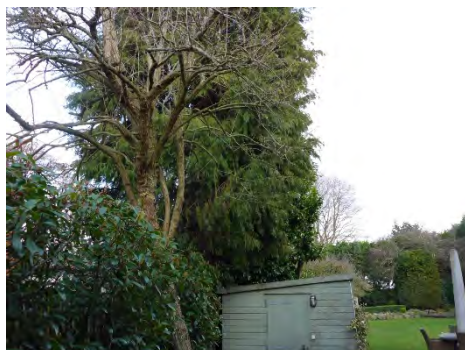
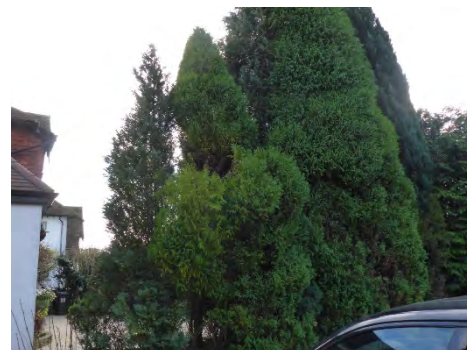
Large trees in close proximity to the building at the front and rear

Trees and shrubs can cause damage to foundations and underground services such as drainage. Where there are trees or large shrubs in close proximity to the property it would be appropriate to draw up a programme of management to restrict future growth to prevent possible damage.

There is a large creeping plant to the front elevation, the roots to which are known to potentially cause damage to the fabric and foundations of the building and our advice would be that the creeper should be removed.

Estimated Costs £800-1000.00

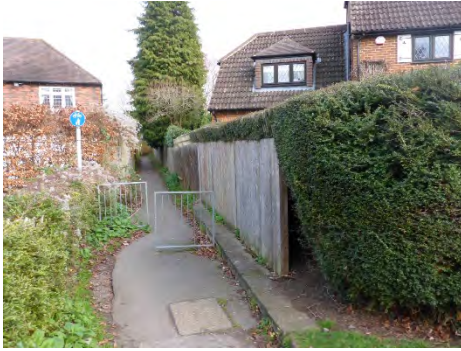
Public footpath to the left boundary
